N60 Breaffy Active Travel and Safety Measures Scheme

Stage 1 Road Safety Audit Report

Stage 1 Road Safety Audit

Document No: N60BA-ROD-GEN-SW_AE-RP-CH-301001 P02

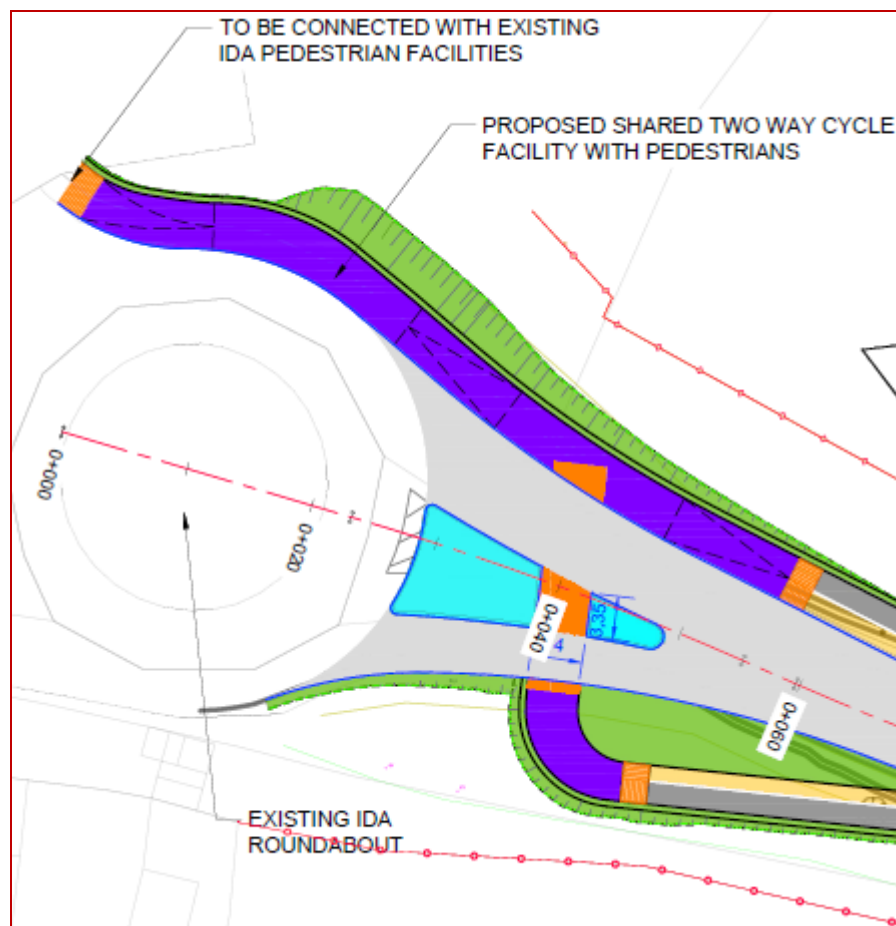
Drawing No. N60BA-ROD-HWY-SW_AE-DR-CH-30051 Rev.P01, it appears that the size of the splitter island has been increased on the eastern arm approach to the roundabout which could reduce the entry path curvature for vehicles travelling westbound along the N60 approaching the roundabout. This could result in high approach speed which could increase the likelihood of collisions between vehicles entering the roundabout and vehicles on the circulatory carriageway.

Figure 6.1: Entry Path Curvature at IDA Roundabout.

Care should be taken during the development of the design to ensure that adequate entry path curvature is provided.

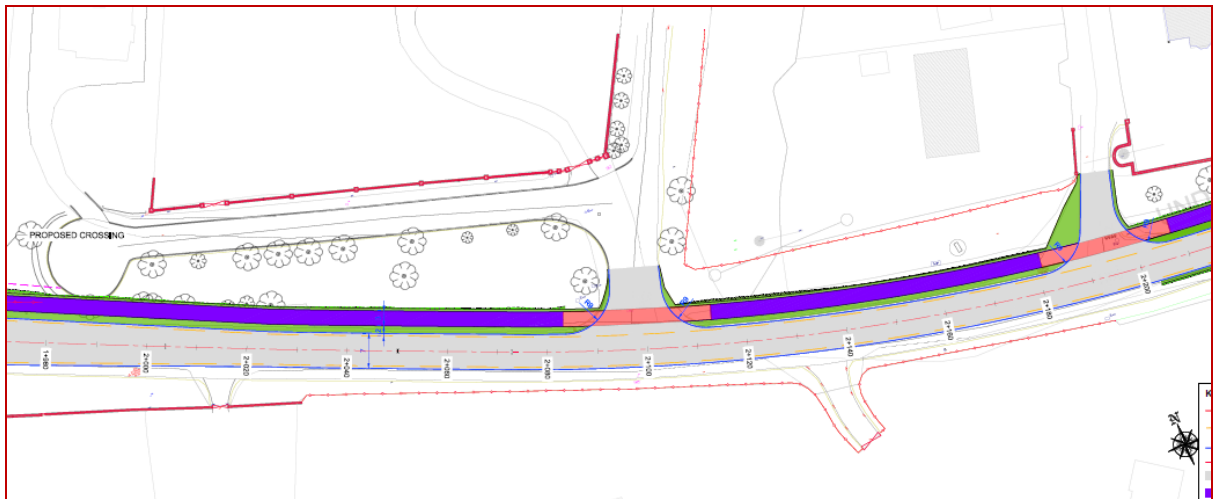
The drawings indicate the shared pedestrian / cyclist facility continuing across the mouth of direct accesses and junctions at various locations and it is unclear if priority lies with pedestrians / cyclists or with vehicles on the public road. It appears that the shared facility continues through the junction with the same priority as the mainline traffic. As this is a two-way shared facility, exiting vehicular traffic may not expect cyclists arriving from the opposite side of the road. This increases the risk of collision between vehicles entering and egressing the local road junction or direct access and pedestrians / cyclists on the shared facility crossing.

Figure 6.2: Typical Layout of Two-Way Shared Facility Crossing at Junctions and Direct Accesses

The shared facility pavement construction should be carried across the entrance to clearly indicate priority to pedestrian / cycle traffic and the road entrance should be at the same level as the shared facility. Appropriate road markings should be provided at the crossing to reinforce the arrangement.

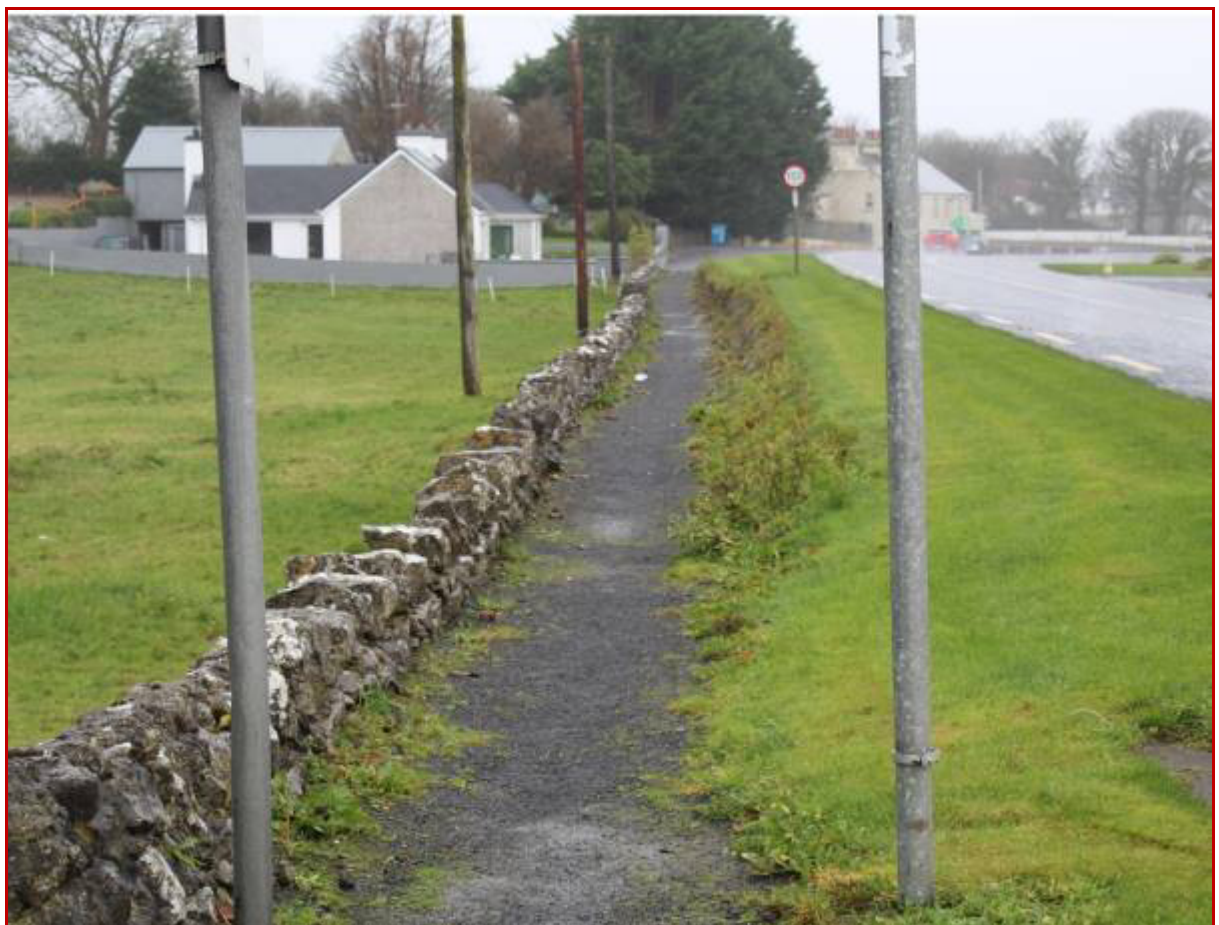
At various locations along the scheme, it was observed on site that existing signs, ESB and Telecom poles, public lighting poles and street furniture is located within the verge on either side of the N60. It is unclear if these will be relocated away from the shared facility to allow for adequate lateral clearance for cyclists travelling along the shared facility who might lose control and collide with a pole or street furniture.

Figure 6.4: Existing Sign Poles located within the Verge

The design should ensure that any existing signs, ESB / Telecom poles, street lighting poles and any street furniture are relocated away from the shared facility.

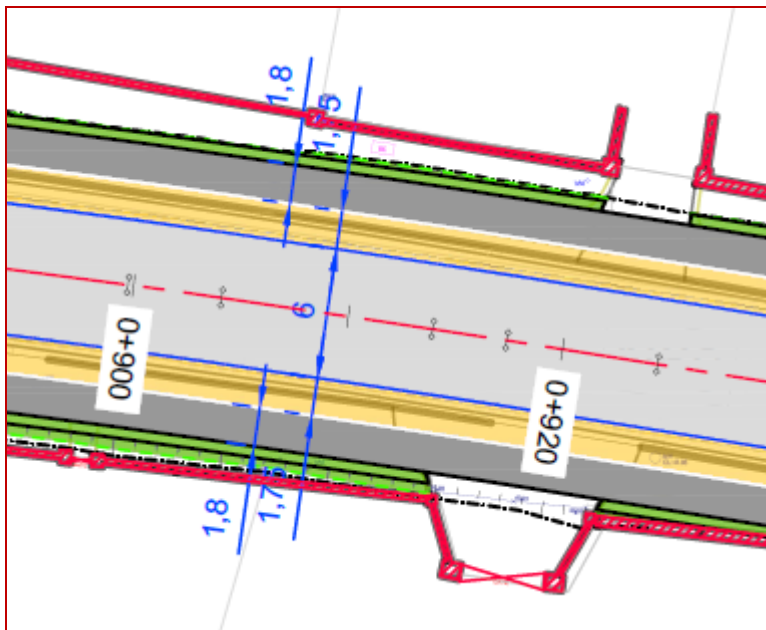
The drawings indicate that there are locations along the scheme where adequate lateral separation does not appear to be provided between the one-way cycle facility and the N60 carriageway, which could lead cyclists to unintentionally entering the carriageway, increasing the likelihood of cyclists colliding with vehicles travelling along the N60 which could result in serious injury to the cyclist.

Figure 6.5: Example of inadequate lateral separation between N60 carriageway and cycle facility

Adequate lateral separation should be provided between the N60 carriageway and the cycle facility along the full extent of the scheme.

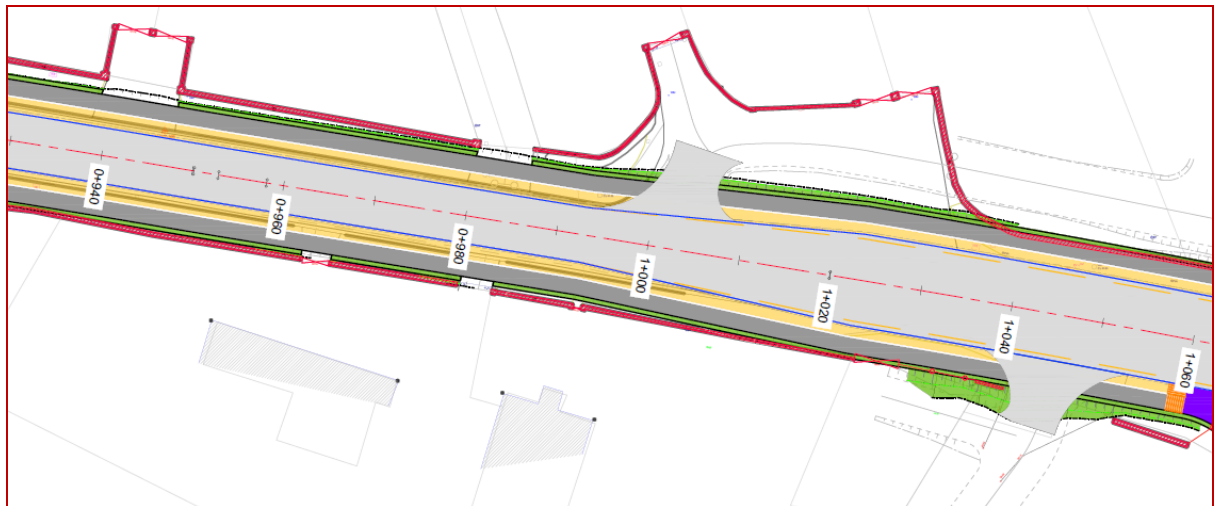
The drawings indicate the one-way cycle facility continuing across the mouth of direct accesses at various locations, and it is unclear if priority lies with the cyclists or with the vehicle on entry or egress to/from the direct access. This increases the risk of collision between vehicles entering and egressing the direct access and cyclists on the cycle facility crossing.

Figure 6.6: Typical Layout of One-Way Cycle Facility Crossing at Direct Accesses and Junctions

The cycle track pavement construction should be carried across the entrance to clearly indicate priority to cycle traffic. Cycle symbol road markings and additional paint lines should be provided to clearly indicate the presence of the cycle facility to motorists. Colour contrast could be provided along the cycle route warning cyclists of the upcoming conflict with motorised vehicles using the direct access. Adequate visibility splay should be provided so that drivers are aware of any oncoming cyclists.

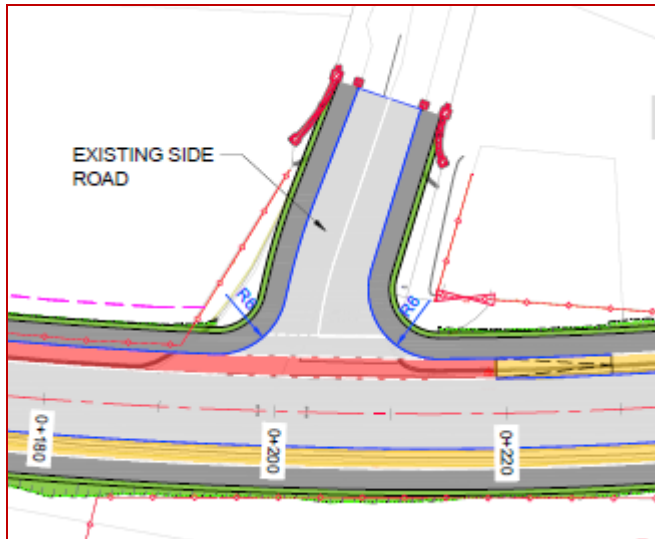
It is noted from the drawings that tactile paving is not indicated at the crossing point at various priority junction locations along the scheme. It is unclear if dropped kerbs are provided at the crossing point. This could increase the likelihood of visually impaired pedestrians being unaware of the presence of the junction and unintentionally entering the carriageway and colliding with vehicles, which could result in serious injury to the pedestrian.

Figure 6.7: Typical Layout of One-Way Cycle Facility Crossing at Priority Junction

Care should be taken during the development of the design to ensure that appropriate tactile paving and dropped kerbs are provided throughout the scheme.

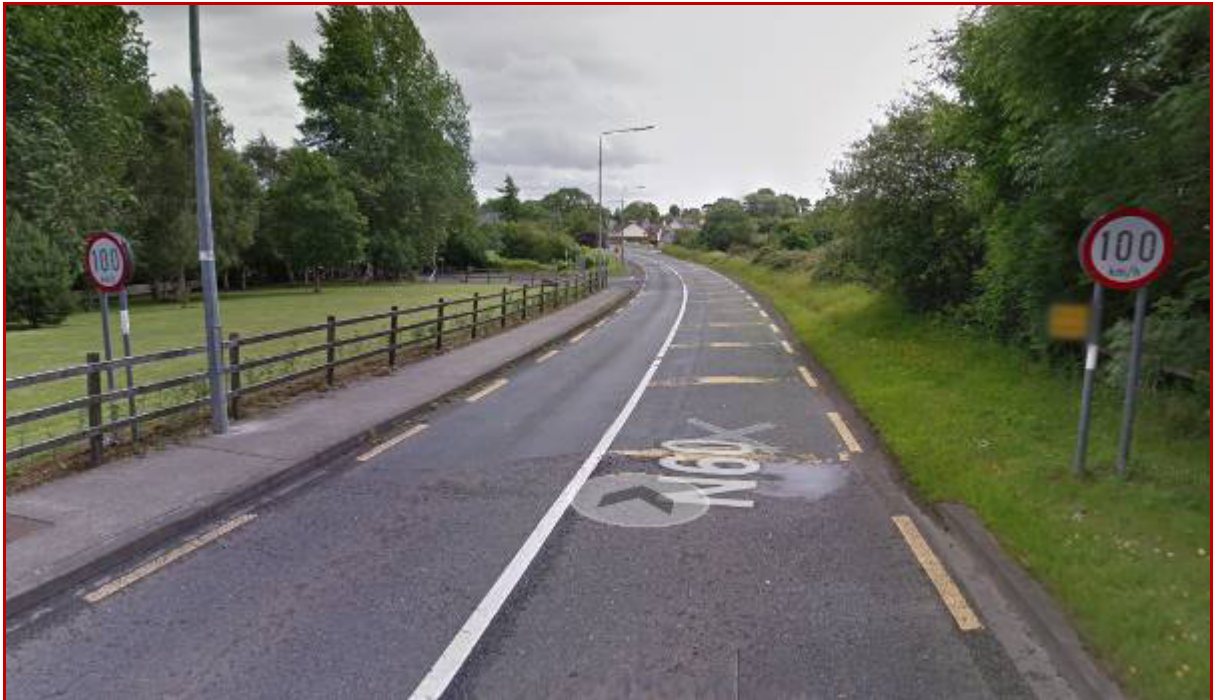
It was noted on Google Street View that a 100kmh speed limit sign is located within the verge along the N60 on the eastern side of the IDA Roundabout. It appears that this is inconsistent with the speed limit zones shown on the scheme drawings, which indicate a 60kmh speed limit zone at this location. This could lead to drivers driving at inappropriately high speed at this location.

Figure 6.8: Existing 100kmh Speed Limit Signs Within the 60kmh Zone for the Scheme

Care should be taken during the development of the scheme to ensure that existing speed limit signs are consistent with the speed limit zones for this scheme and any signs which do not comply with the proposed speed limit zones of the scheme should be removed

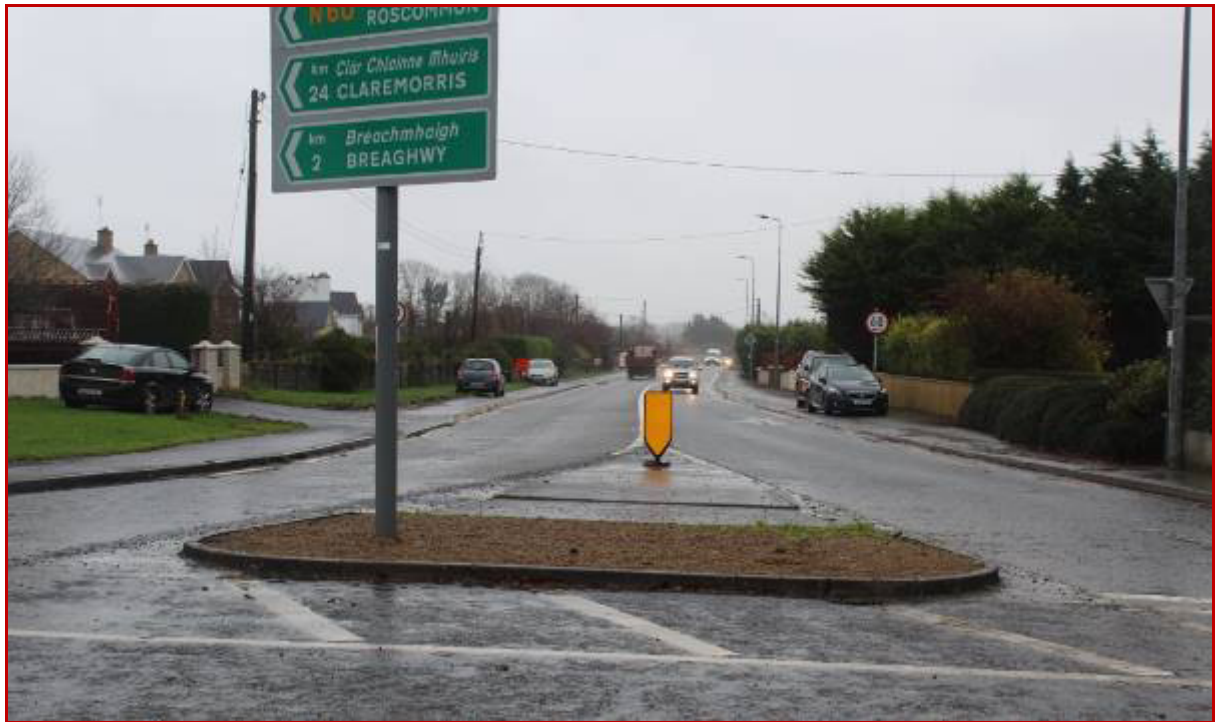
It was noted on site that vehicles were parking within the grass verge and footpath on either side of the N60 approaching Kilkenny Cross Roundabout. This could lead to vehicles colliding with a vehicle door being opened out towards the carriageway by a person in the parked vehicle. Parking could impede forward visibility of drivers approaching the roundabout which could lead to collisions between vehicles on the N60 carriageway. Parking could impede visibility of drivers to pedestrians crossing at the entry to the roundabout. Parking could also impede pedestrian movements, causing them to step into the carriageway, increasing the risk of collision with vehicles.

Figure 6.9: Parking within N60 Verges and Footpaths adjacent to Kilkenny Cross Roundabout

Care should be taken during the development of the design of the scheme to prevent vehicles from parking within the grass verges and footpaths on the approach to the roundabout junction.

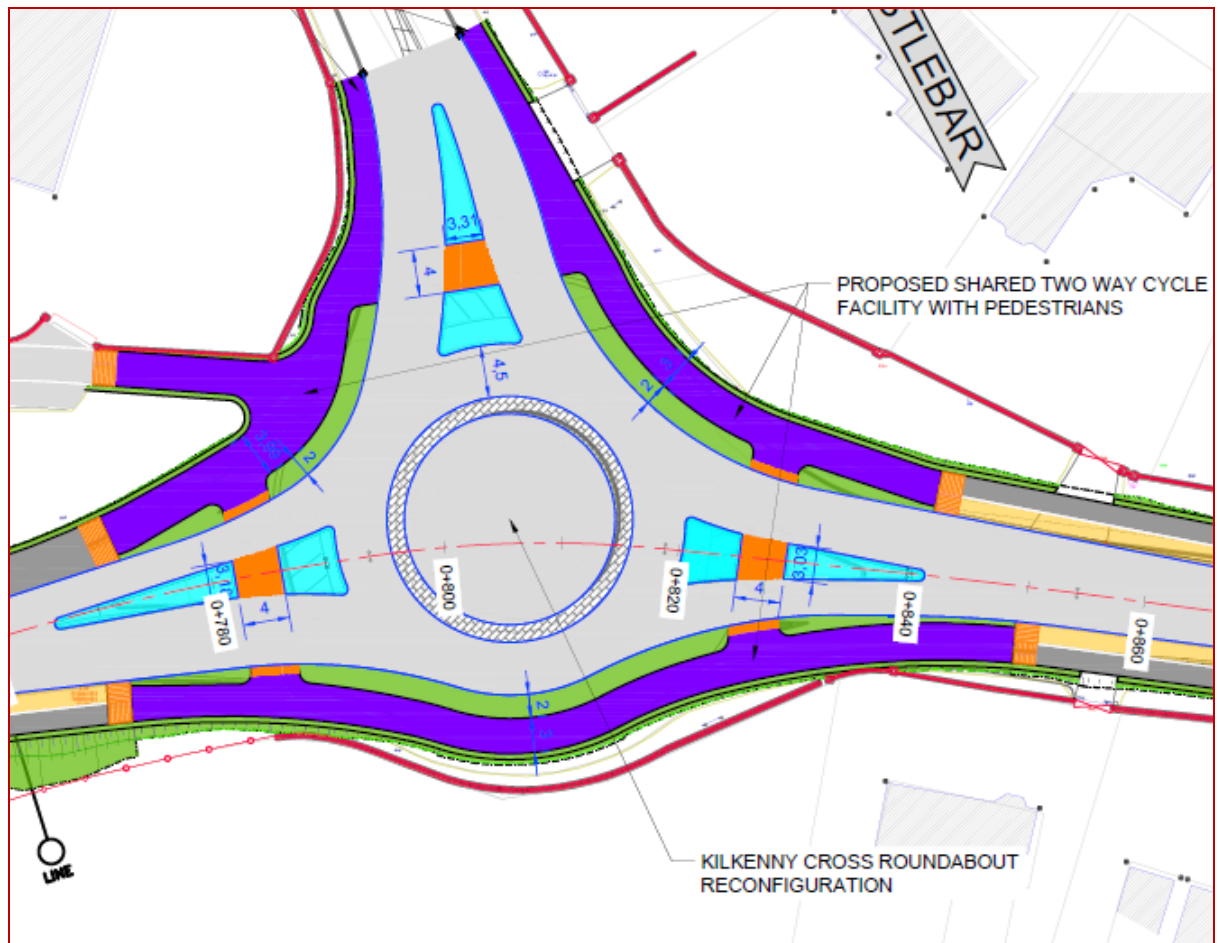
The drawings provided indicate that the layout of the roundabout with segregated cycle facilities may not be consistent with other roundabout junctions in this area. It is unclear if the layout is readily understandable by cyclists in that they will need to use the crossing points at the splitter islands to travel around the roundabout. The typical roundabout layout in similar locations, cyclists are required to use the circulatory carriageway. This could increase the likelihood of collisions between cyclists and pedestrians / vehicles if cyclists fail to use the dedicated crossing points.

Figure 6.10: Kilkenny Cross Roundabout – Reconfigured Layout with New Pedestrian & Cyclist Facilities

Care should be taken during the development of the design of the scheme at this roundabout junction to ensure the layout is clear to cyclists so that they understand the roundabout layout. Additional signing, lining and appropriate road markings should be provided to help cyclist understand the new layout.

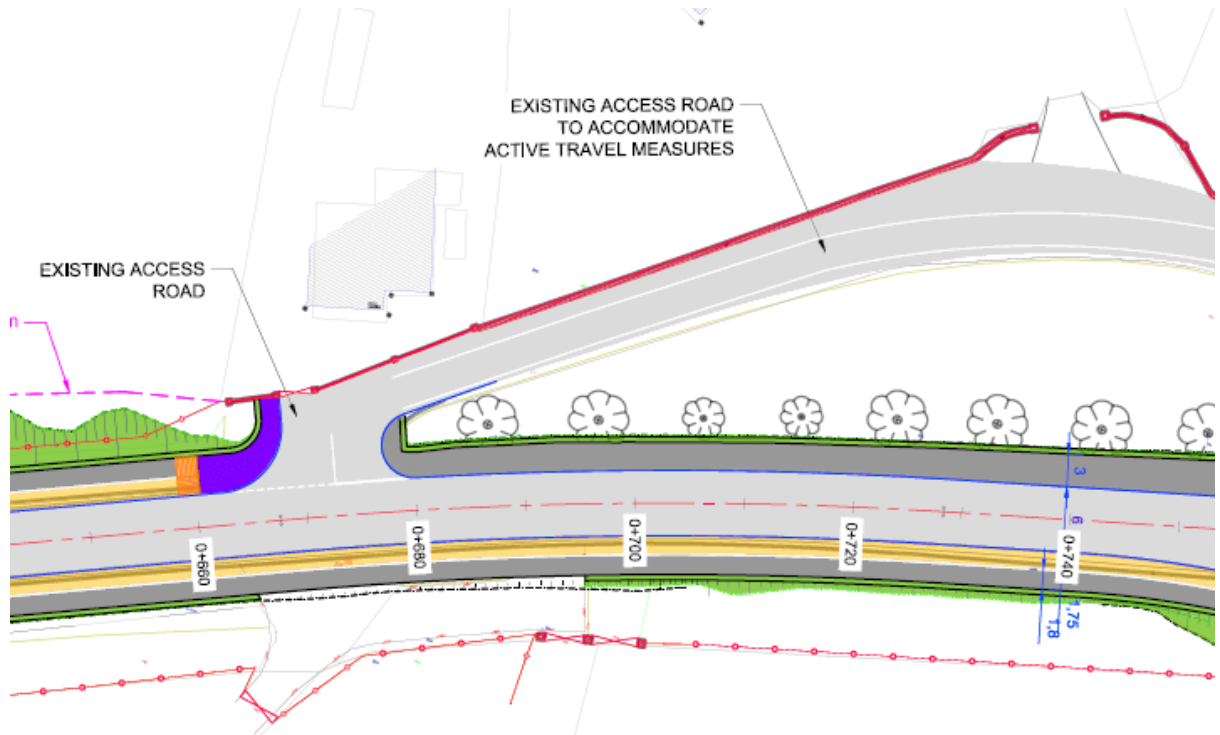
The drawings provided indicate that the bell mouth at the junction to the access road at Ch.670 has been tightened, with a corner radius of $R=2.5m$ provided at the eastern corner of the junction. It is noted that the access road is on a sharp skew angle approaching the junction with the N60. Should an insufficient swept path be provided to cater for turning requirements of HGV's and large vehicles turning left from the access road onto the N60 this could increase the likelihood of large vehicles over-running the footpath and colliding with pedestrians which could result in serious injury to the pedestrian. HGV's and large vehicles turning left from the access road may need to use the opposing lane to complete the turning manoeuvre which could

Figure 6.12: Sharp Skew angle at junction Between N60 and Access Road

Care should be taken to ensure that the corner radius is adequate to cater for the turning requirements of HGV's and large vehicles.

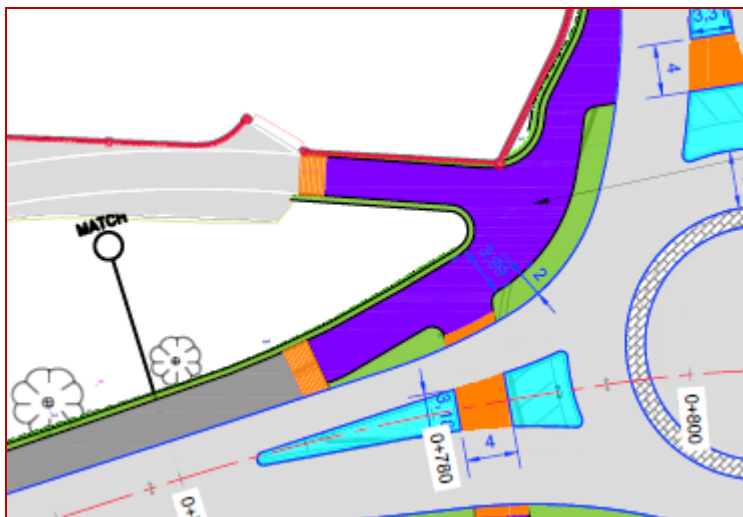
Figure 6.15: Shared Area Link to Footpath at Kilkenny Cross Roundabout

Care should be taken during the development of the design to ensure that cyclists are provided with a clear route through the roundabout junction.

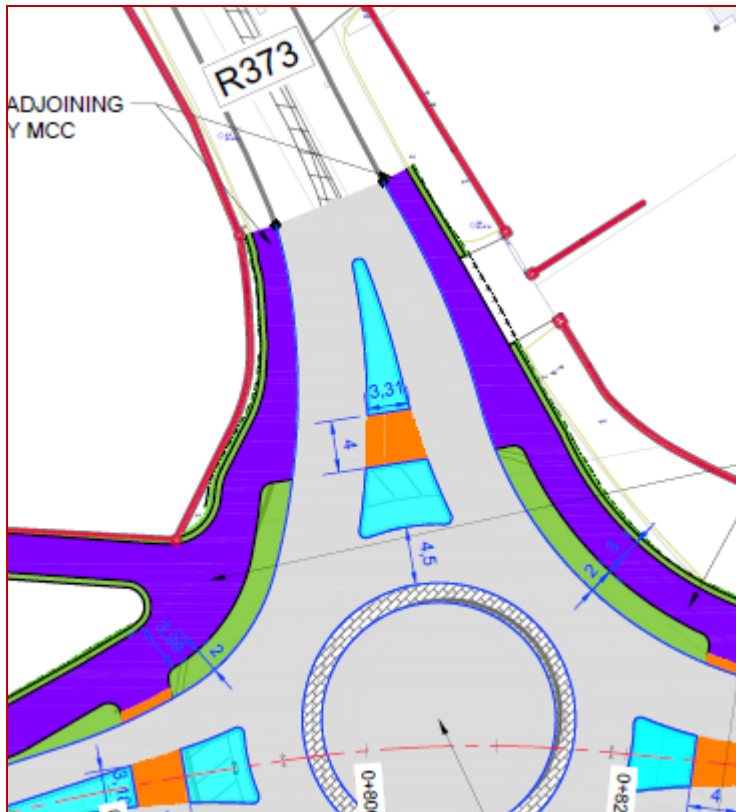
Figure 6.16: Direct Access at Kilkenny Cross Roundabout

Care should be taken during the development of the design to prevent a driver egressing the direct access to turn right onto the R373. A no-right turn sign should be

provided opposite the direct access and the length of the splitter should be increased to prevent right-turning from the direct access.

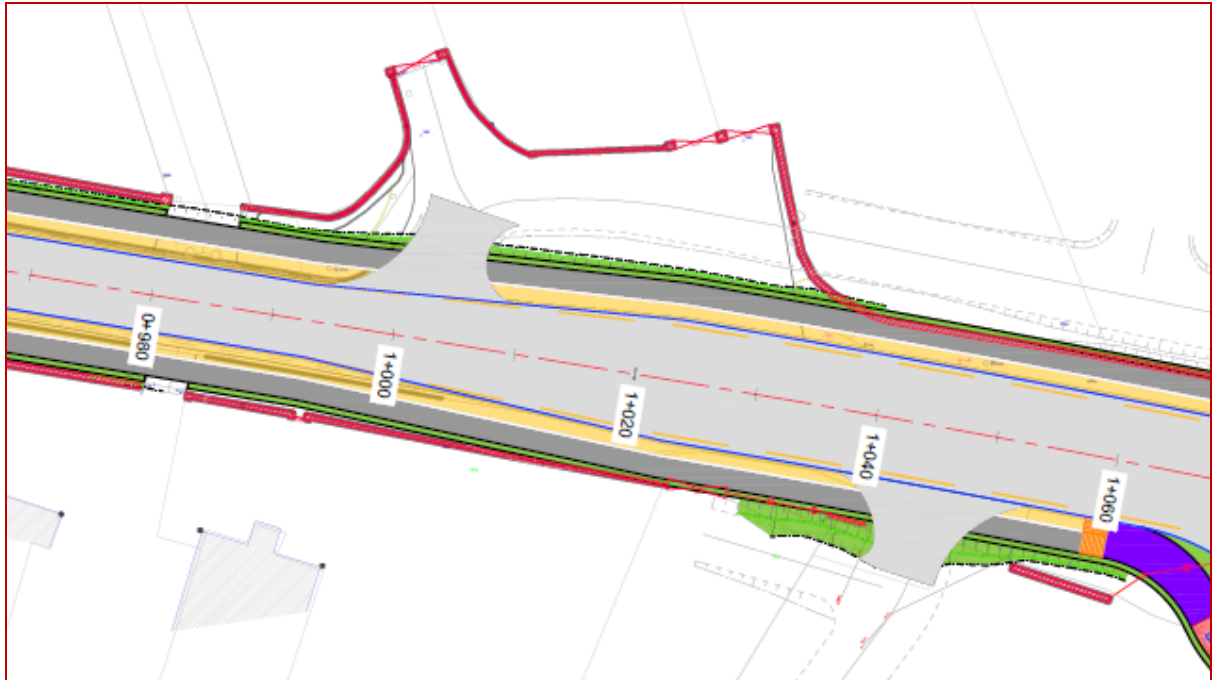
The drawings provided indicate that the proposed road widths narrow, and it is noted that the taper rates appear to be sharp at various locations along the scheme. This could increase the likelihood of drivers colliding with the kerb at the narrowing sections, particularly at night.

Figure 6.18: Example of Taper along N60

Care should be taken during the development of the scheme to ensure that a smooth transition in road width is provided at these locations. Warning signs should also be provided to inform drivers that the road narrows ahead.

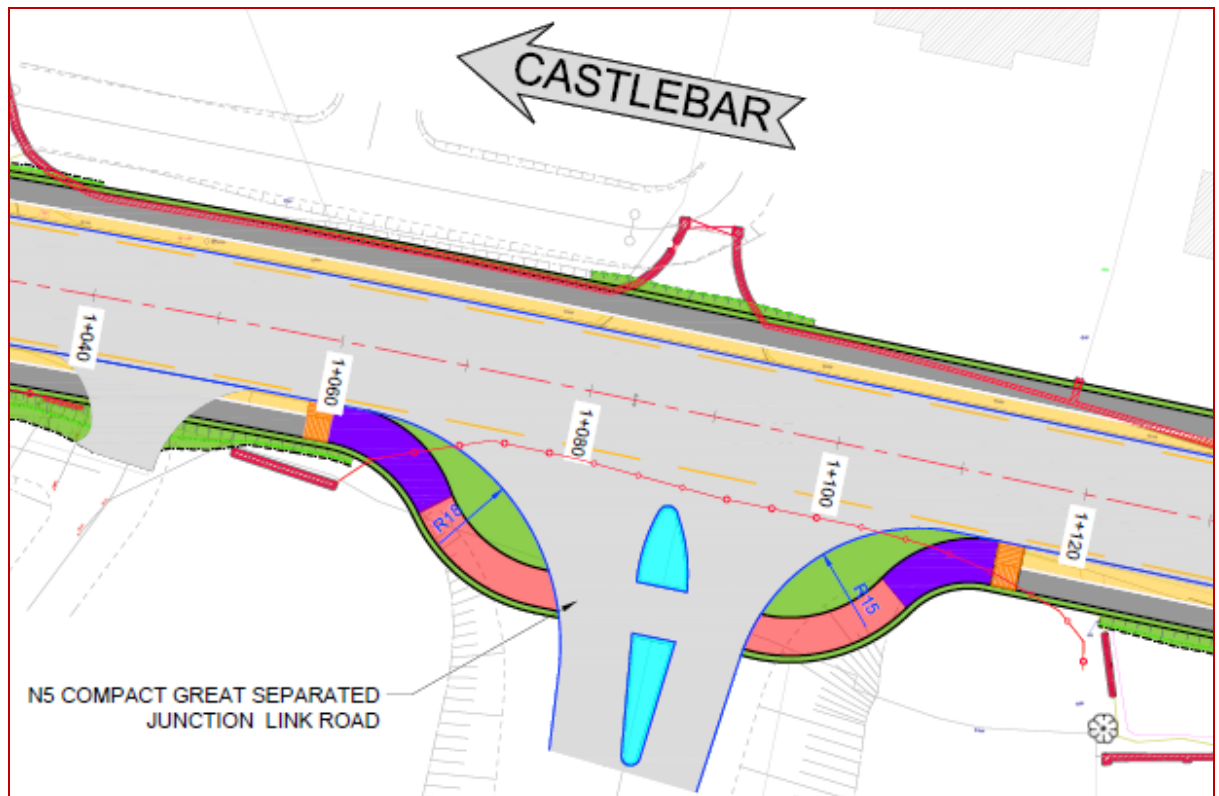
Figure 6.19: Example of Central Island at Bend Out Crossing

Care should be taken during the development of the scheme to ensure that the central island at bend out crossings is safe for use by pedestrians and cyclists.

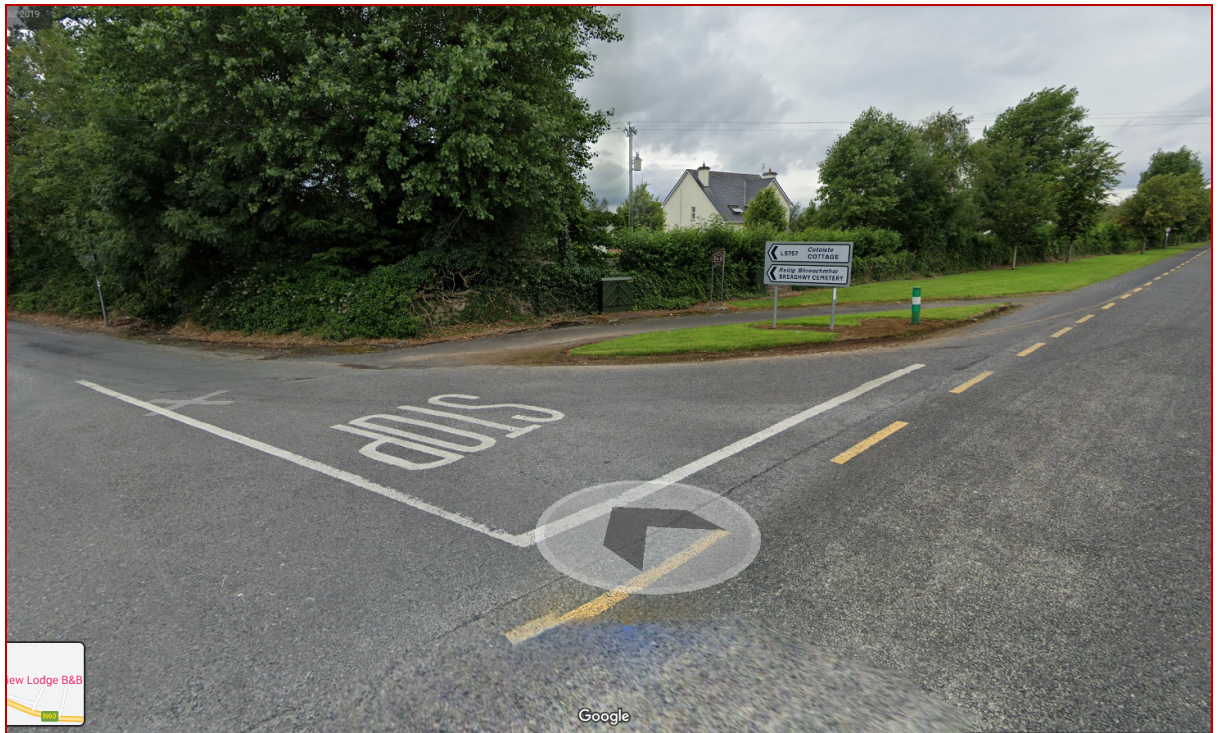
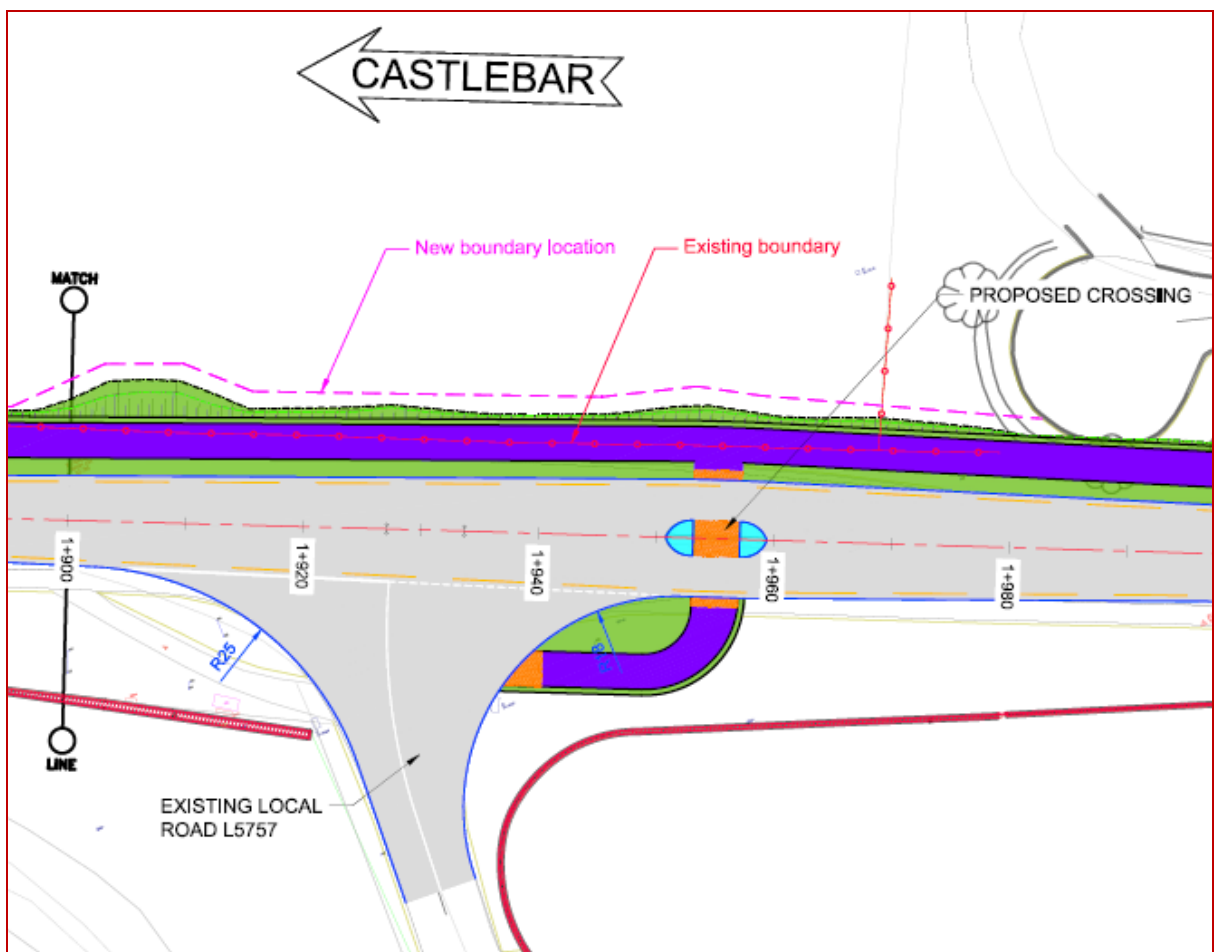
Drawing No. N60BA-ROD-HWY-SW_AE-DR-CH-30053 Rev.P01 indicates that a new crossing point for pedestrians and cyclists is located adjacent to Local Road L5757, however, it is unclear if the crossing point is linking to an existing footpath on the southern side of the N60. If a pedestrian / cycle facility is not provided at this location this could increase the likelihood of pedestrian and cyclists entering the carriageway at an inappropriate and unsafe location.

Figure 6.20: Existing Layout at Priority Junction at Local Road L5757

6.20a: Proposed Crossing Point at Priority Junction at Local Road L5757

Care should be taken during the development of the scheme to ensure that a pedestrian / cycle facility is provided on the southern side of the N60 at this location, linking to the crossing point. If it is not intended to provide a pedestrian and cycle facility, the provision of the new crossing point should be relocated.

6.20	Yes	No	It is not intended to provide a pedestrian and cycle facility on the south of the N60. The existing short section of footpath west of the junction will be removed to avoid confusion. The crossing is provided to connect housing on the L5757 to the new facility and has been located to be consistent with previous recommendation that this should be on the right of the junction.	Yes

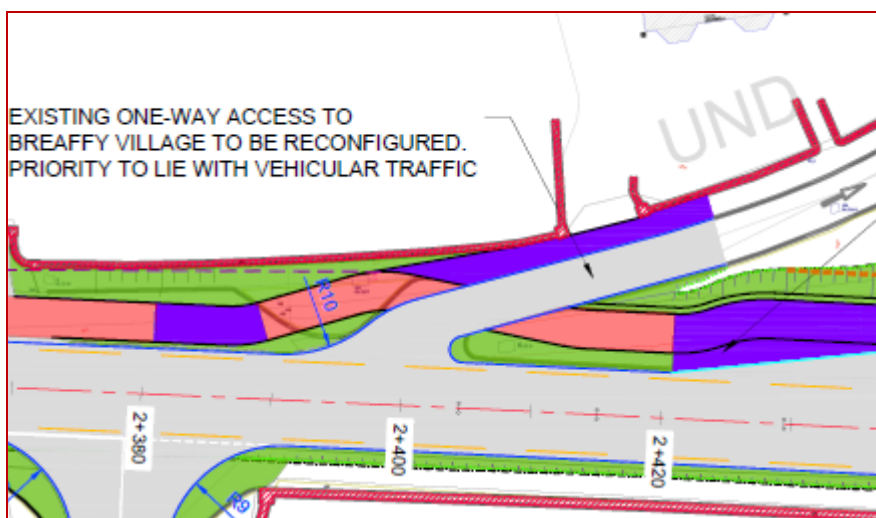
Drawing No. N60BA-ROD-HWY-SW_AE-DR-CH-30054 Rev.P01 indicates that a new crossing point is located at the existing one-way access road to Breaffy Village. It is unclear if kerbing is provided at this location. Without the provision of kerbing, drivers turning left off the N60 could over-run the grass verge to smoothen the turn and thus maintain higher speed. It is noted that tactile paving is not provided at the crossing which could increase the likelihood of visually impaired pedestrians unintentionally entering the carriageway and colliding with vehicles.

Figure 6.21: Proposed Crossing Point at One-Way Access to Breaffy Village

Care should be taken during the development of the scheme to ensure that kerbing is provided to clearly define the junction and tactile paving should be provided to cater for the requirements of visually impaired pedestrians.

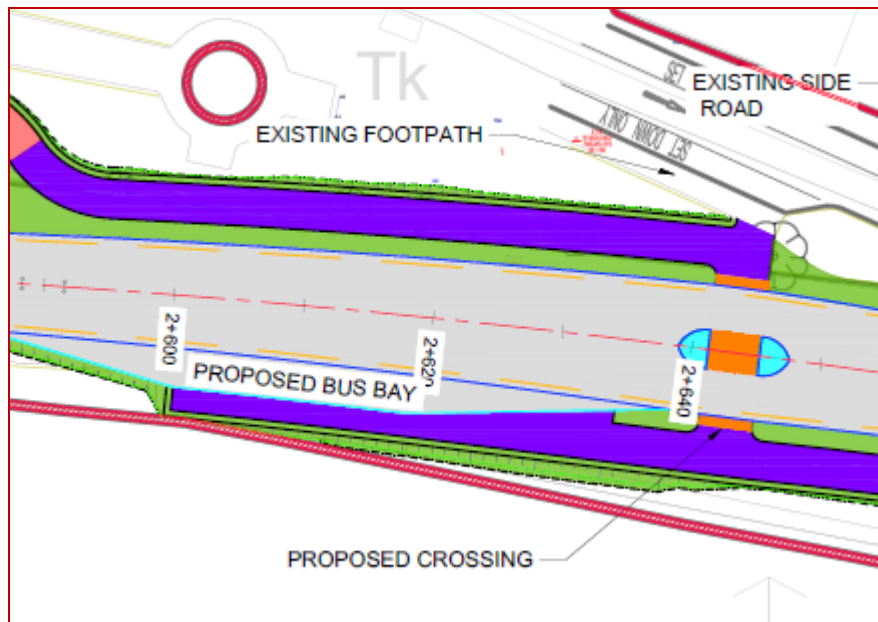
Figure 6.22: Shared Facility Crossing Point at Breaffy Village

Care should be taken during the development of the design to ensure that pedestrians / cyclists are informed that the shared facility switches to the opposite side of the N60 and are directed to the crossing point with provision of signs or road markings.

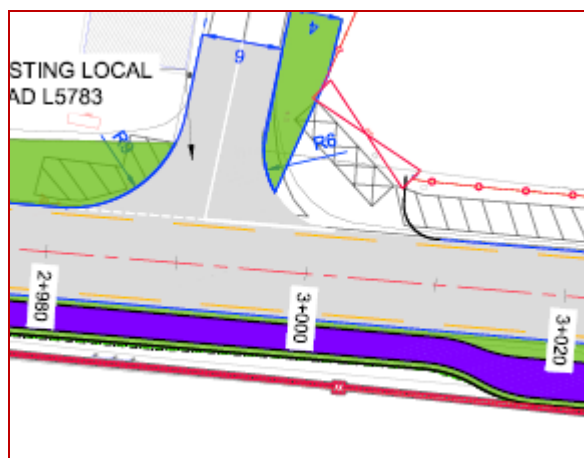
Figure 6.23: Access to Premises on Eastern Side of Priority Junction at the L5783

Care should be taken during the development of the scheme to ensure that access is not permitted to the premises via the corner of the priority junction. A single defined access to the premises should be provided which should be located away from the priority junction to enable clear demarcation between the direct access to the premises and the priority junction.
