Visual Inspection Record
On
Trial Holes
At
Tom Ruane Park, Ballina, Co Mayo
For
Sensory Park Project

Prepared by Enda Jones, Eng Dip, MIEI

On behalf of Mayo County Council Ballina Municipal District

28th May 2021

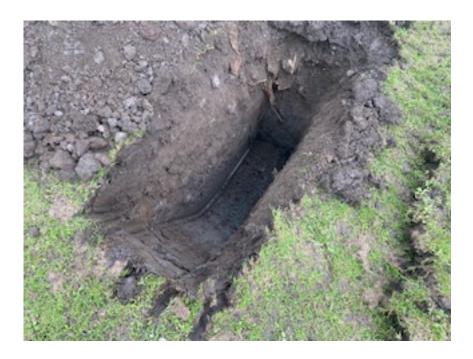
Trial Hole No 1			
Depth 1200mm			
Depth	Description	Colour	Density/compactness
0mm-150mm 150mm-700mm	Top Soil Brown clay	Brown	Soft
	With waste fill	Brown	Loose
700mm-1200mm	Grey daub	Grey	Firm

Trial Hole No 1 – Clay/Waste material mix to 850mm below surface

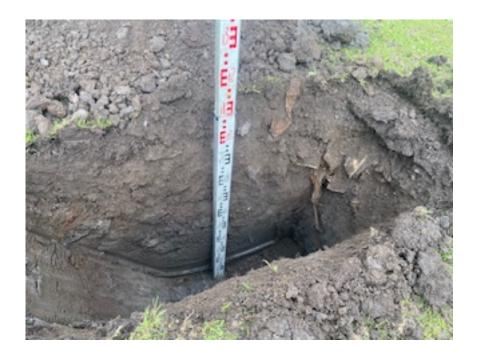
Trial Hole No 1 – 1200mm depth to bearing ground

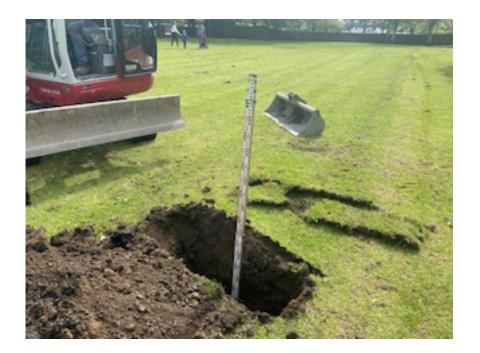
Trial Hole No 2				
Depth 1100mm				
Depth	Description	Colour	Density/compactness	
0mm-150mm 150mm-500mm	Top Soil Brown clay	Brown	Soft	
500mm-1100mm	With waste fill Dauby Clay	Brown	Loose	
	With waste fill	Brown	Firm

Trial Hole No 2 –1100mm depth

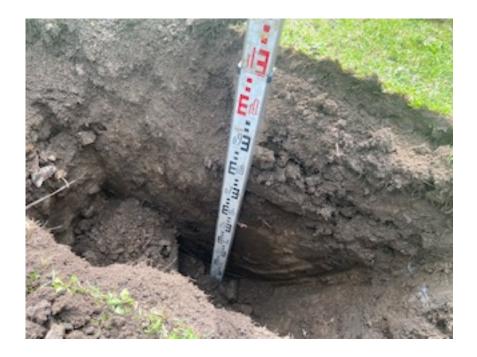
Trial Hole No 2 – Clay/Waste material mix to 750mm below surface

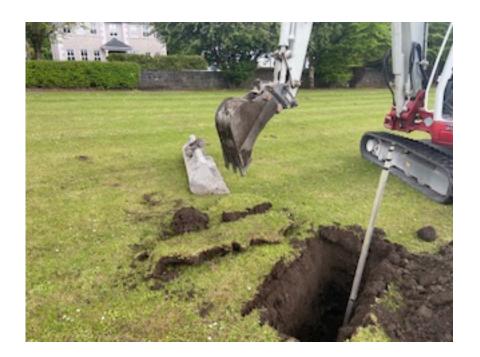
Trial Hole No 3				
Depth 1200mm				
Depth	Description	Colour	Density/compactness	
0mm-150mm 150mm-750mm	Top Soil Brown clay	Brown	Soft	
	With stone fill	Brown	Firm	
750mm-1200mm	Dauby Clay	Brown	Firm

Trial Hole No 3 – 1200mm to bearing ground

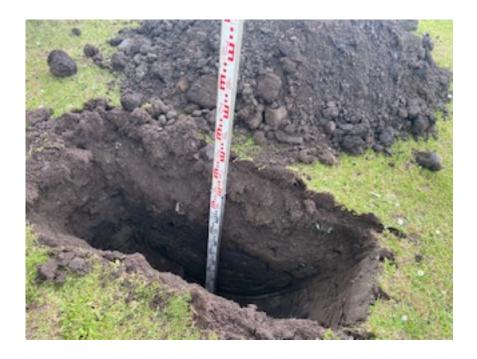
Trial Hole No 3 – Clay/Waste material mix to 750mm below surface

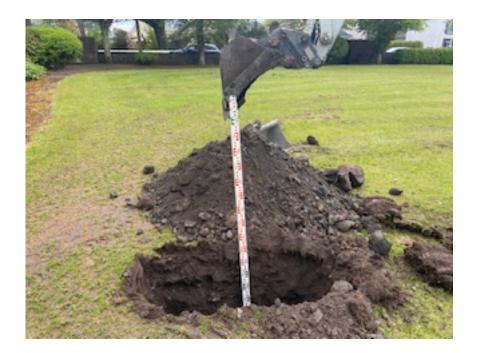
Trial Hole No 4				
Depth 1200mm				
Depth	Description	Colour	Density/compactness	
	·		·	
0mm-150mm	Top Soil	Brown	Soft	
150mm-700mm	Clay with stones	Brown	Firm	
700mm-1200mm	Dauby Clay	Brown	Firm

Trial Hole No 4 – 1200mm to bearing ground

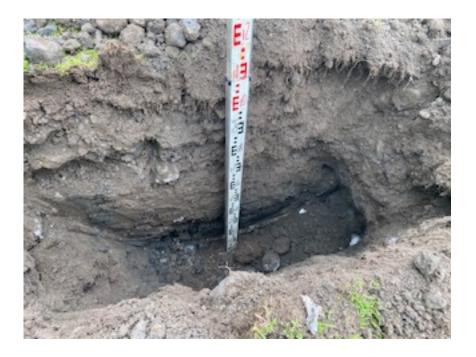
Trial holes indicate an extensive vein of landfill material graded across site with covering blanket of good quality topsoil. Depths of landfill waste material was found to be consistent in trial holes with the exception of Trial Hole No 4 adjacent to car park where firm subsoil clays with stone mix was recorded.

Trial Hole No 4 – Clay/Waste material mix to 700mm below surface

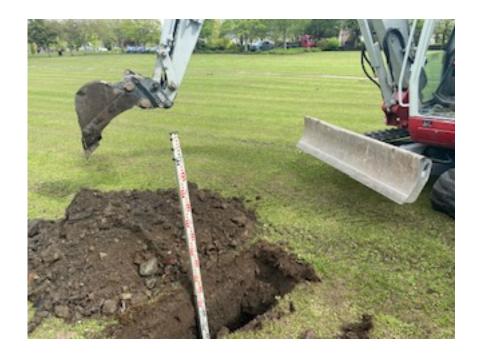
Trial Hole No 5			
Depth 1200mm			
Depth	Description	Colour	Density/compactness
0mm-150mm 150mm-1000mm	Top Soil Clay	Brown	Soft
	With waste fill	Brown	Loose
1000mm-1200mm	Dauby Clay	Brown	Firm

Trial Hole No 5 – 1200mm depth to bearing ground

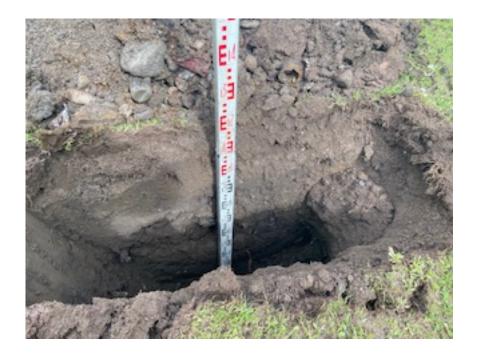
Trial Hole No 5 – Clay/Waste material mix to 1000mm below surface

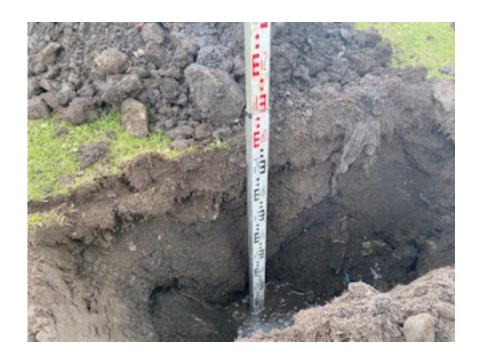
Trial Hole No 6			
Depth 1000mm			
Depth	Description	Colour	Density/compactness
0mm-150mm	Top Soil	Brown	Soft
150mm-800mm	Clay		
	With waste fill	Brown	Loose
800mm-1000mm	Dauby Clay	Brown	Firm
Water ingress at 80	0mm depth

Trial Hole No 6 – 1000mm depth

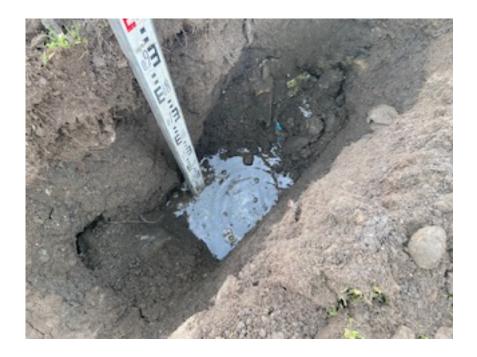
No water table or moisture ingress was noted apart from Trial Hole No 6, which is closest to the tidal waters of the river Moy.

Trial Hole No 6 – Water table at 800mm below surface
