Clifton Scannell Emerson & Associates

Castlebar Town, Co. Mayo

Non-Motorised Road User Accessibility
Assessment

Document Ref:	P22-018-UQA-GEN-RP-001
----------------------	-------------------------------

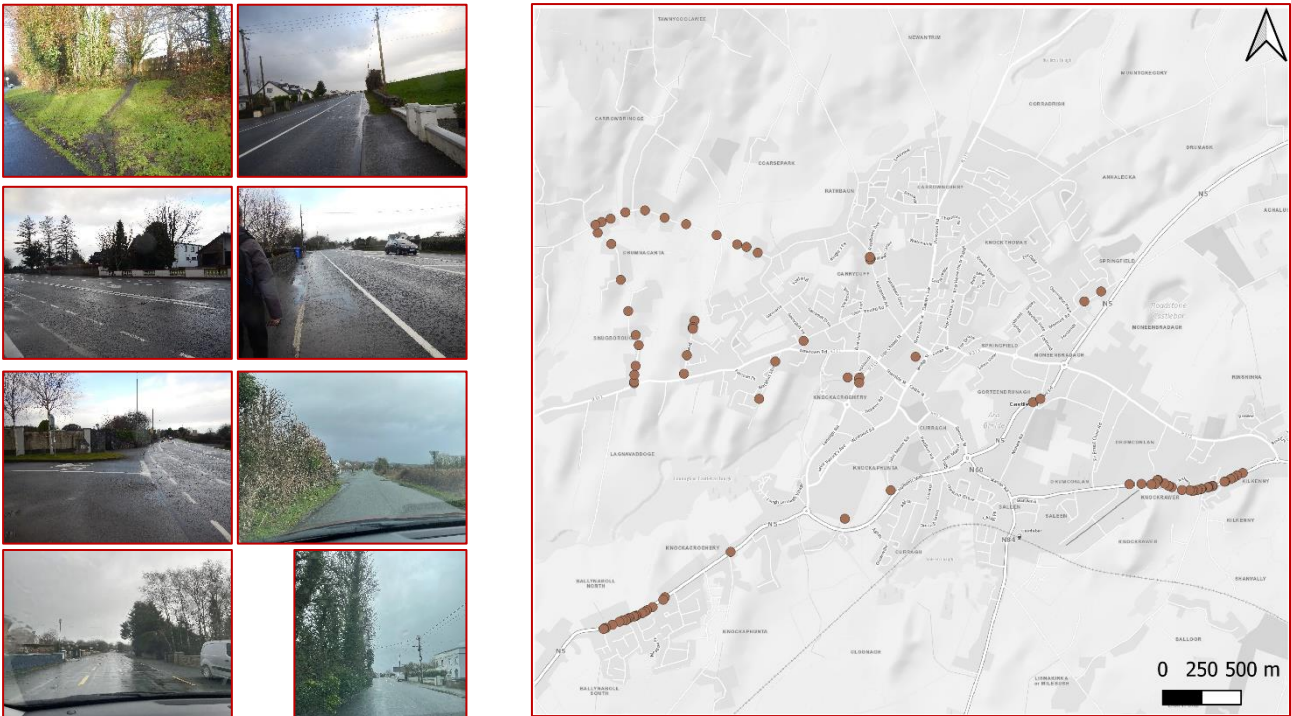
At locations where there are no footpaths, visually-impaired pedestrians have no safe means of accessing the town centre and other facilities independently.

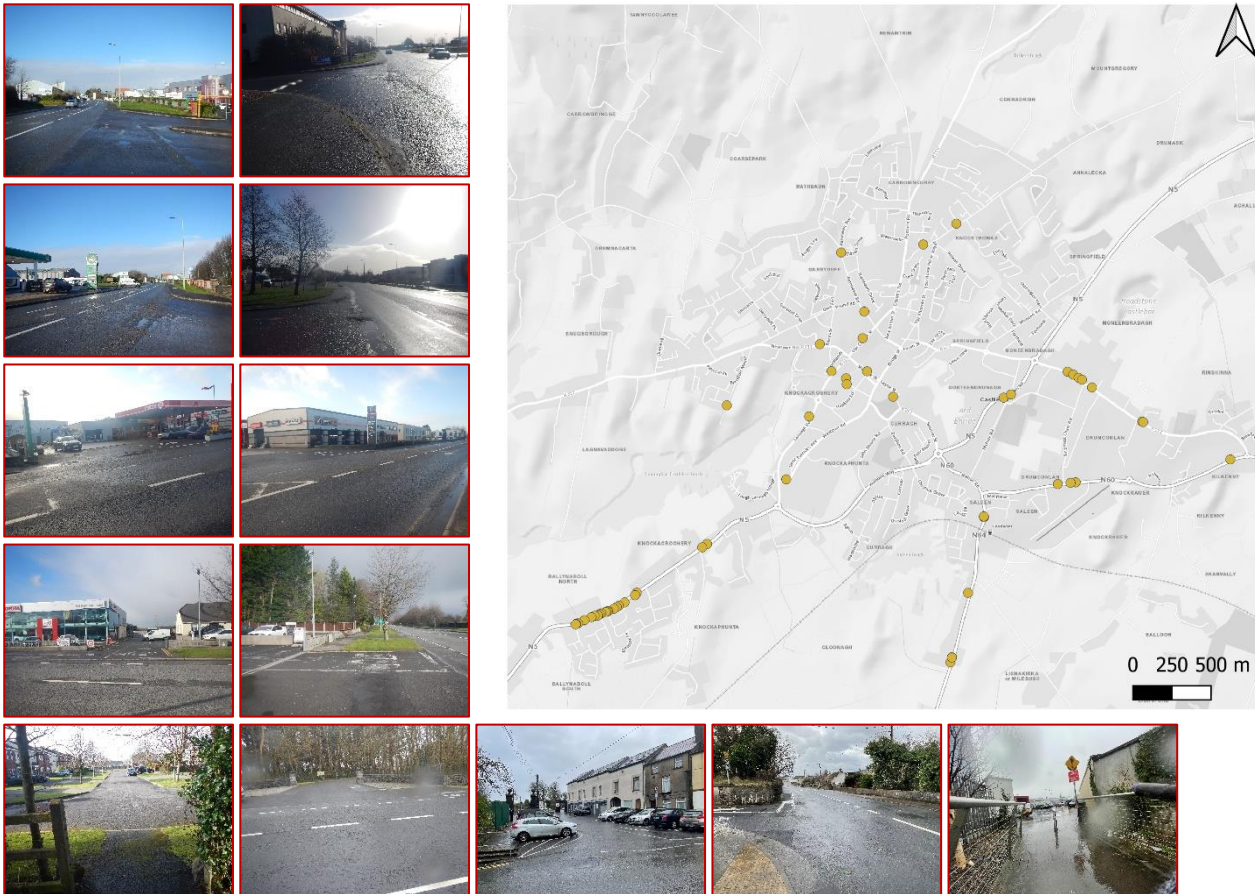
In some locations footpaths terminate flush with the adjacent carriageway, or sections of footpath have no vertical separation from the adjacent carriageway. At these locations there is a risk that visually-impaired pedestrians may inadvertently enter the carriageway, where they are at risk of being struck by a vehicle or cyclist.

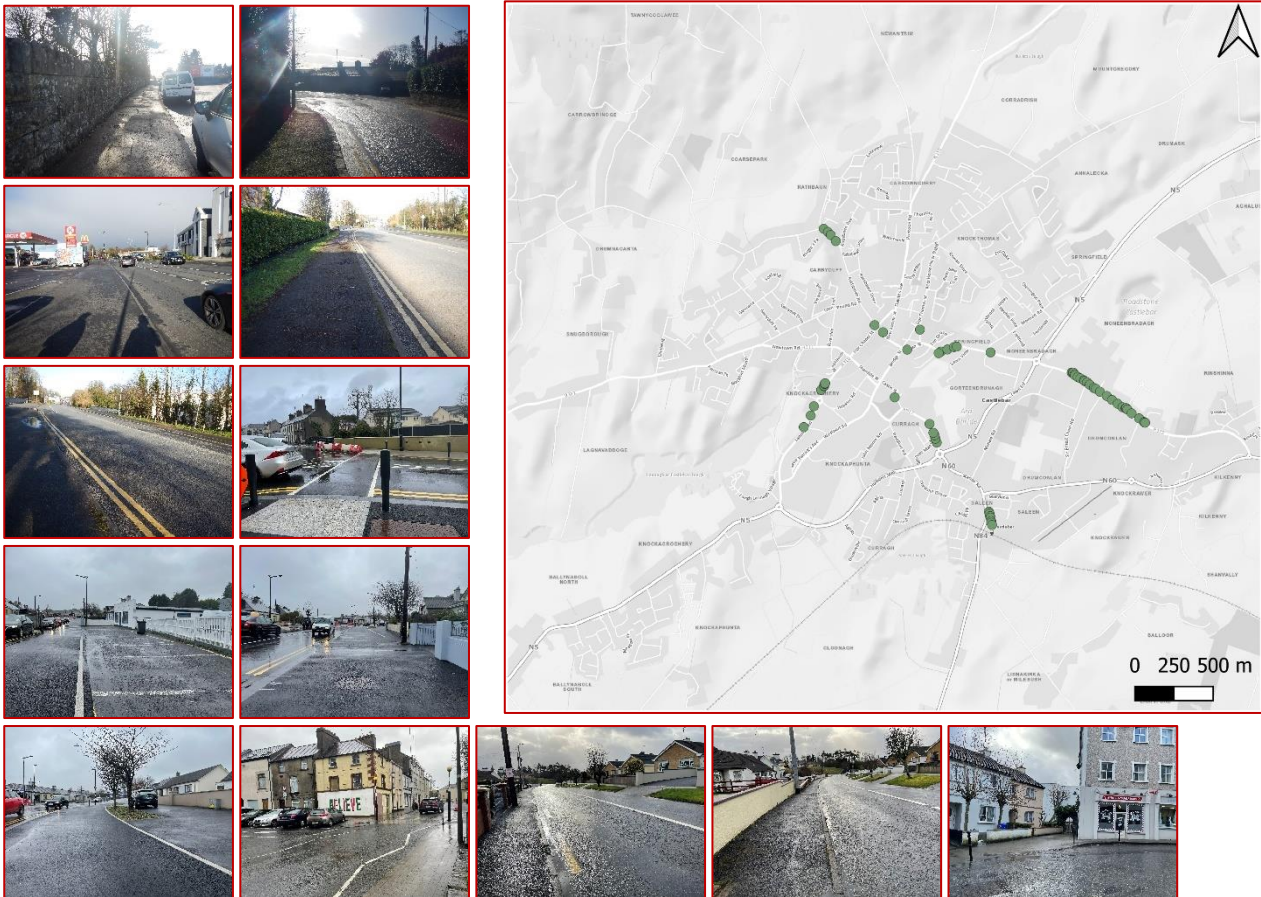
There is no vertical separation between the carriageway and some of the footpaths within the Town Centre and also on some the other existing pedestrian routes into the Town Centre. Variations in kerb heights may lead to an increased risk of trips and falls, particularly for visually impaired pedestrians. Visually impaired pedestrians may inadvertently enter the carriageway where there is insufficient vertical separation.

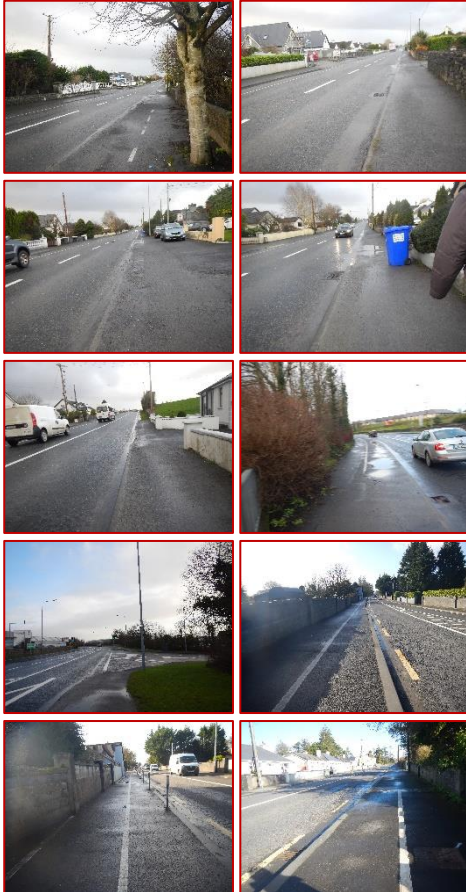
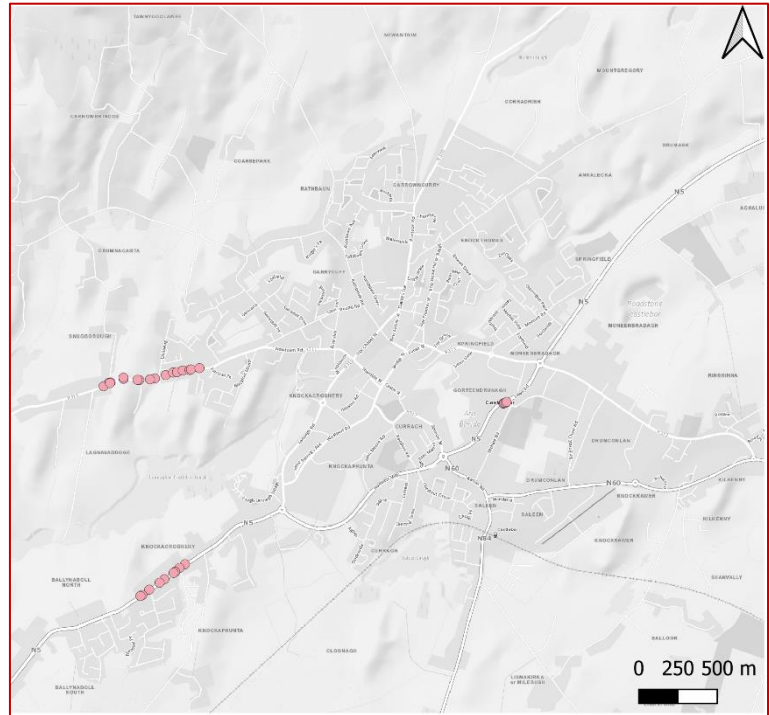
4.1.4 Inadequate Width of Shared Paths

There are a number of existing paths which pedestrians share with cyclists. The width of these shared paths varies, and in some instances the path is narrow and is unlikely to be able to safely accommodate both cyclist and pedestrian volumes. This could result in collisions between cyclists and pedestrians or to cyclists choosing to travel within the adjacent carriageway, obviating the benefit intended by the provision of the shared path.

Where possible segregated cyclist and pedestrian facilities should be provided. Where this not feasible the shared facilities should have a width sufficient to accommodate the expected volumes of pedestrians & cyclists, and in line with the recommendations in the National Cycle Manual.

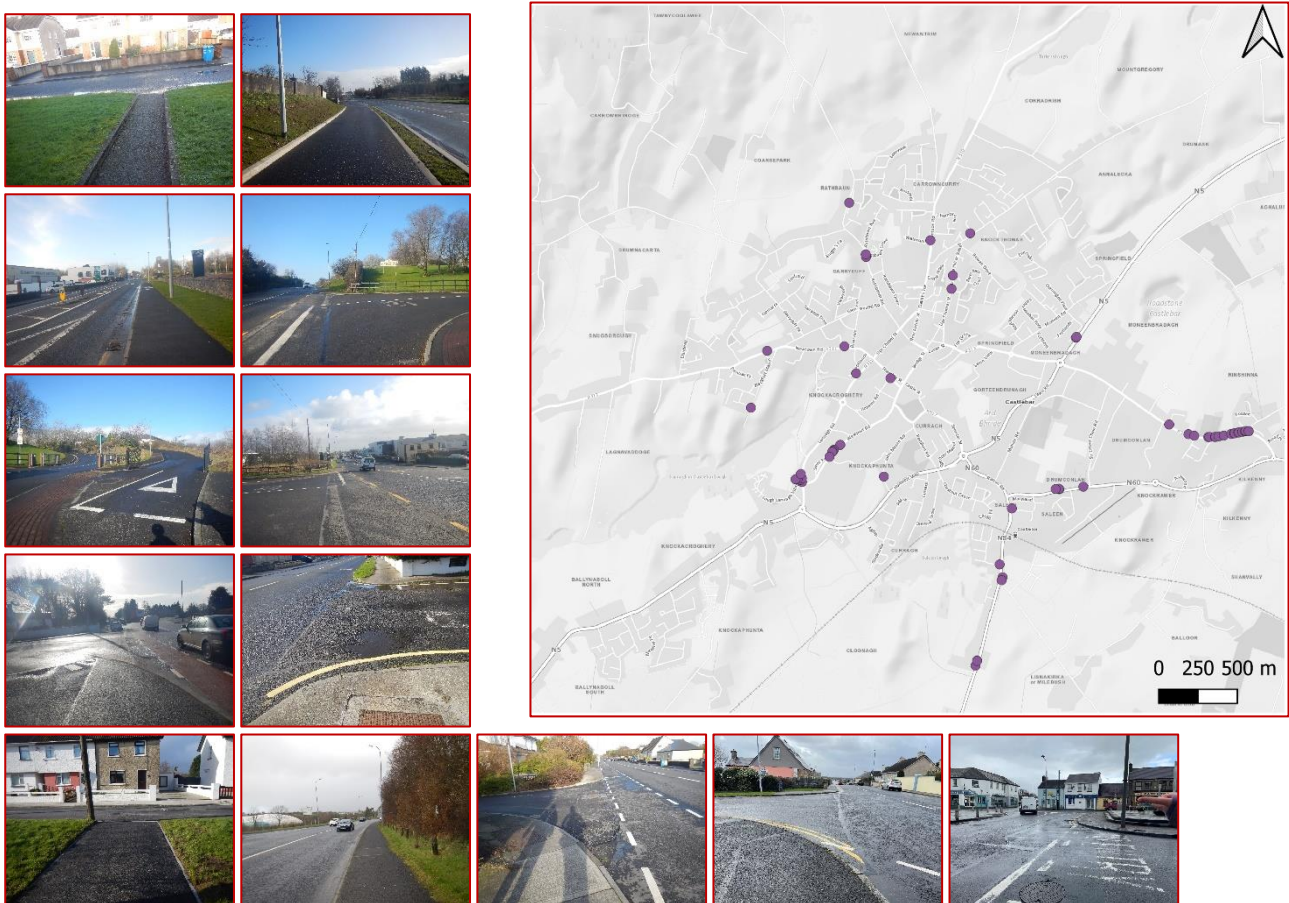
Where dropped kerbs are provided to facilitate the mobility-impaired undertaking a crossing, accompanying tactile paving has not been provided in all instances. The absence of tactile paving could result in visually-impaired or partially-sighted pedestrians inadvertently entering the carriageway or encountering difficulties identifying the other side of the crossing.

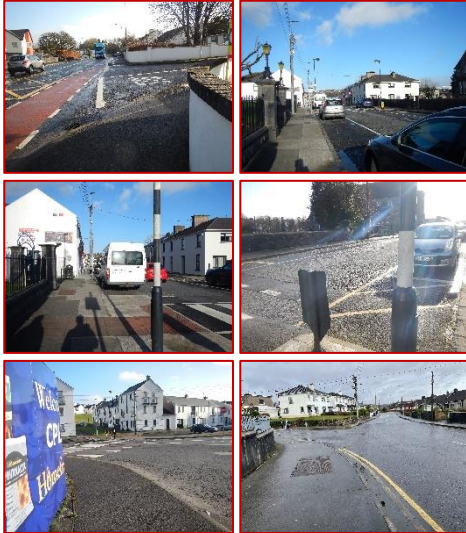
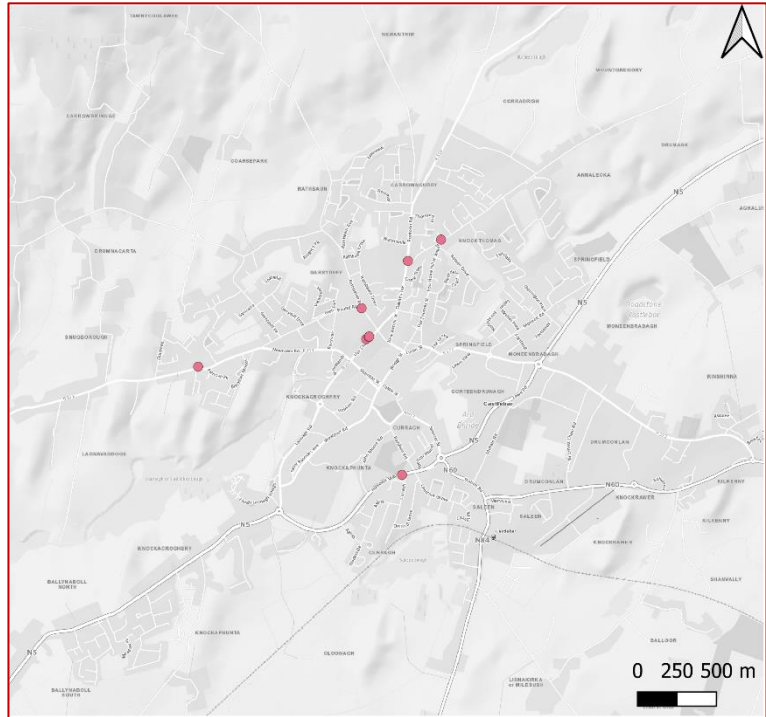
At a number of the uncontrolled pedestrian crossing locations there is a lack of adequate inter-visibility available from the crossing point between approaching drivers and a pedestrian about to commence a crossing, often as a result of the position of adjacent boundary walls or the distance the crossing is offset away from the junction mouth.

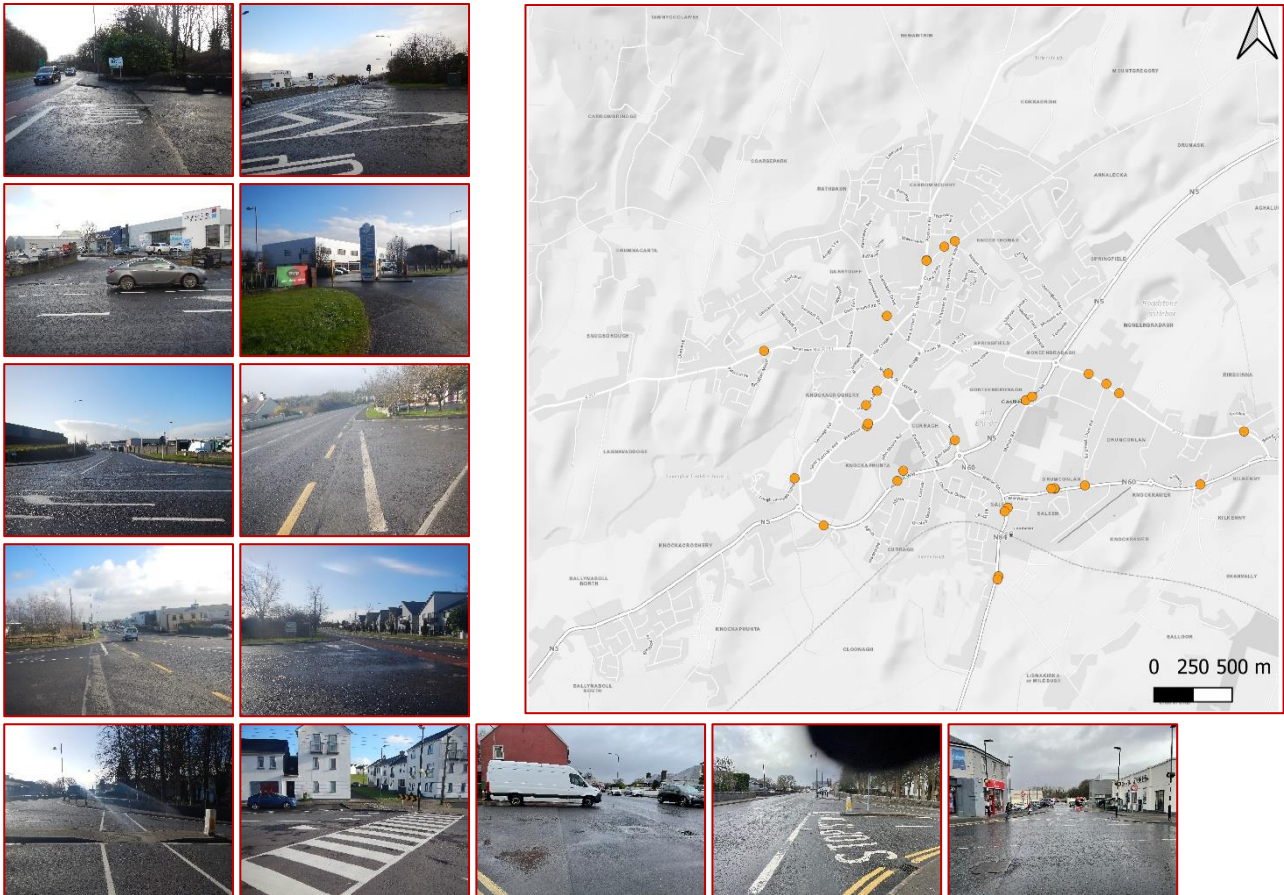
Wide junction mouths often arise as a result of large-radius corners at junctions, which can encourage high speeds by turning vehicles, further increasing the risk presented to Vulnerable Road Users (VRU).

Within the extents of the Town centre, the Overall Town Area and the sub-urban areas junction mouths should be amended in accordance with the recommendation of the Design Manual for Urban Roads & Streets (DMURS). Where crossing distances remain significant, pedestrian refuge islands should be provided.

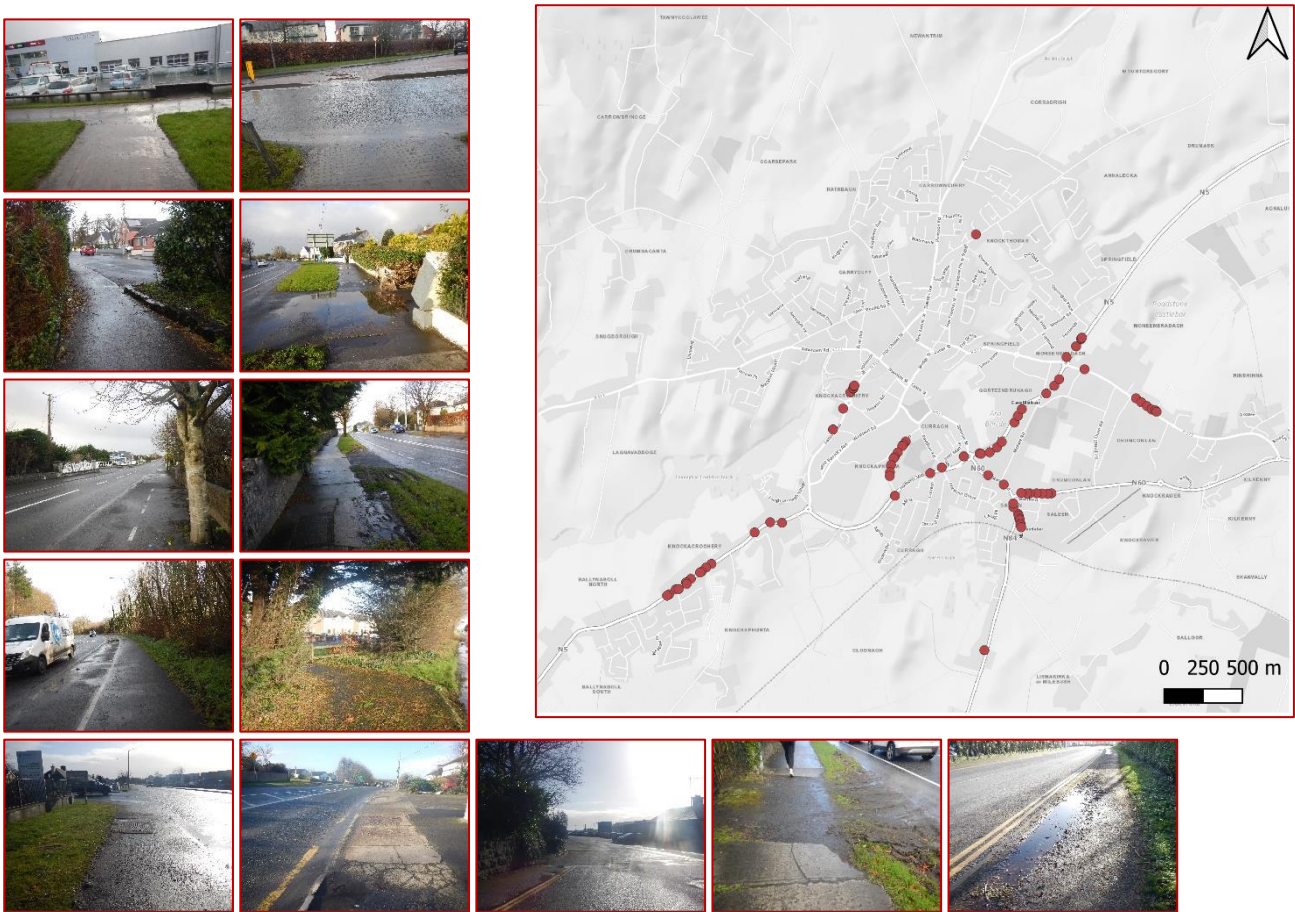
4.1.8 Footpath Condition

The footpath condition at number of locations was noted as being in a poor condition, presenting a possible slip or trip hazard to pedestrians.

Footpath surfaces at these locations should be renewed, ensuring that where vehicles cross the footpaths (e.g. at private vehicular accesses) that the footpath strength is sufficient to withstand the vehicular loading without deformation or deterioration.

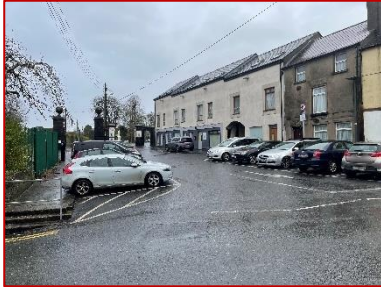
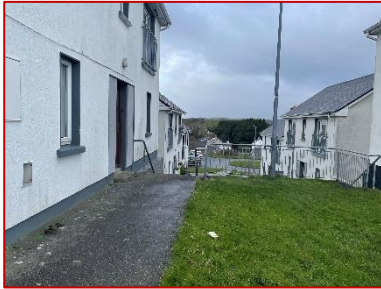
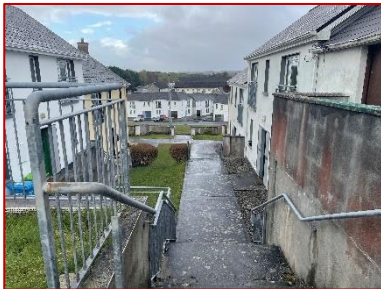
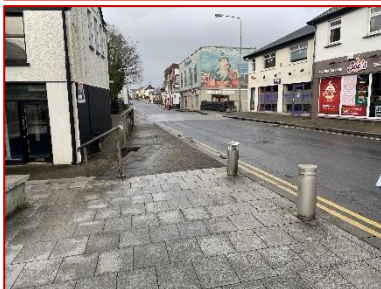
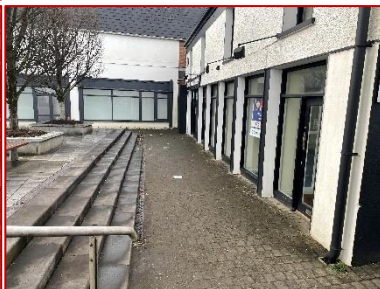
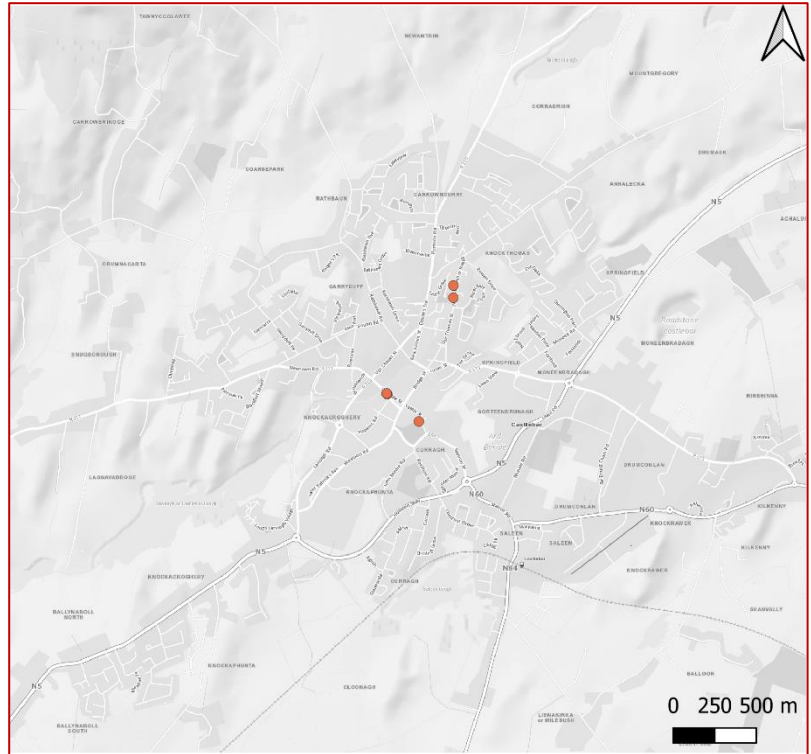
4.1.9 Absence of Hazard Tactile Paving at Steps

Tactile paving at height hazards (i.e. corduroy tactile paving) is absent at the landings at the top and bottom of steps at a number of locations within the Town. The absence of hazard tactile paving at the top and bottom of steps may lead to visually impaired pedestrians being insufficiently aware of the height hazard resulting in an increased risk of falls.

Hazard tactile paving should be provided at steps in accordance with the recommendations of the National Disability Authority.

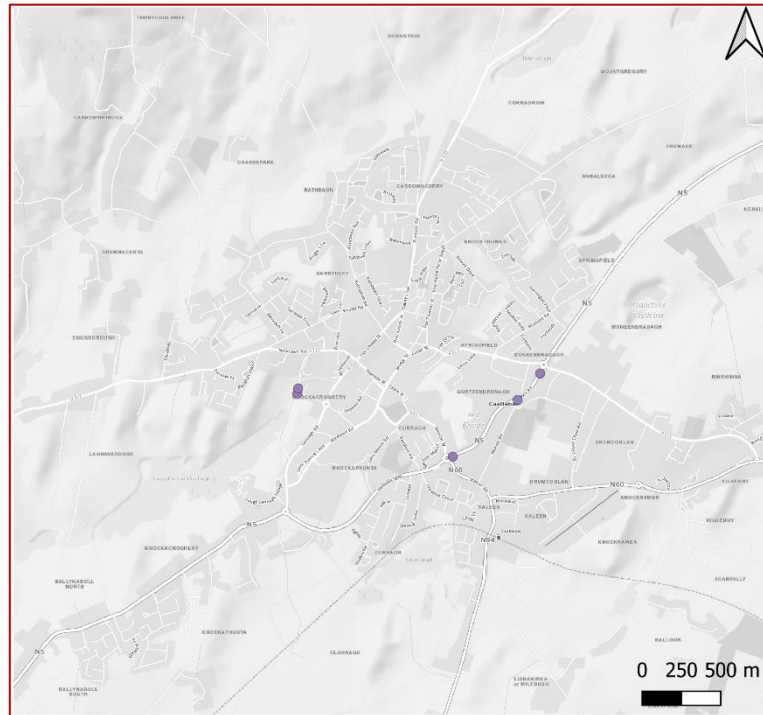
At the start & end of shared pedestrian and cycle facilities the roadmarkings provided (e.g. pedestrian and cyclist symbols and straight-ahead arrows) are faded and there is no 'Ladder & Tramline' tactile paving to advise visually-impaired pedestrians that they are entering/leaving an area shared with cyclists.

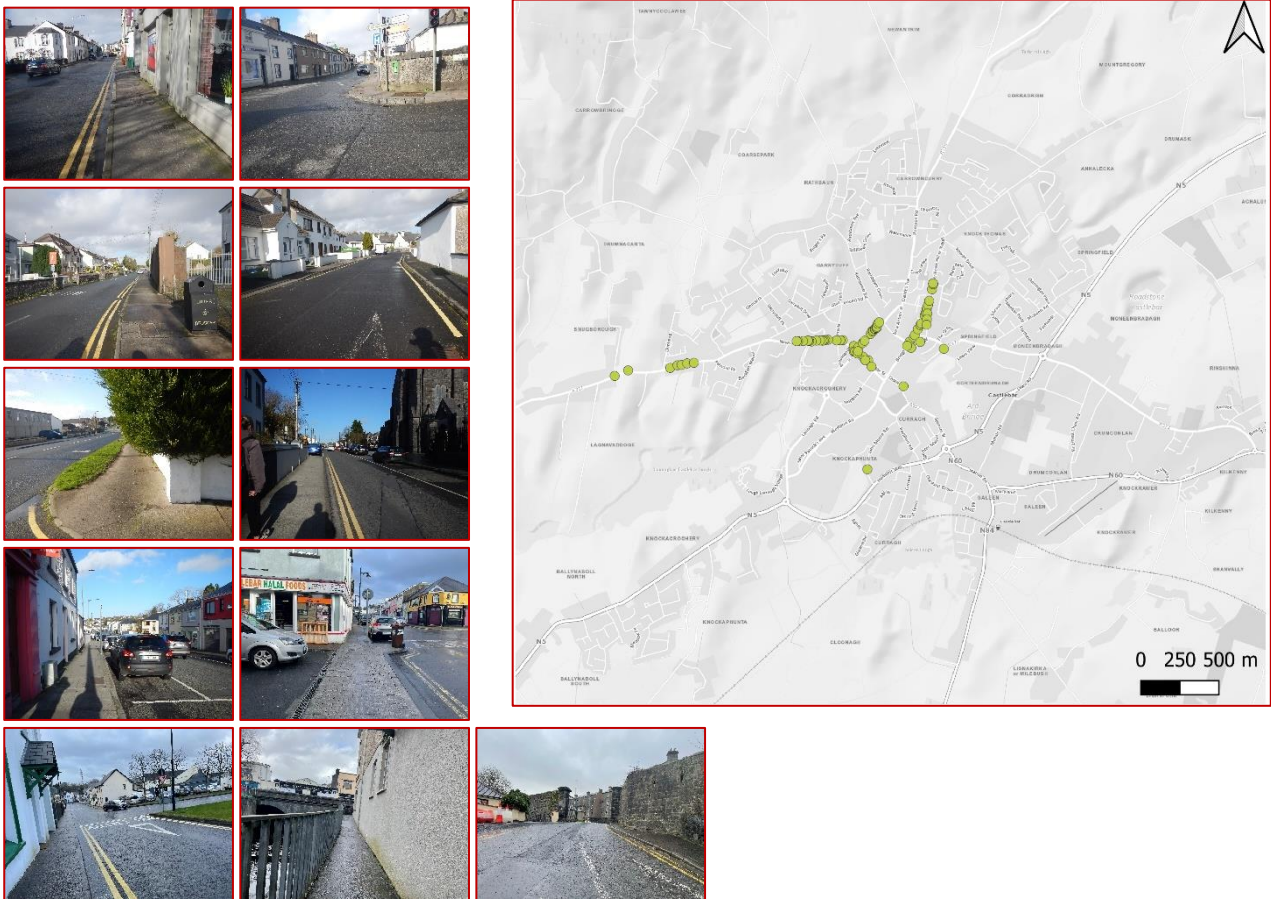
In addition, items of roadside furniture are positioned centrally within the footpath reducing the effective width of the footpath, and presenting an obstacle to mobility impaired individuals using a wheelchair, possibly leading to these road users entering the carriageway in order to progress along the road where they are at an increased risk of a collision with a vehicle.

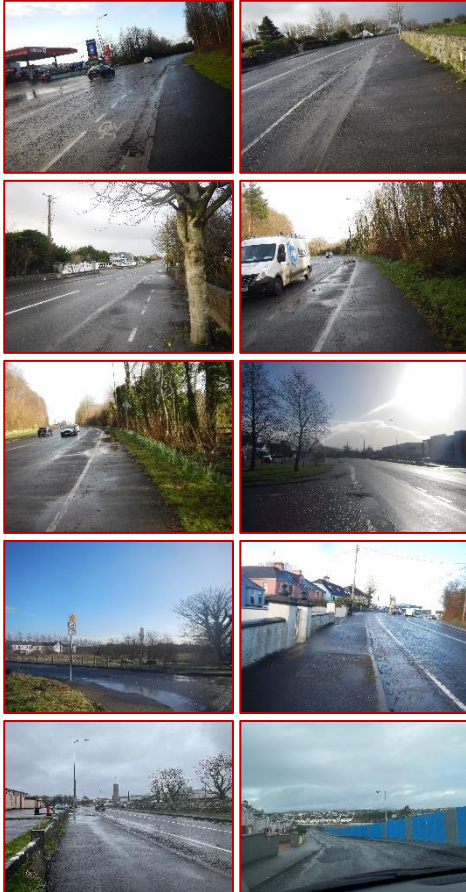
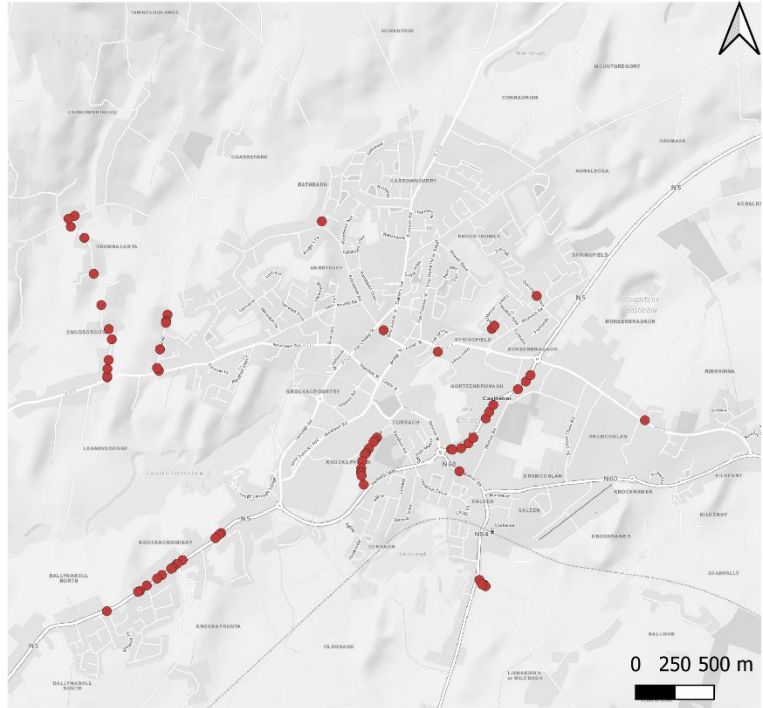
4.1.12 Cycle Lane Pavement Condition

At number of locations along the existing cycle lanes and shared pedestrian/cyclist facilities the pavement condition was noted as being poor. The poor surface condition within the cycle lanes could lead to erratic cyclist manoeuvres as they undertake avoidance measures with resulting increased risk of vehicle/cyclist collisions.

The pavement should be repaired within the cycle lanes and where new cycle facilities are proposed along existing routes then the existing pavement condition should be assessed and improved where necessary.

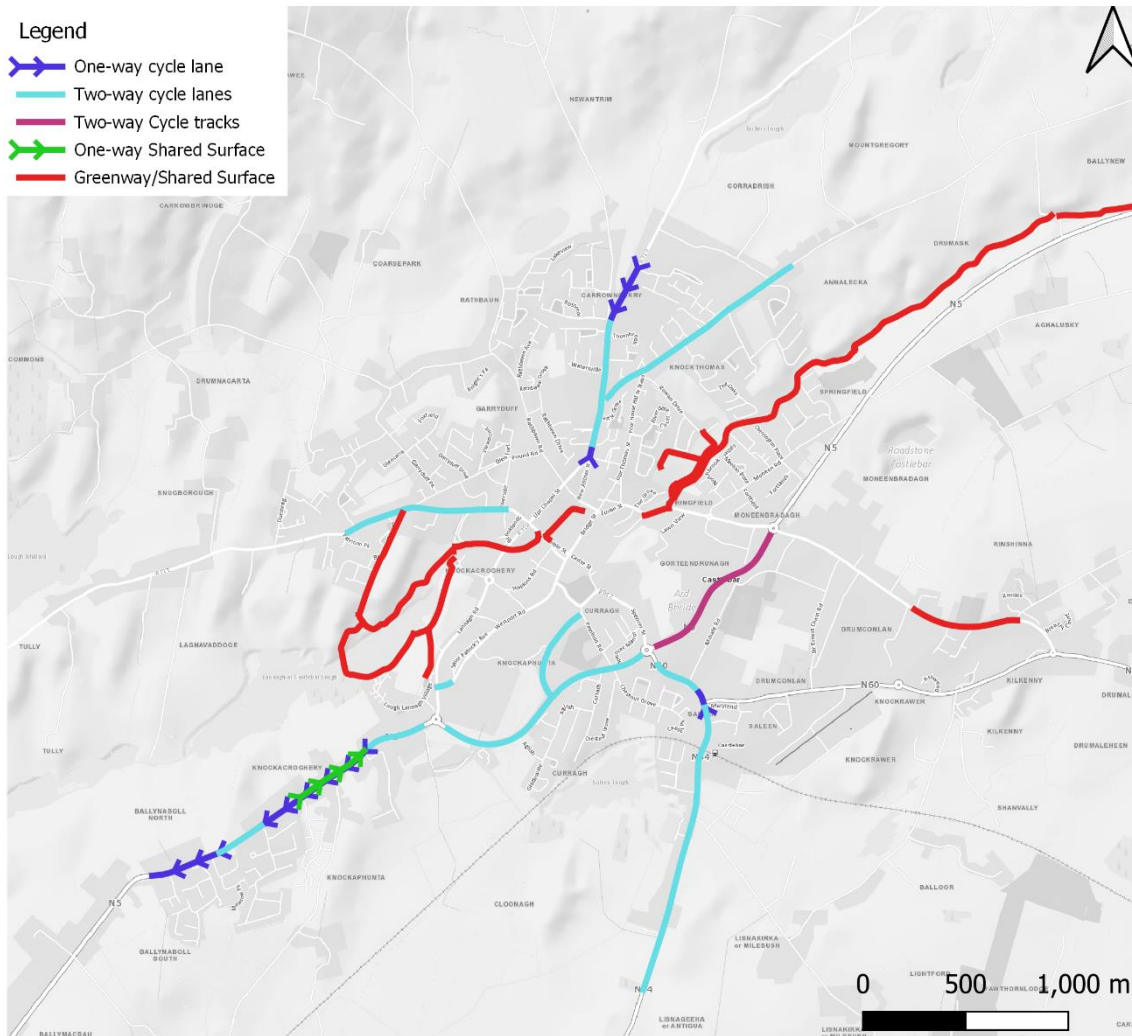
This results in cyclists using the carriageway for many of the journeys, making cycling a less attractive mode of transport for the young or inexperienced, and increasing cyclists' exposure to the risk of being struck by a vehicle. Alternatively, some cyclists may choose to travel within the footpaths, with a resulting increased risk of collisions between cyclists & pedestrians.

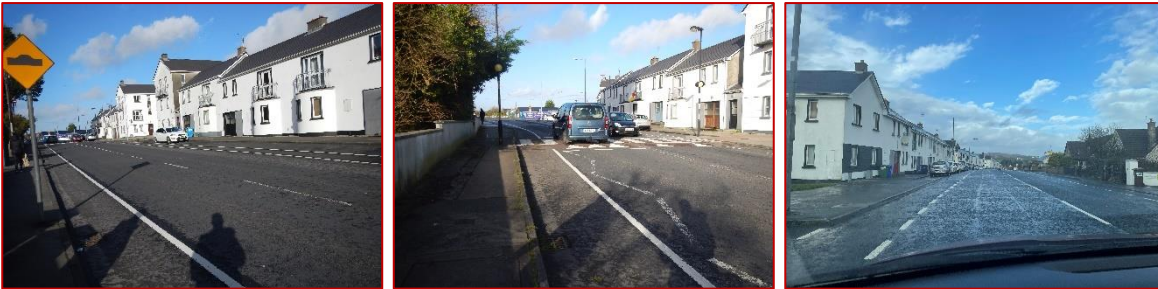
At number of locations along the existing cycle lanes there is no buffer area between the cycle lane and the existing parallel parking spaces. This might result in vehicle occupants opening doors into the path of an oncoming cyclist.

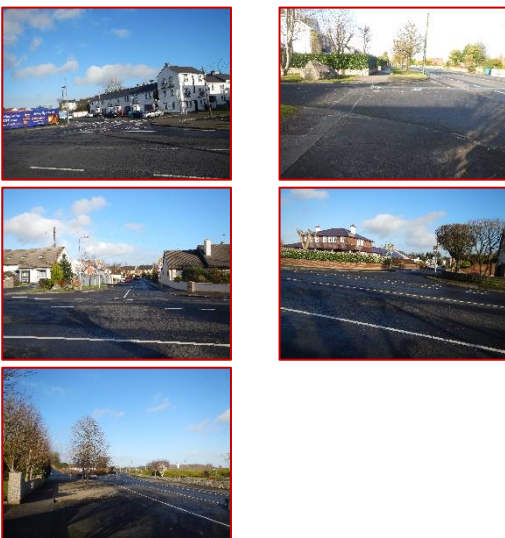
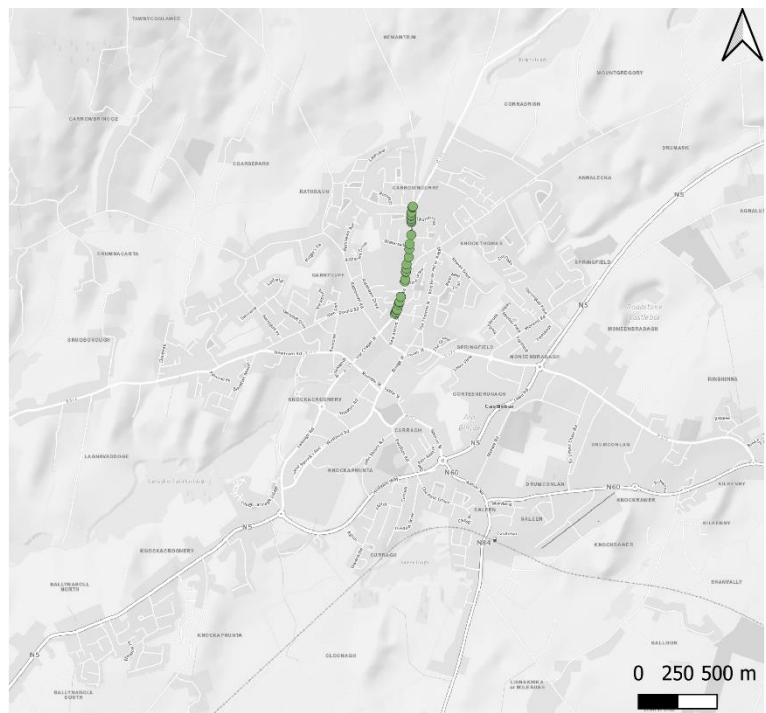
At number of locations along the existing cycle lanes the existing red surfacing is faded. At some locations (i.e. junctions) where no red surfacing is present there is an increased potential for conflicts between cyclists and vehicles. The absence of the red surfacing may result in drivers being insufficiently aware of the cycle lane resulting in possible conflicts with cyclists or in sudden avoidance manoeuvres to avoid cyclists.

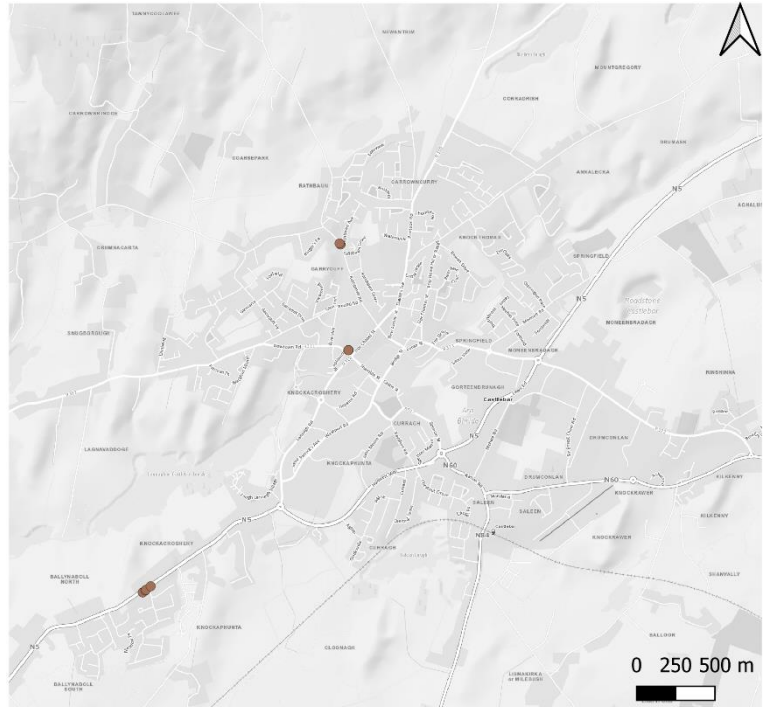
At number of locations along the existing footpaths have relatively steep crossfalls. Steep crossfalls make it difficult for elderly or encumbered pedestrians to walk on the footway. Crossfalls steeper than 3% are uncomfortable to walk on and if the slope runs towards a road it can be dangerous, as wheeled users will tend to edge down the crossfall.

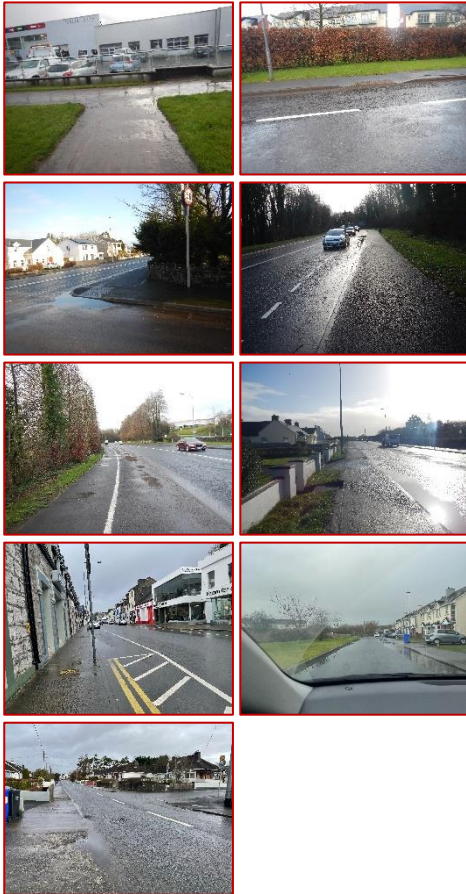
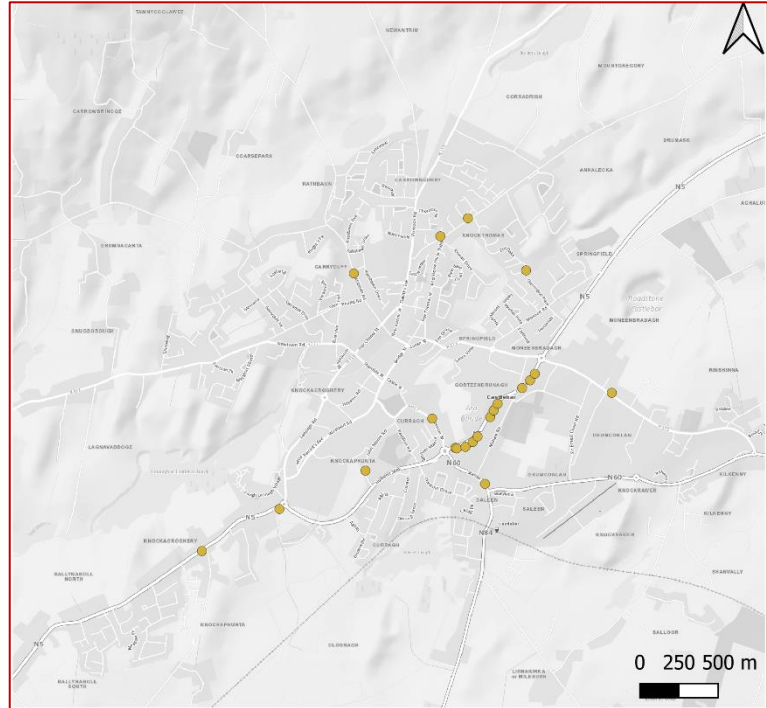
During the site visit ponding was noted within the carriageway, footway, cycle facilities and/or within the pedestrian crossings. Ponding within the cycle facilities or pedestrian crossings could result in loss of traction for cyclists, especially during icy weather, leading to loss of control type incidents and the potential for cyclists to fall from their bicycle and suffer personal injury or fall into the adjacent traffic lane where more serious injuries are likely.

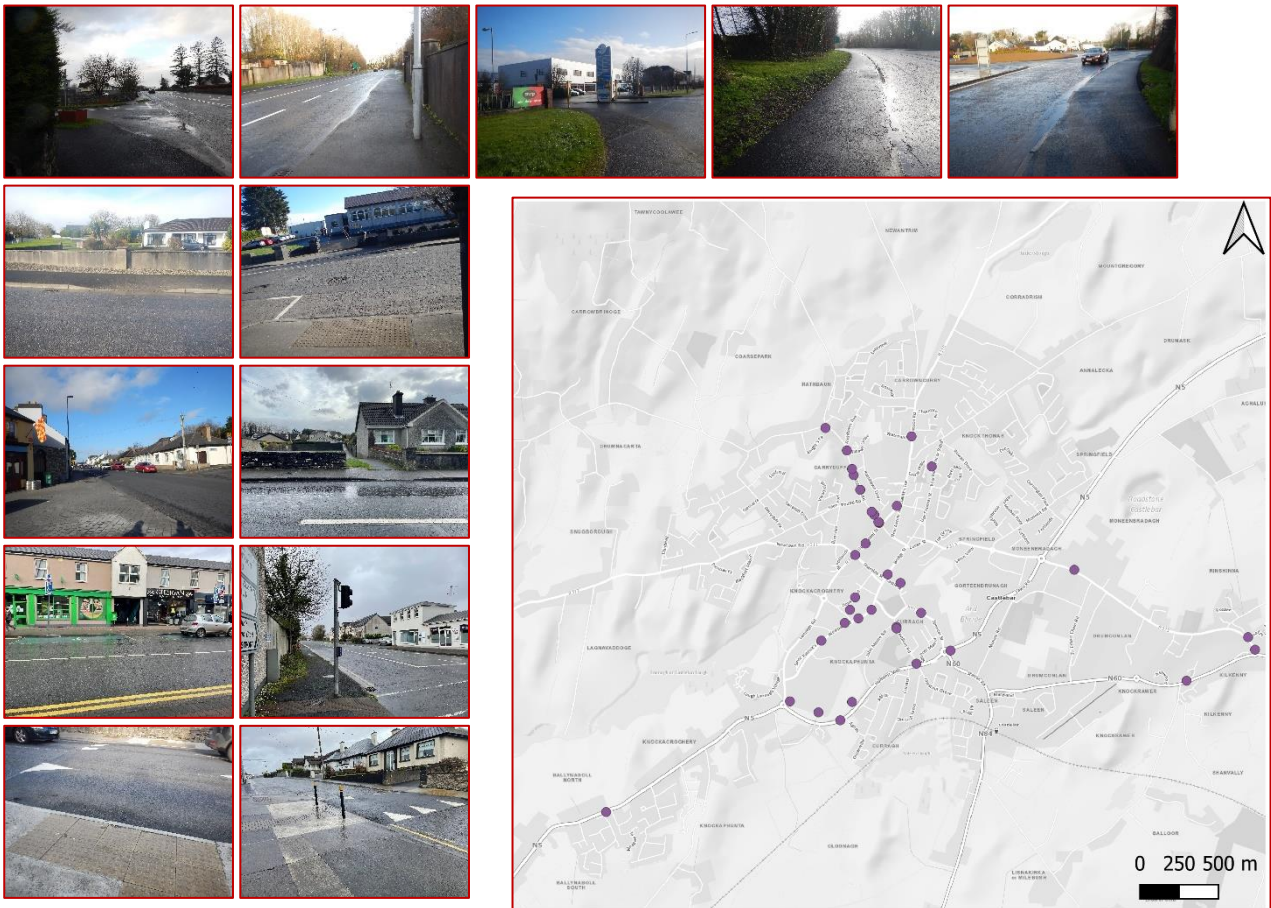
4.1.18 Missing or Incorrect Tactile Paving

At some locations the tactile paving colour and layout is incorrect for the type of crossing.

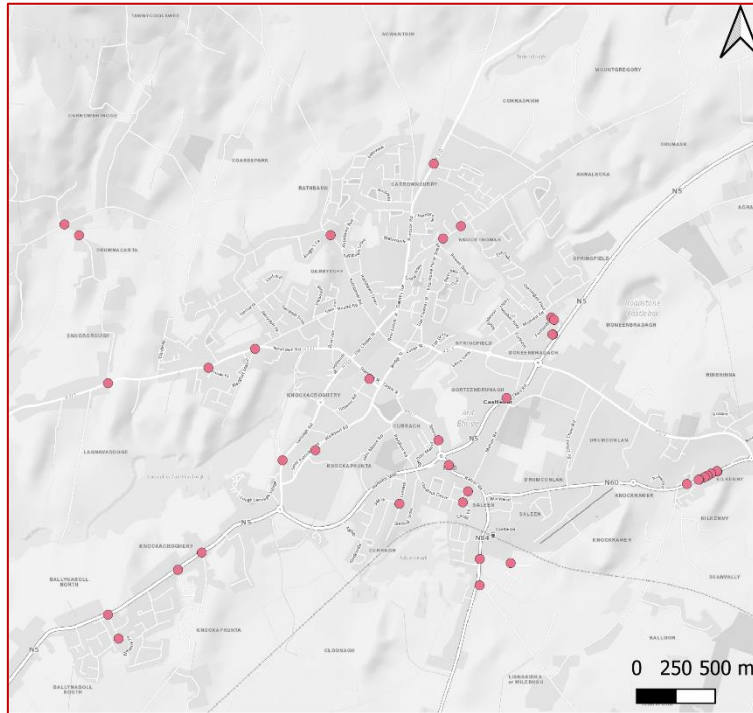
Poor lighting exists at some locations resulting in dark areas within the carriageway, in other locations there is no public lighting provision. Dark areas within the carriageway, footway or cycleway could result in cyclists/pedestrians being insufficiently visible to other road users resulting in collisions between cyclists and pedestrians or motorists.

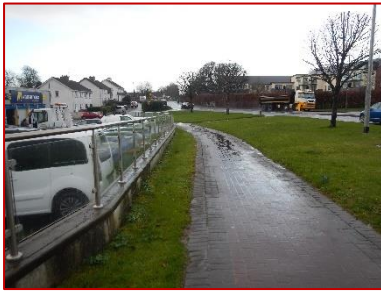
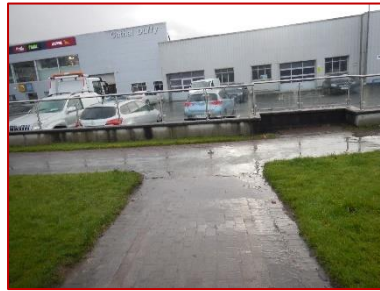
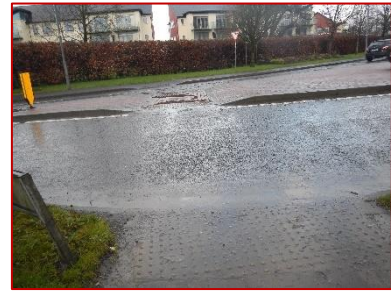
The footpath within the south-western quadrant of the N5/N60 roundabout is at lower level than the adjacent verge area. This results in ponding along this length of footpath. Similarly, ponding was noted at the pedestrian crossing of the roundabout's western arm.

Ponding within the footway and crossing could result in slips, especially during icy weather, leading to personal injury.

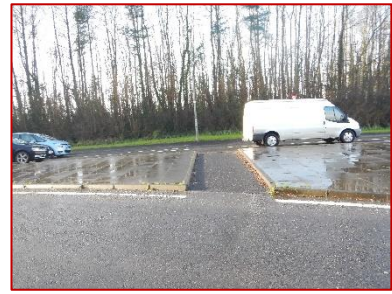
No cyclist provisions are provided on the approaches to, or at the roundabout which would present challenges to less-confident cyclists in navigating the roundabout.

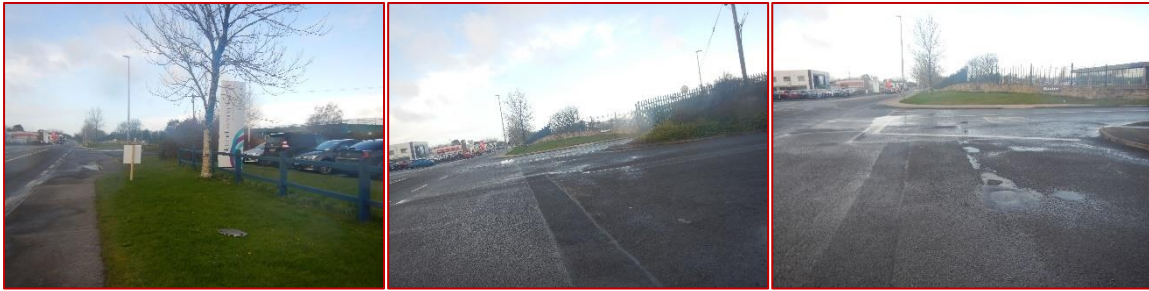
The accesses have wide junction mouths resulting in lengthy crossings for non-motorised road users. In addition, the access layouts prevent the visually impaired from crossing the accesses safely and independently.

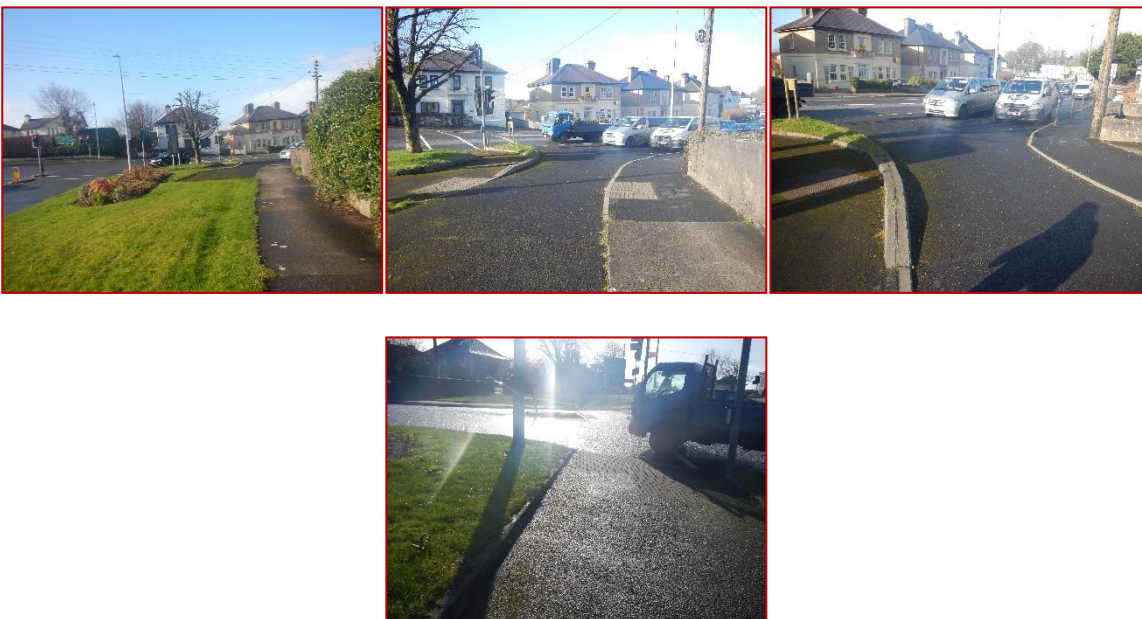
The combination of these problems creates difficulties for visually impaired pedestrians navigating the junction safely and independently. The lack of sufficient crossing time might result in the mobility-impaired and/or elderly pedestrians being stranded in the centre of the carriageway.

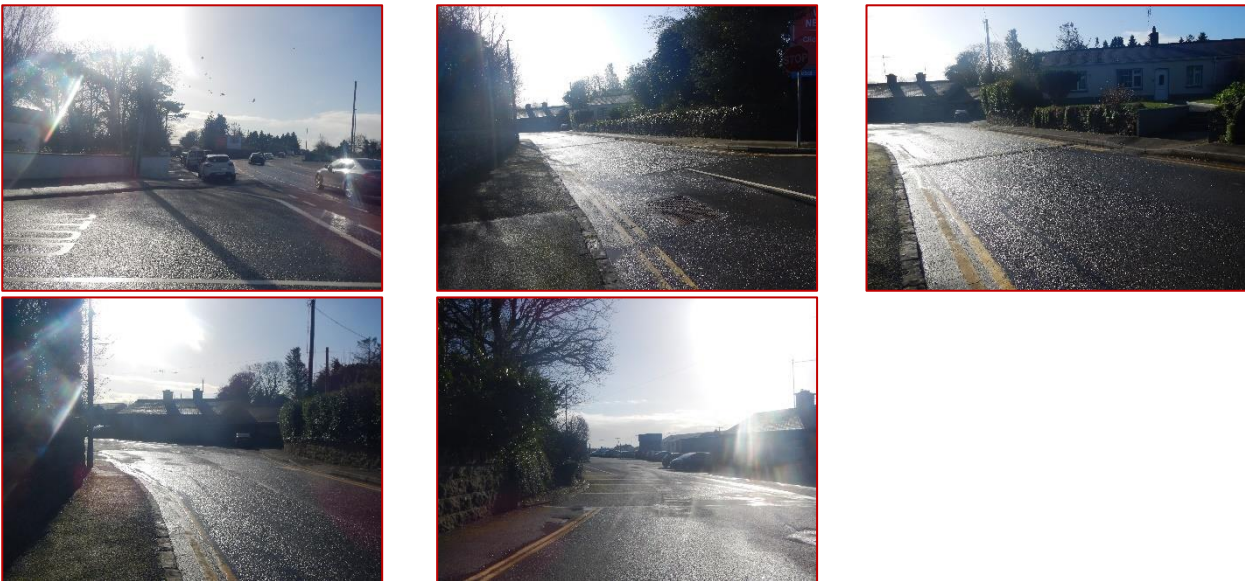
The footpath width at the link road between the N84 and the Castlebar Train Station is relatively narrow and the footpath along the eastern side of the carriageway terminates at an uncontrolled crossing. Insufficient footpath width for peak pedestrian volumes might lead to pedestrian entering the carriageway where they are at increased risk of being struck by vehicle. The absence of a controlled crossing presents an obstacle for visually-impaired public transport users.

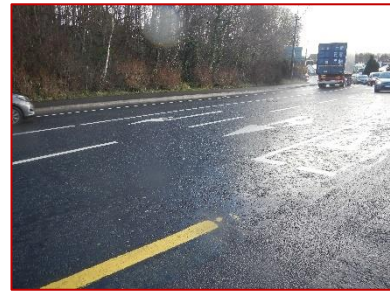
The footpath layout at this location would present difficulties for visually impaired in safely and independently travelling along Station Road.

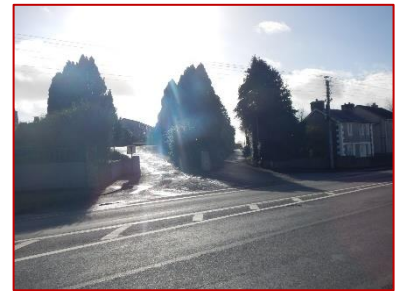
The absence of crossing facilities at the Newport Road could result in pedestrians crossing the road at unsafe location increasing the likelihood of conflicts with vehicles. In addition, the lack of crossing facilities would also prevent the mobility impaired from crossing to the opposite side of Newport Road resulting in them having to undertake a longer route to access the footpath on the other side.
