Clifton Scannell Emerson & Associates

Castlebar Town, Co. Mayo

Non-Motorised Road User Accessibility
Assessment

Document Ref:	P22-018-UQA-GEN-RP-001
----------------------	-------------------------------

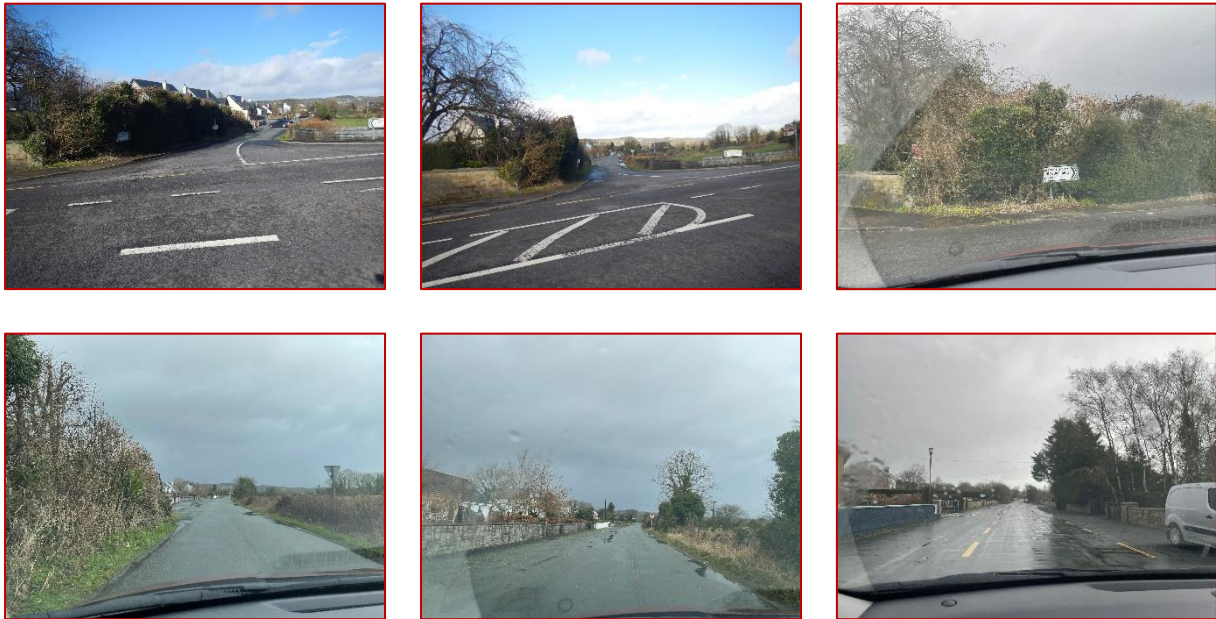
The L1725 local road leading to Snugborough is relatively narrow and includes a number of high demand bends where forward visibility is limited. In addition, the pavement condition was noted as being poor in places and during the site visit ponding was observed occurring frequently along the whole route.

There is no public lighting along this route and pedestrians were observed travelling within the carriageway during daylight and darkness hours. There are no footpaths along the route, and the absence of provisions for non-motorised road users coupled with the carriageway condition could increase the likelihood of pedestrian/vehicular collisions.

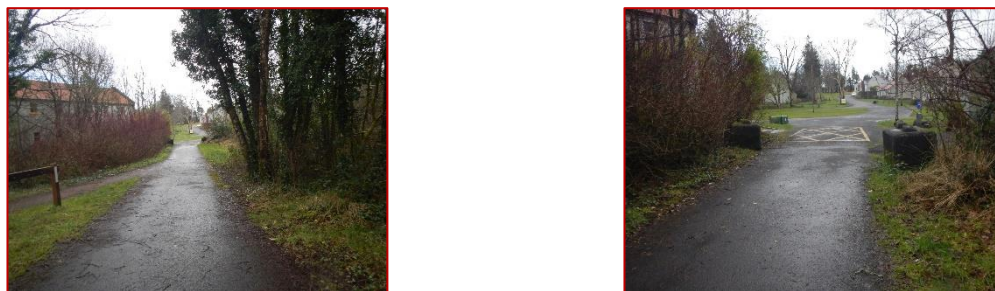
There is a pedestrian link from Lough Lannagh Amenity Park to Lough Lannagh Village the link leads pedestrian onto the carriageway. This might lead to visually impaired being unaware that they have entered carriageway resulting in increased risk of conflicts.

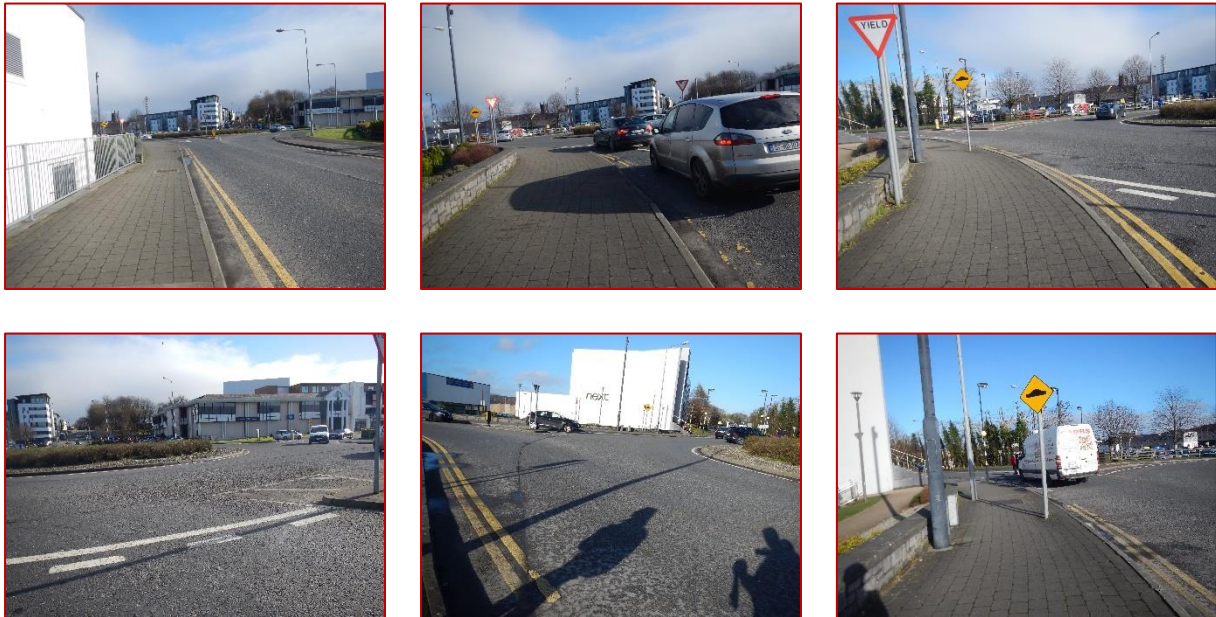
No cyclist provisions are provided on the approaches to, or at the roundabout which would present challenges to less-confident cyclists in navigating the roundabout.

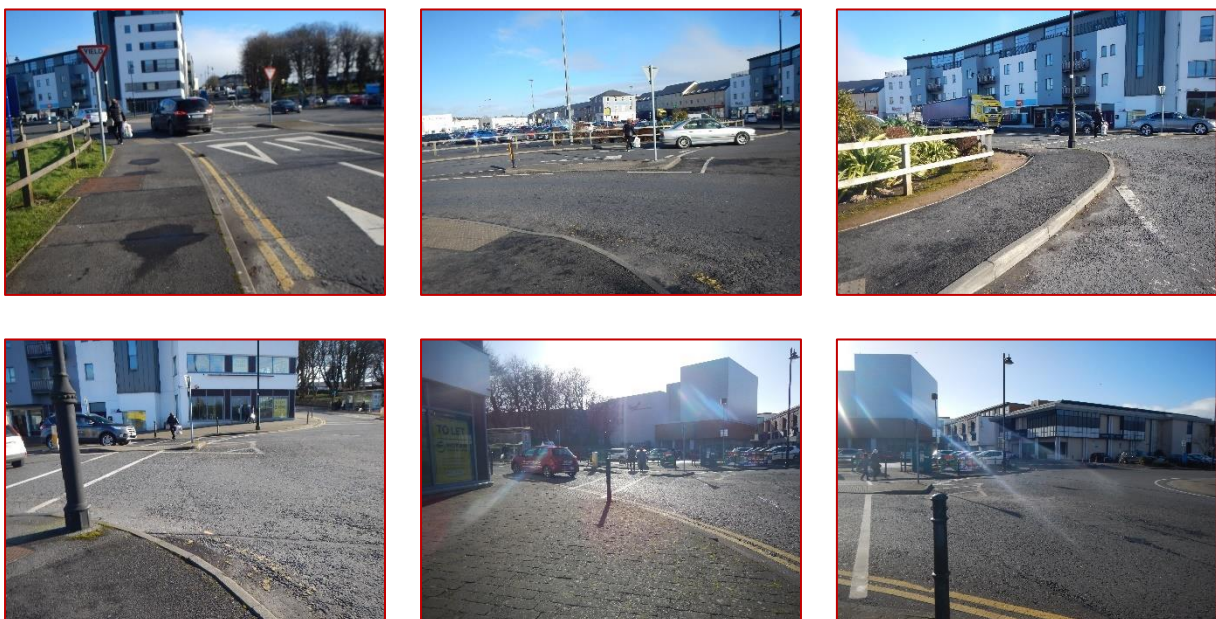
4.2.19 Hopkins Road/Stephen Garvey Way Roundabout

Hopkins Road/Stephen Garvey Way Roundabout have five wide approach arms. The Roundabout includes one zebra crossing at the northern arm and lacks suitable pedestrian crossing facilities at the other arms.

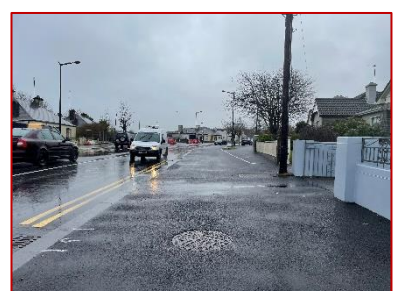
The lack of vertical separation between the carriageway and the shared surface could result in visually-impaired pedestrians inadvertently entering the carriageway.

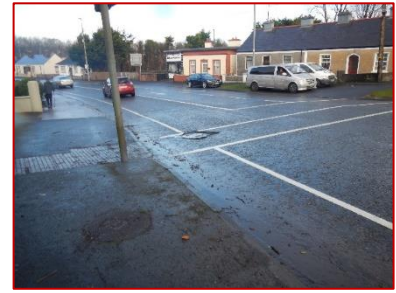
4.3.1 N60/N84 Junction

Deteriorating pavement around a manhole cover located within crossing and cycle lane. This may lead to slips trips or falls.

The carriageway pavement should be repaired.

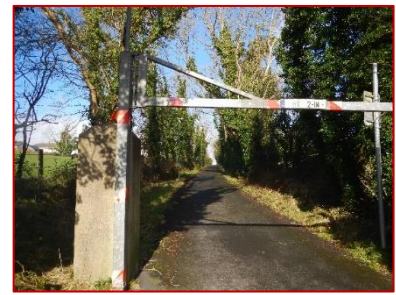
The height of the barrier is low and would present a hazard for cyclists using this access and may lead to personal injury.

The height of the barrier should be increased to a minimum of 2.5m

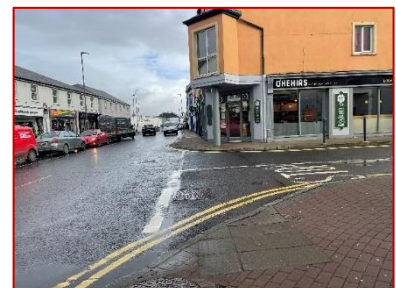
4.3.5 Westport Road

The tactile paving at the uncontrolled crossing of Westport Road is damaged, resulting in pedestrian trip hazards and unstable ground.

The tactile paving either side of the crossing should be repaired to remove any trip hazards and unstable pavement.
