Predevelopment Archaeological Testing
Kiltamagh Emigrant Park
Kiltamagh
Co. Mayo

Sue Zajac

Archaeologist
Mayo County Council

1st April 2021

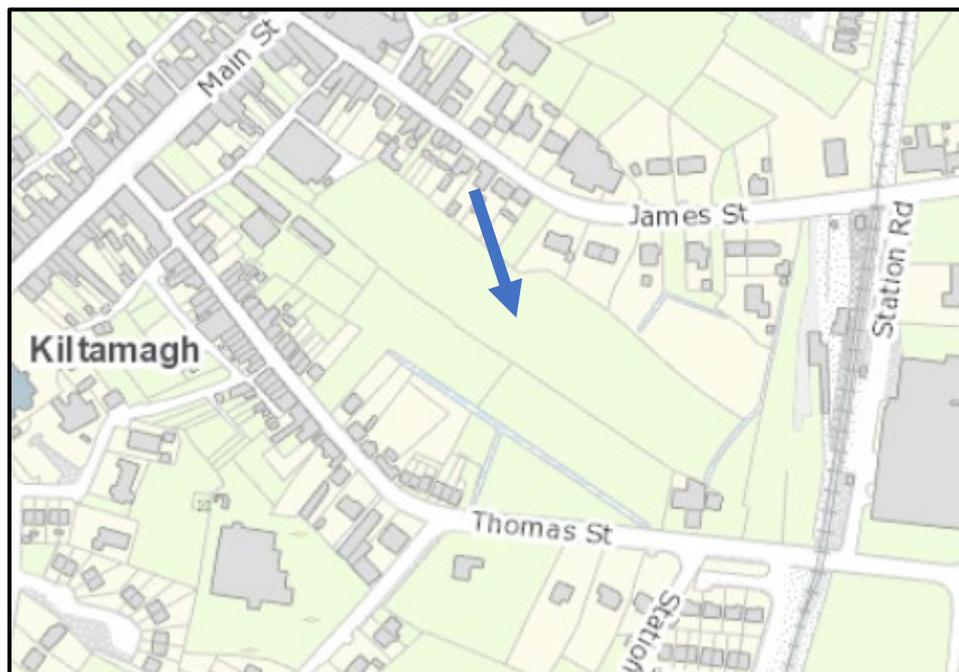
Fig 1 Centre of proposed Development Site between James Street and Thomas Street.

The development site is located between Thomas Street and James Street (formerly Georges Street), in the centre of Kiltamagh town, Co. Mayo (Fig 1). The townland is also Kiltamagh, Parish of Killedan and Barony of Gallen. It is found on Mayo OS six-inch Sheet 80 (ITM E534420/N789200). The development site is irregular in plan and now covers two green fields, divided by either dry stone walls, that are collapsed and overgrown or open, water-filled drains. The narrower sector of the development site at north and north-west is high, dry ground. The remaining areas are low-lying bog. Both are covered by rough to marginal grassland. Residential or industrial units back onto the development site in most areas (Fig 2).

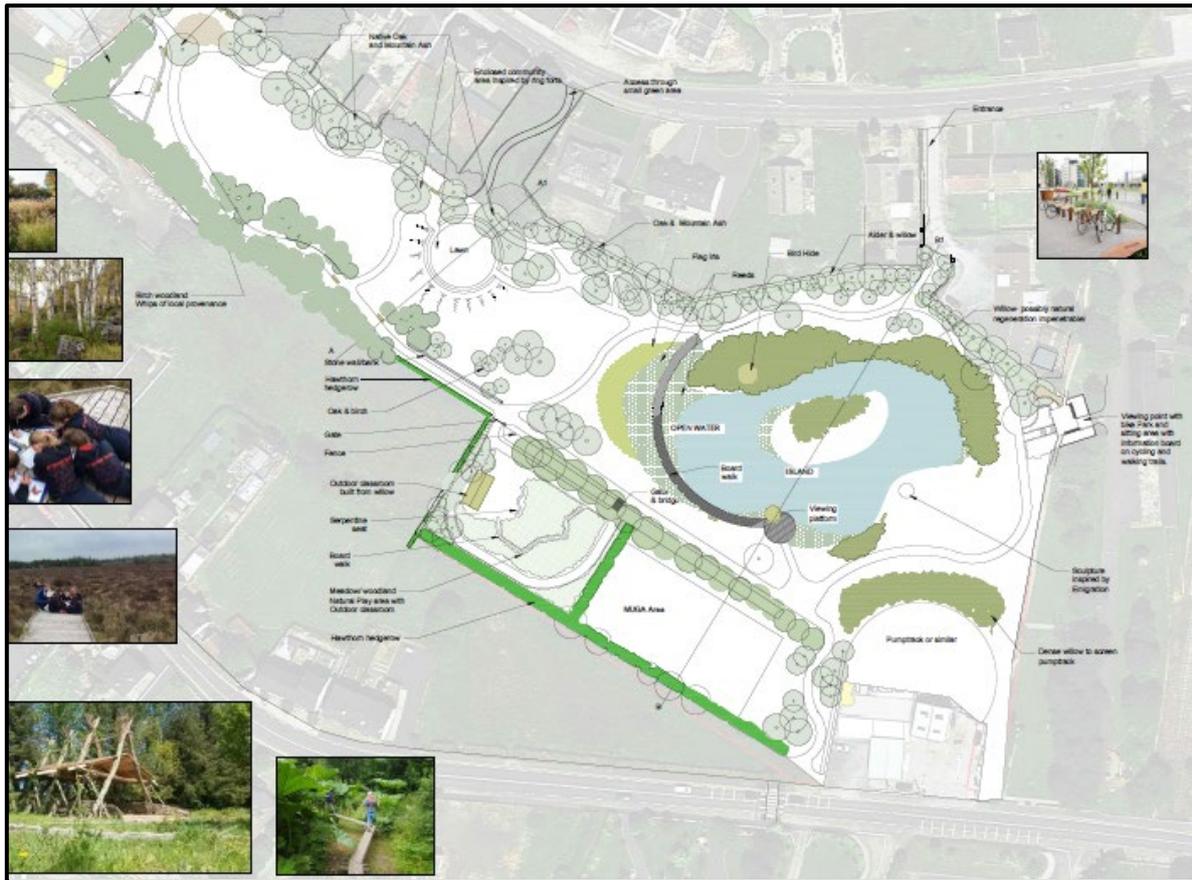
Fig 3 Design of Emigrant Amenity Park proposed for Kiltamagh.

The proposed development is the construction of an Amenity Park within a green field site 0.915 Ha. in size and owned by Kiltamagh Amenity Park Ltd. The development design is themed as an Emigration Park connecting with the existing Railway Museum, that borders the eastern edge of the development. As well as a Multi Usage Games Area the site will also be given over to allotments and wildflower areas. A small lake is planned for the north-eastern corner of the site. Mechanical excavation for the lake will cover a sub-circular area of approximately 20m x 30m. Otherwise large parts of the central, north, and north-eastern sectors of the development site will be left untouched in order to provide a natural habitat for biodiversity. On the higher ground at north-west a mock ringfort is planned (Fig 3).

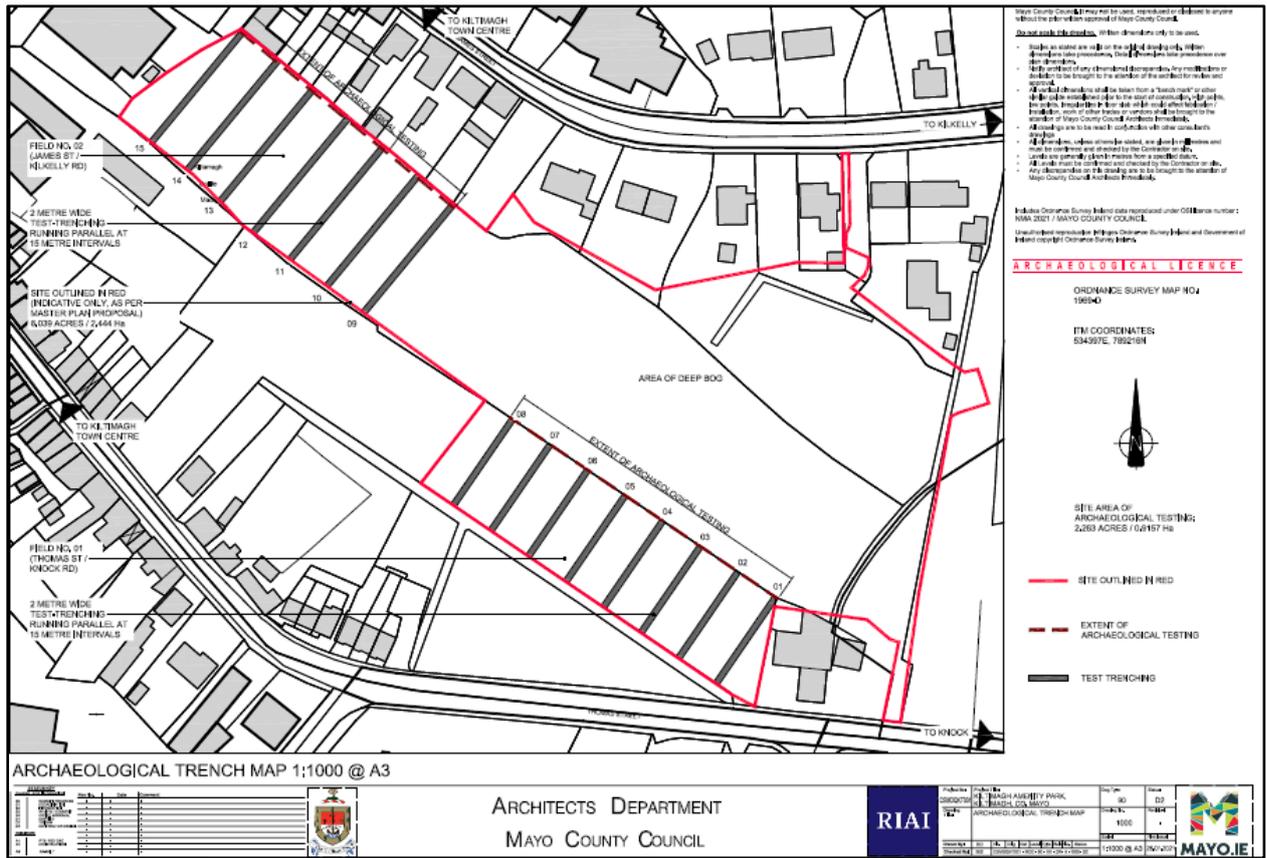
Fig 5 Development site outlined in red showing location of archaeological test trenches.

The archaeological, pre-development testing was carried out over three days from the 23rd to the 25th February 2021. During this time fifteen test trenches were mechanically excavated under licence number 21E0099. The testing took place in two fields. The field at south, closest to Thomas Street (Field 1), is level and low-lying. Testing in the second field (Field 2), to the north of Field 1 took in an area of higher ground that sloped down from north to south. Testing did not take place in the central and eastern sectors of Field 2 as the only planned disturbance here was for a small, artificial lake 20m x 30m in diameter. Eight test trenches were excavated in Field 1 and seven in Field 2. A total of nine contexts were recorded, six in Field 1 and two in Field 2. All test trenches were 2m wide and set 15m apart. They were aligned north-north-east x south-south-west and were mechanically excavated using a toothless grading bucket (Fig 5).

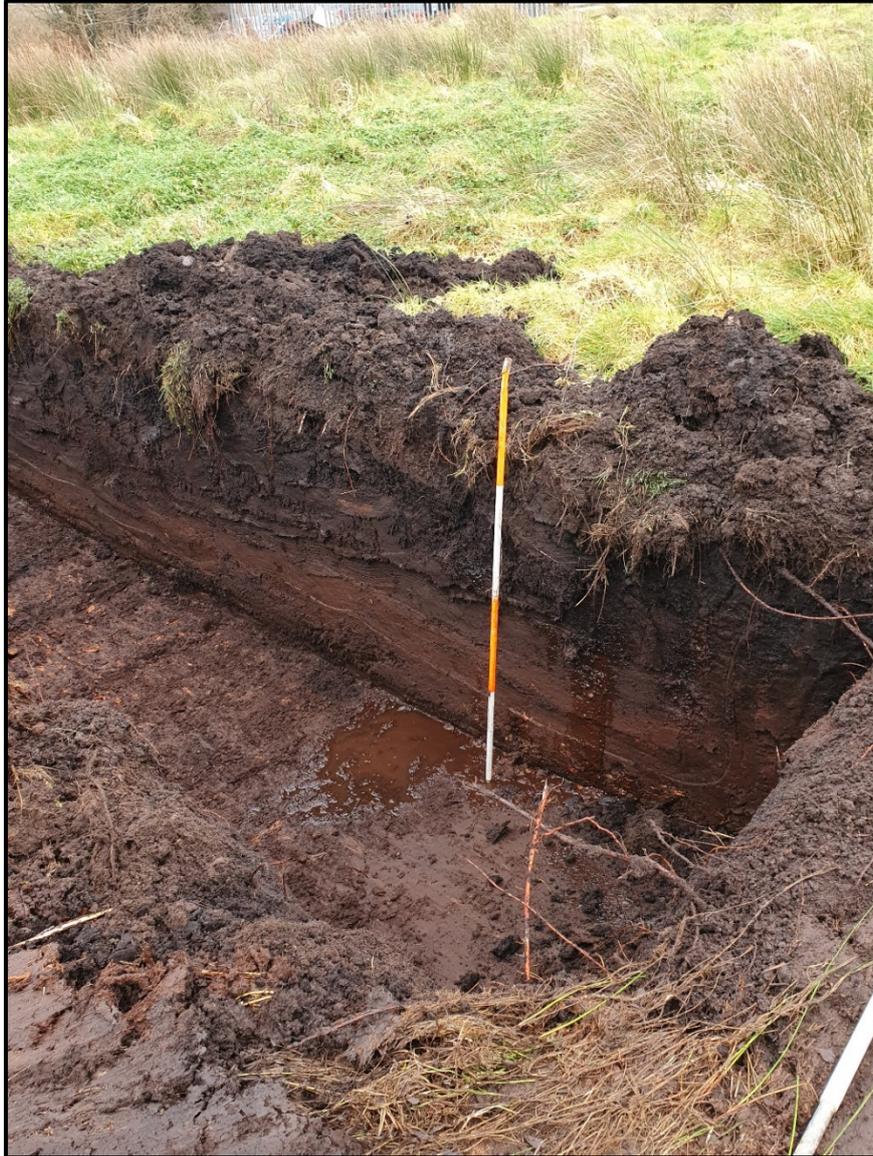
Plate 1 Looking east to excavation of peat (C4) in southern end of Test Trench 1.

Located on the west side of a service station fronting onto Thomas Street. A fine, loose topsoil (C1) between 0.6m and 0.7m deep, overlay compact peat (C4), with a natural layer of silver birch at a depth of 1m. A land drain (C5) ran through the centre of the trench on an east-west axis, on top of the peat, for 9m before it ran into the east facing section of the trench. The trench was excavated to a depth of 1.8m and the peat was seen continuing (Plate 1).

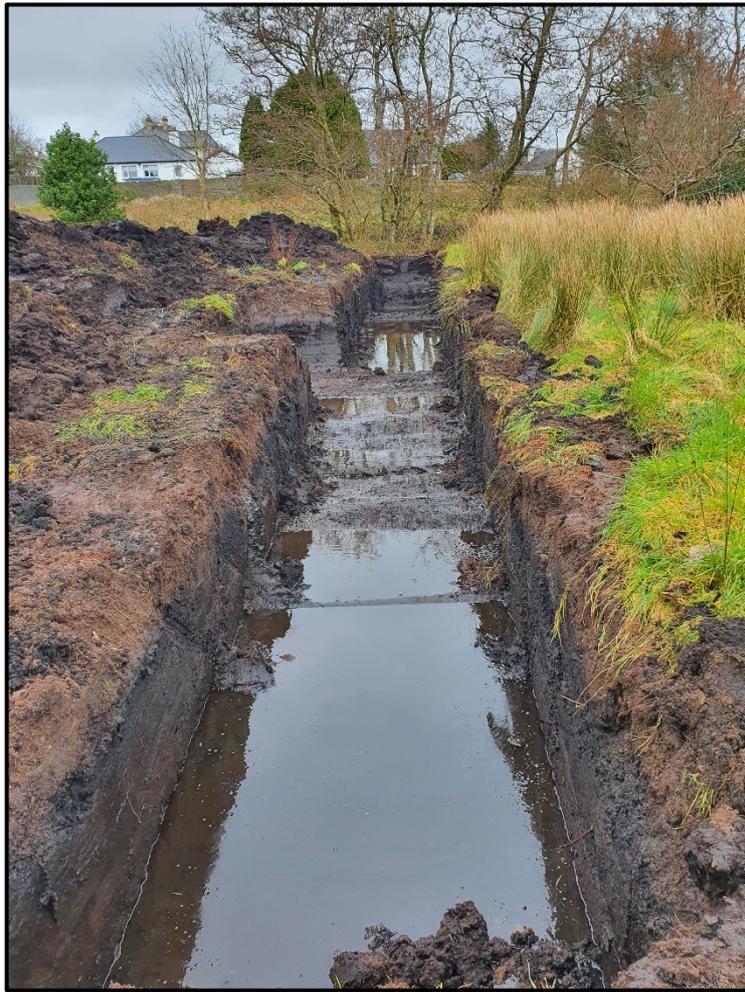
Plate 2 Looking north to general view of Test Trench 4.

A heavy clay topsoil (C2) overlay compact peat (C4) to a depth of 0.3m. Stony fill (C6) occurred as a layer covering almost the width of the trench just north of centre and running for 5m. The fill did not extend into the east section face of the trench but was seen continuing into the west section face where it was followed for 4m. The fill seemed to have been used to level up a low area of the field and to help with drainage. Within it were broken sherds of modern pottery. The trench was excavated to a depth of 1.8m and began to fill with water at this depth (Plate 2).

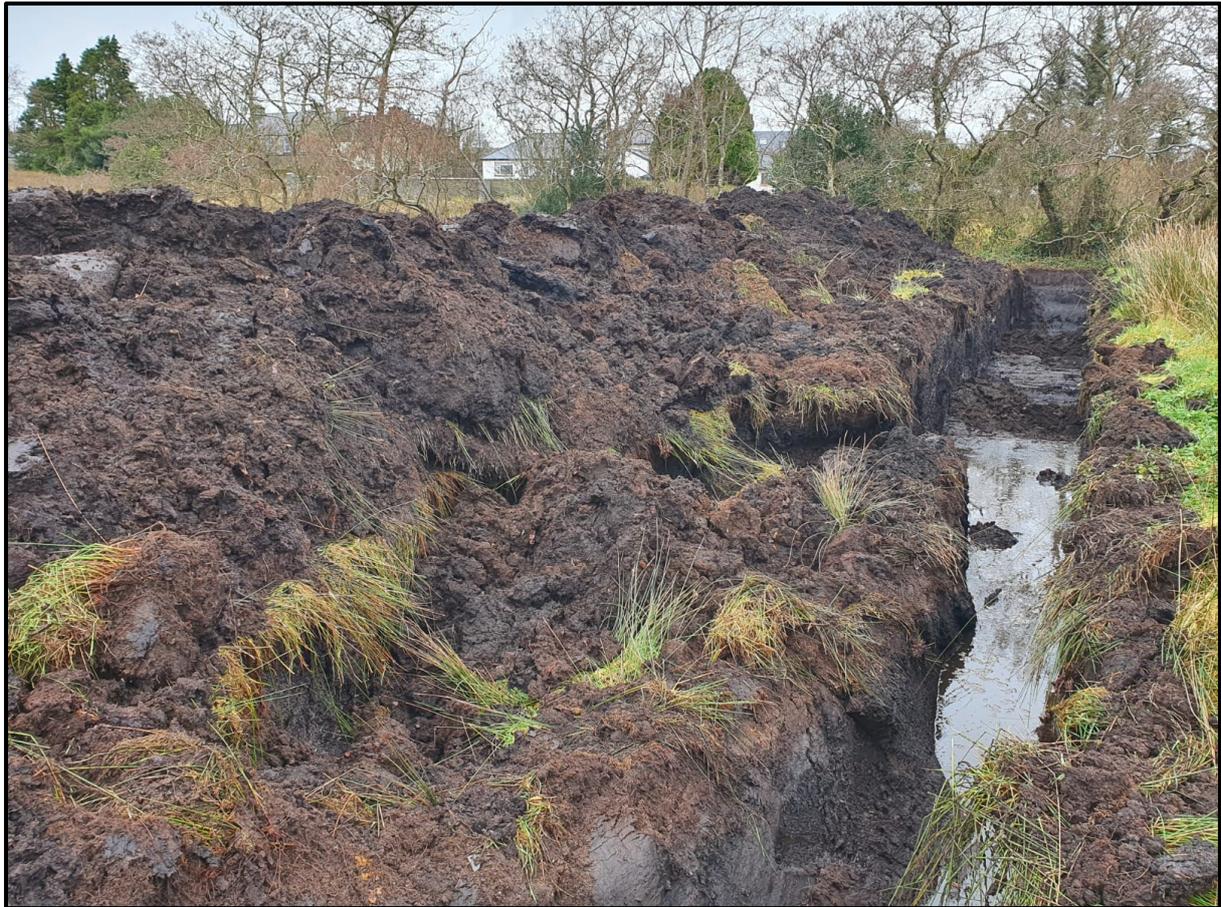
Plate 3 Collapse in Trench 5.

A compact clay topsoil (C2) overlay peat (C4) to a depth of 0.3m. Trench 5 was excavated to a depth of 2.2m and the west section face at the northern end of the trench collapsed in due to the unstable nature of the ground and the weight of the excavated peat (Plate 5).

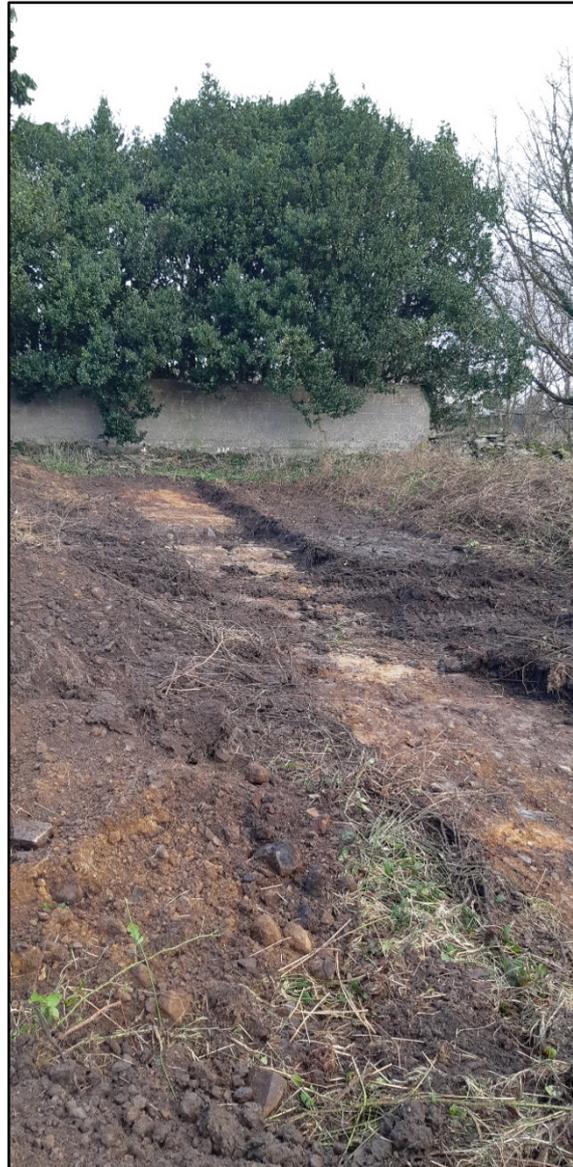
Plate 4 Looking north to Test Trench 9.
Shallow layer of topsoil (C7) above boulder clay (C8).

A shallow layer of clay topsoil (C7) between 0.15m and 0.25m deep overlay a natural boulder clay (C8) on the higher ground at the northern end of Test Trenches 9-12. The topsoil becoming slightly deeper as the testing moved west across the site (Plates 4 & 5). For the final 15m of Test Trenches 9-12 an abrupt fall off the hill gave way to deep peat (C9) containing some large tree trunks. (Plates 6 & 7). The peat was again overlain by a shallow layer of clay topsoil (C7). Modern crockery sherds were found in the topsoil, particularly where it overlay boulder clay (C8) on the higher ground at north.

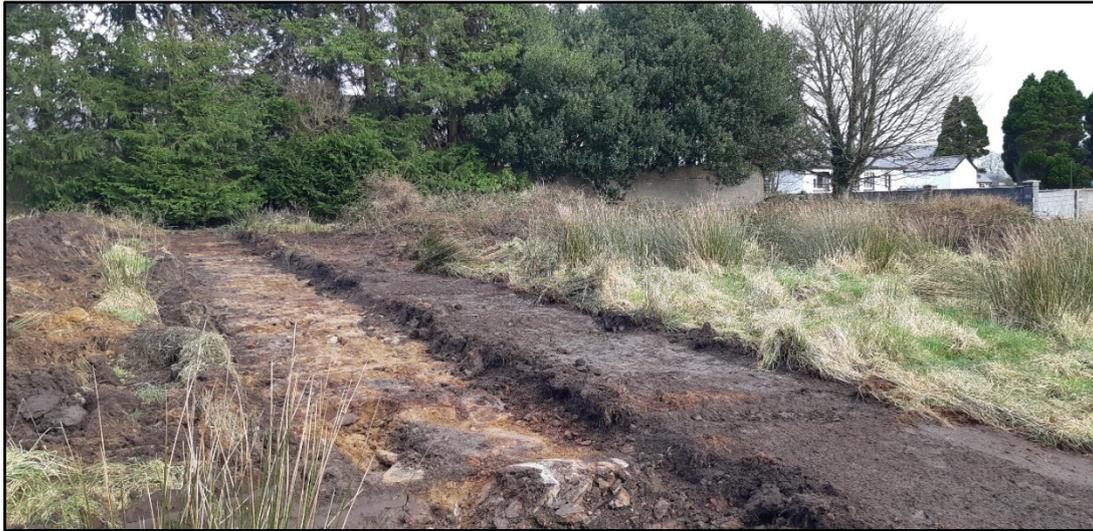
Plate 4 Looking north-east to Test Trench 10.
Rock coming through boulder clay (C8) in foreground.

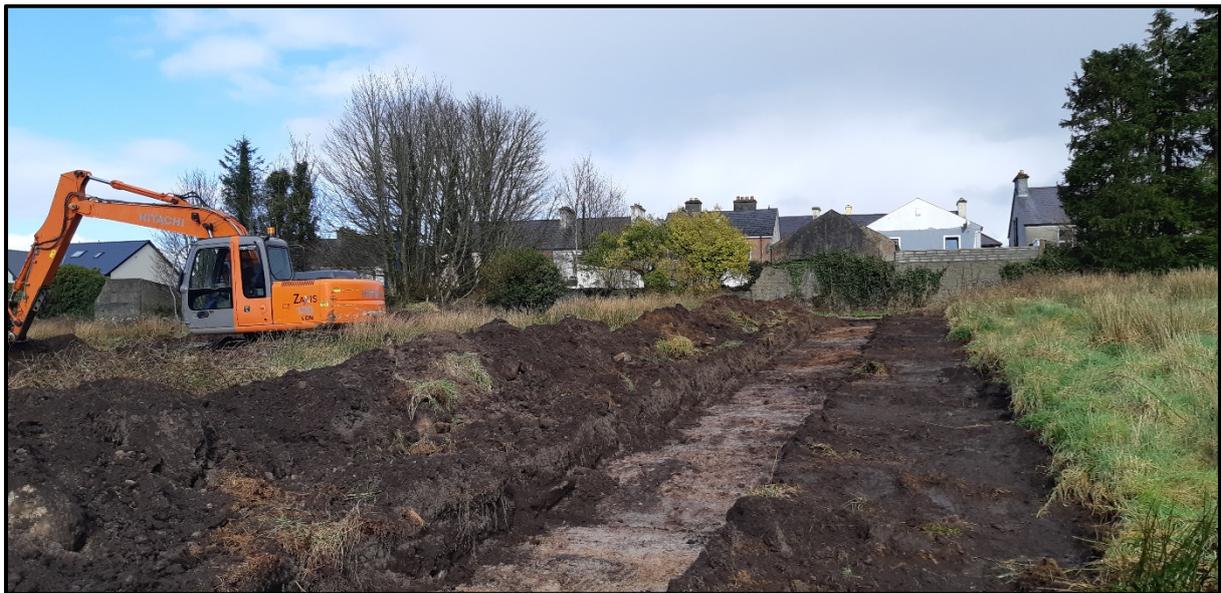
Plate 5 Looking north to general view of Test Trench 11.

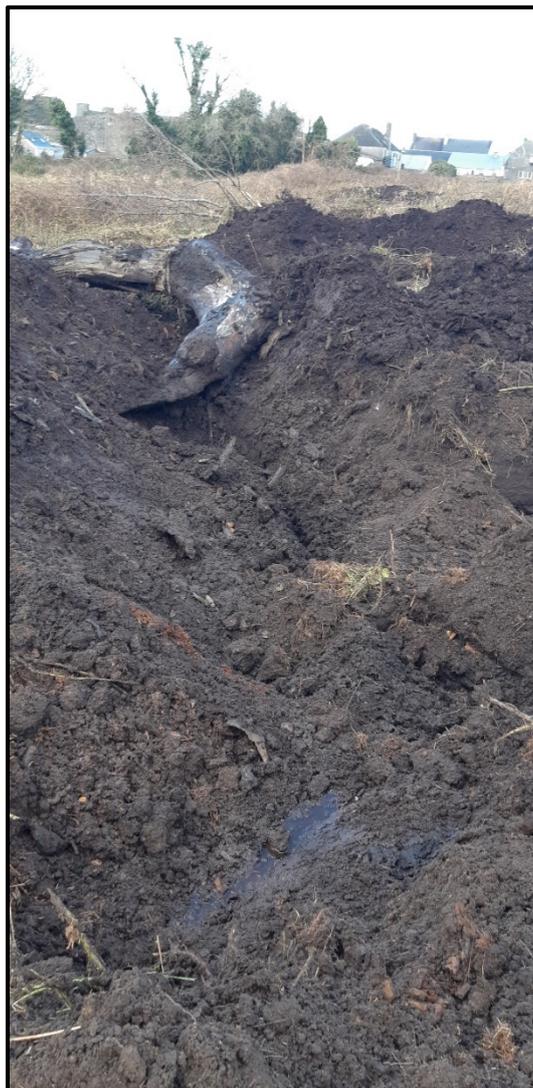
Plate 6 Looking south to large tree trunk from excavation of peat (C9) in Test Trench 12.

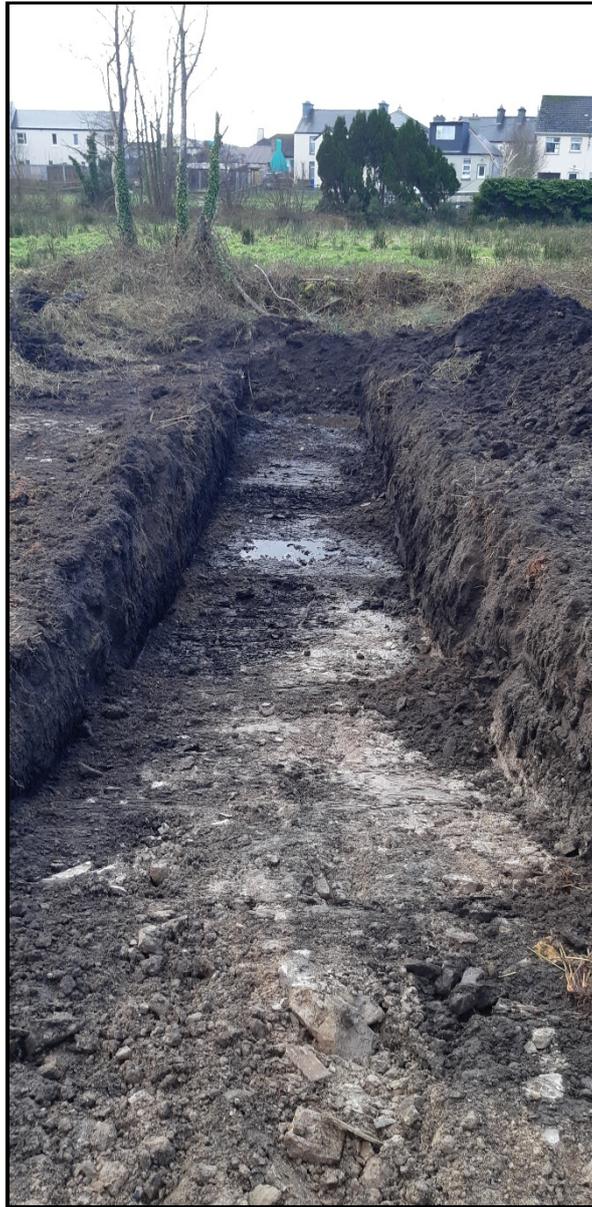
Plate 7 Looking south to gradual fall from natural boulder clay (C8) into pocket of deep peat (C9) in Test Trench 13.

The stratigraphy in Test Trenches 13-15 was the same as that in Test Trenches 9-12. Clay topsoil (C7) now reached an average depth of 0.4m however, on the higher ground where it again overlay natural boulder clay (C8). The peat (C9) only occurred for the final 6m at the southern end of Test Trenches 13-15 and the fall, off the higher ground, was more gradual (Plate 7). Modern crockery sherds were again found in the topsoil, particularly on the higher ground at north.
