**RICHARD CRUMLISH, B.A., M.I.A.I.
CONSULTANT ARCHAEOLOGIST**

**ARCHAEOLOGICAL IMPACT ASSESSMENT
OF A
PROPOSED GREENWAY
FOR
BALLINROBE,
COUNTY MAYO**

May 2021

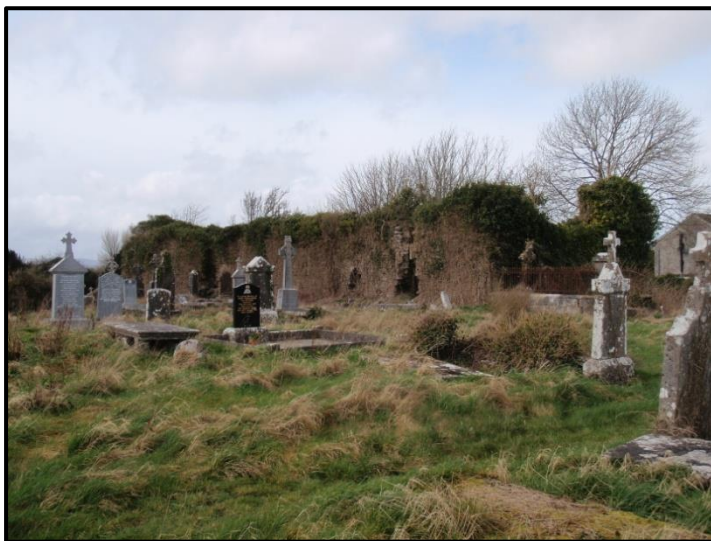
Plate No. 1 Carrownalecka Church, from SE.

'Carrownalecka Church' (RMP No. MA118-022006) stands in the NE corner of a graveyard (RMP No. MA118-022007) and is heavily overgrown with ivy (Plate No. 1). It is located at the N end of the town to the W of the River Robe (Figure 2).

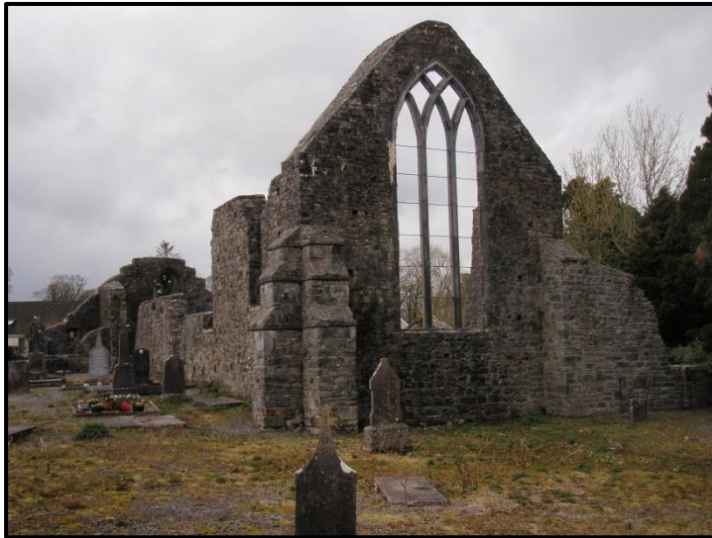
Plate No. 2 Augustinian Friary from ESE.

The friary (Plate No. 2) was founded *c.* 1312, probably by Elizabeth de Clare and was the first Augustinian house in Connaught. It is located just E of the river at the N end of the town (Figure 2). Its buildings were repaired in 1400 and 1431 with friars in occupation in 1574 and again after the rebellion of 1641.

It was excavated prior to its restoration and conservation between 1990 and 1994. Burial still occurs in the surrounding graveyard (RMP No. MA118-022003).

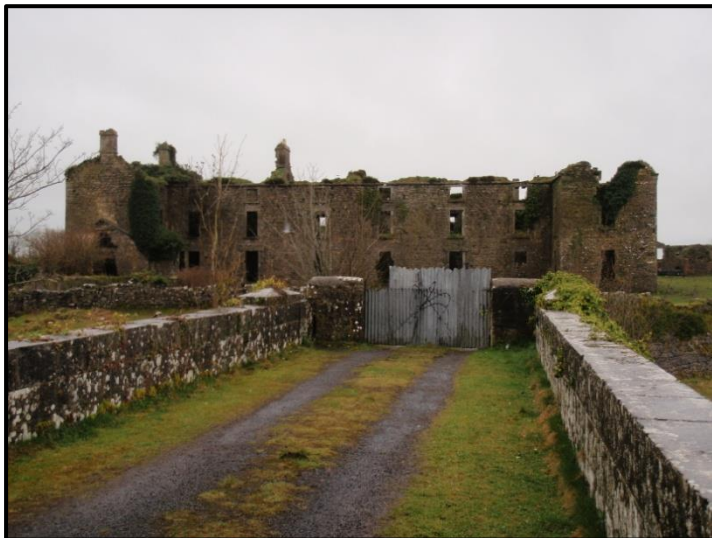
Plate No. 3 Cavalry Barracks from N.

According to Knox (1908), a Norman castle was erected here in the 1230s. The medieval borough included a castle (RMP No. MA18-022001), which changed ownership many times and was transformed into a manor house, before being levelled to build a military barracks in the late 18th century (Plate No. 3).

The ruins of the Cavalry Barracks stand on the southern bank of the River Robe (Figure 2).

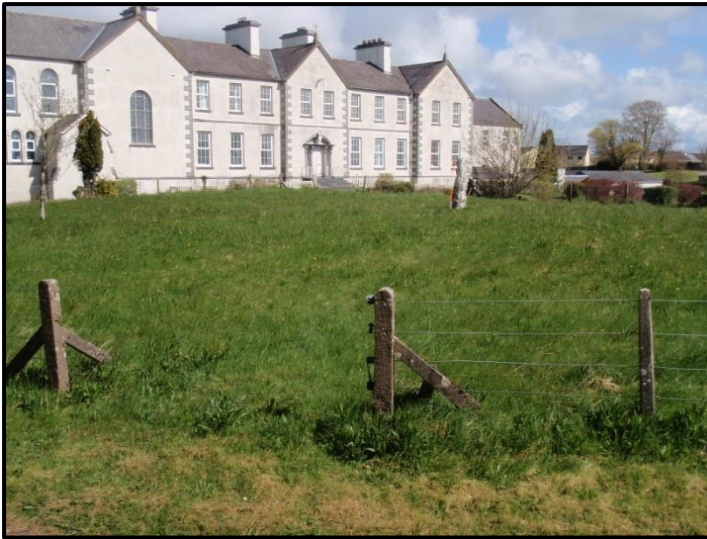
Plate No. 4 Enclosure from SW.

Description: According to An Archaeological Survey of Ballinrobe and District (Lavelle, 1994) the enclosure (RMP No. MA118-023) consists of a 'Roughly circular area (37.8m N-S; 28.2m E-W), enclosed by low earthen bank (H 0.3m) SW to ESE. Standing stone... in interior' (Plate No. 4).

The enclosure (RMP No. MA118-023) is located to the front (S) of the former Sisters of Mercy convent, which dates to the mid 19th century and is now in use as a crèche (Figure 2 and Plate No. 4). A tarred access road is located around the circumference of the monument.

- The proposed greenway is not located within the constraint for Ballinrobe (RMP No. MA118-022) (Figure 2), however, it is located within the archaeological constraint for an enclosure (RMP No. MA118-023) in Cornaroya townland (Figure 2). The proposed route is located 6.5m away from the recorded monument (RMP No. MA118-023). Due to the proximity and the possibility that a ditch/fosse was located outside the extant bank of the enclosure, associated sub-surface features and/or deposits may be adversely affected by the construction of the greenway.

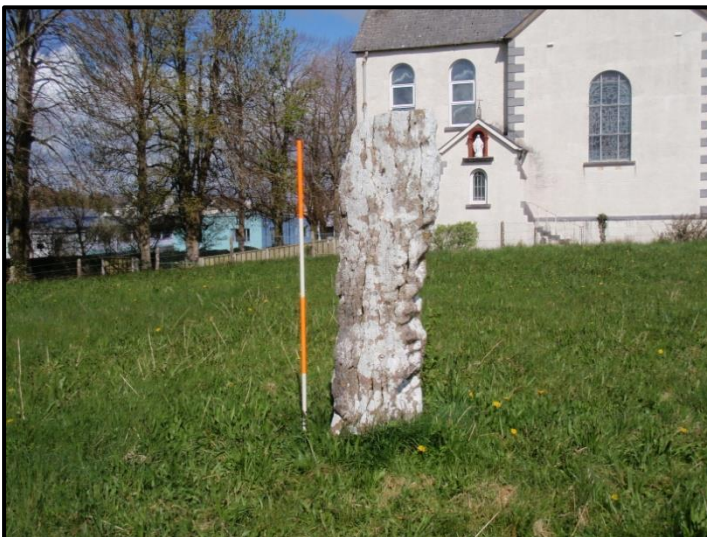
Plate No. 5 Standing Stone from S.

The standing stone (RMP No. MA118-023001) is described as 'Rectangular in plan (max. dims. H 2.16m; Wth 0.6m; T 0.3m), of limestone material' (Plate No. 5). These descriptions were based on site visits which took place in March 1990.

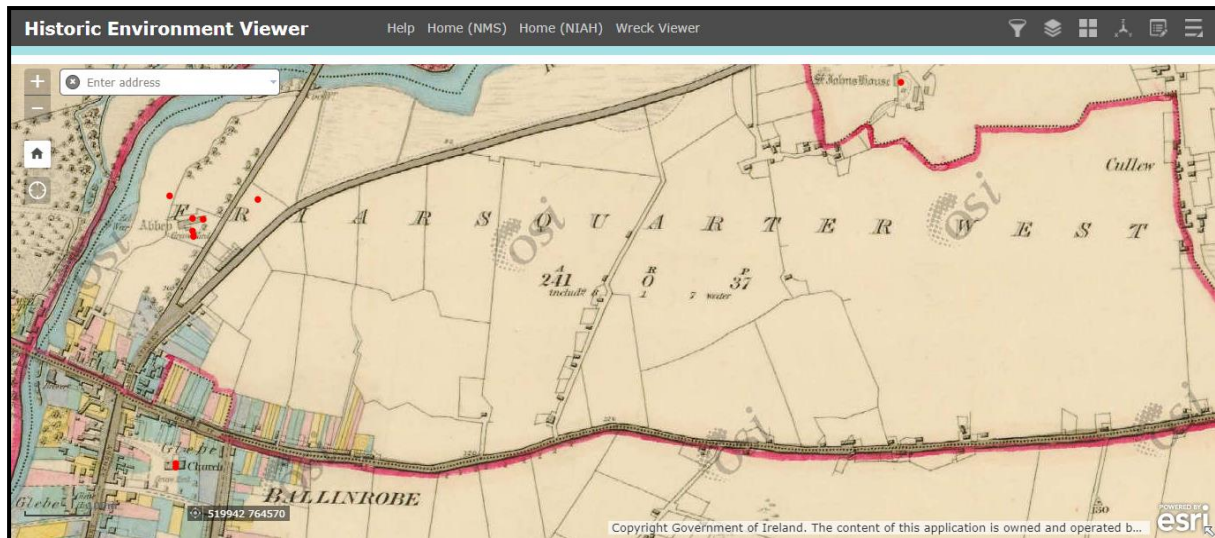
Figure 3 Site Location Map – extract from 1st edition of OS six-inch sheet of 1838 (courtesy of www.archaeology.ie).

A number of buildings, possibly dwellings, are indicated along the WNW side of the NNE/SSW aligned breen/road located along the S half of Section 1 of the proposed Greenway route on the 1838 edition of the OS six-inch map (Figure 3). None of these buildings are extant.

Only one of the buildings marked on the 1838 edition of the OS six-inch map (Figure 3) along the S half of Section 1 of the proposed Greenway route appears to have survived by the time of the OS 25-inch map of the late 19th/early 20th century (Figure 5).

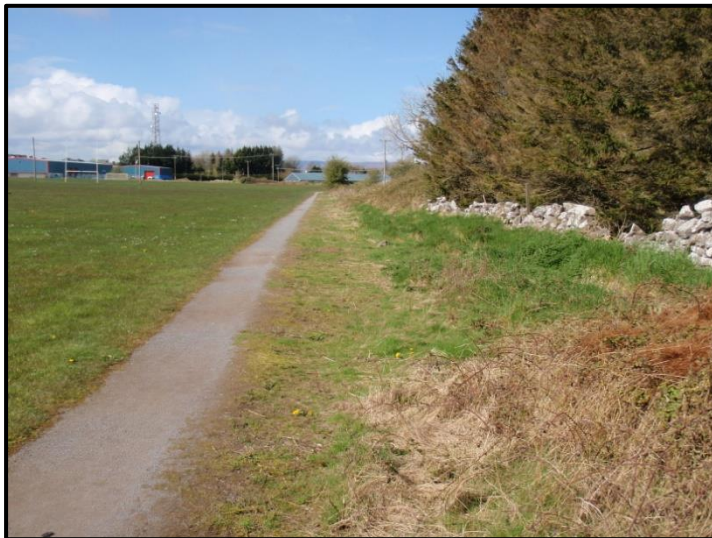
Plate No. 7 Looking W along N side of Ballinrobe Community School playing pitches.

The pitches have necessitated ground disturbance during their construction with a fall in ground levels of over 1m along the E side of the playing field, indicating the filling up of this side of the area.

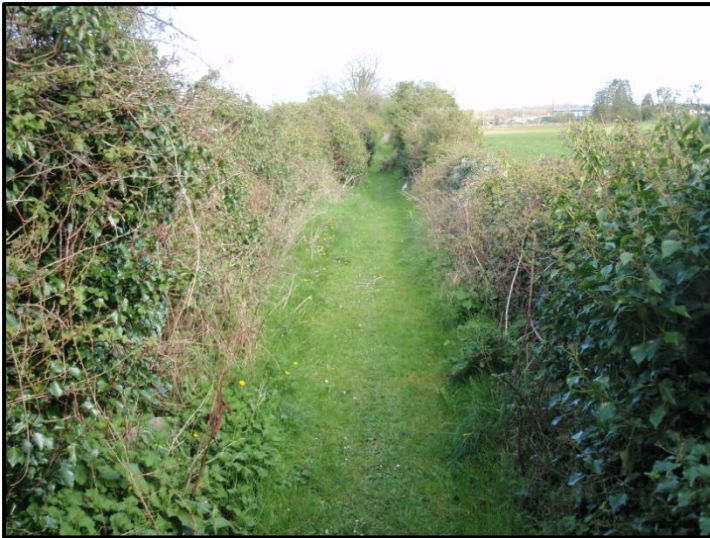
Plate No. 8 Looking NNE along grassy boreen.

The proposed route then turns SSW along the E side of the playing fields and runs along an existing grassy boreen enclosed by drystone walls overgrown with ivy, hawthorn, elder and briars (Plate No. 8).

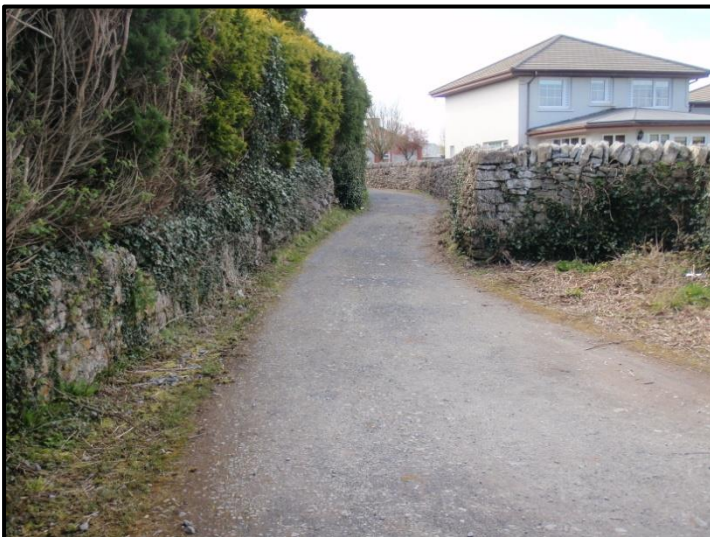
Plate No. 9 Looking SSW along stoned access road.

To the SSW of the Ballinrobe Community School pitches the proposed route will utilise an existing stoned access road which runs from pitches to the S end of Section 1 on the Convent Road (Plate No. 9).

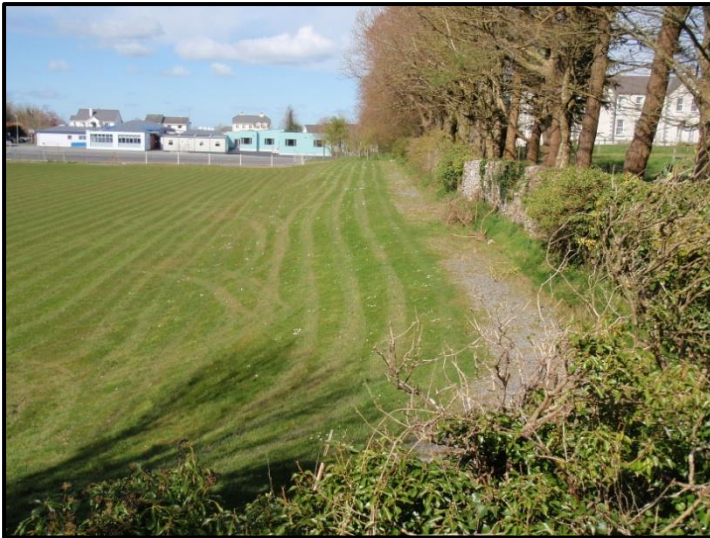
Plate No. 10 Looking NNE along ESE side of St. Joseph's Primary School pitch.

This area and the NNE end of the school pitch to the SSW borders the former Sisters of Mercy Convent (to the E). Further to the SSW is the school pitch, at the ESE end of which the route is located on a landscaped raised area along the same mortared stone boundary wall (Plate No. 10).

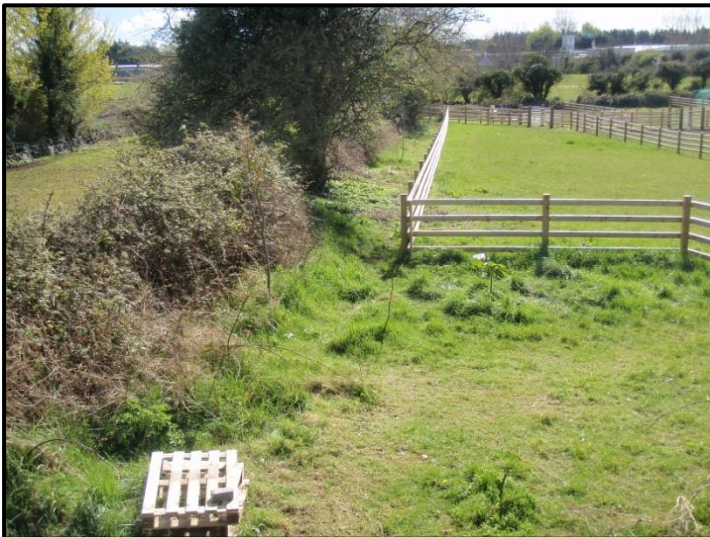
Plate No. 11 Looking SSW along Section 2 through garden centre grounds.

The SSW end of Section 2 of the proposed route is located in the grounds of a garden centre, which consists of pasture sloping down to the S and W, which is divided into a number of paddocks by modern wooden post and rail fencing (Plate No. 11). A number of saplings are found along this section.

Along the ESE side of this section is a drystone wall overgrown with hawthorn and briars (Plate No. 11).

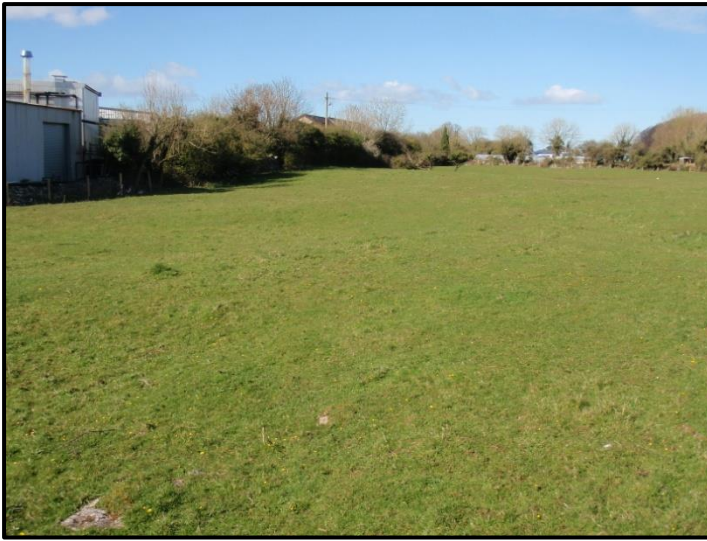
Plate No. 12 Looking N along proposed route of Section 3.

Most of the length of the third and final section of the proposed Greenway is located within a large field of undulating pasture which is enclosed by drystone walls lined with ash, hawthorn and briars (Plate No. 12).

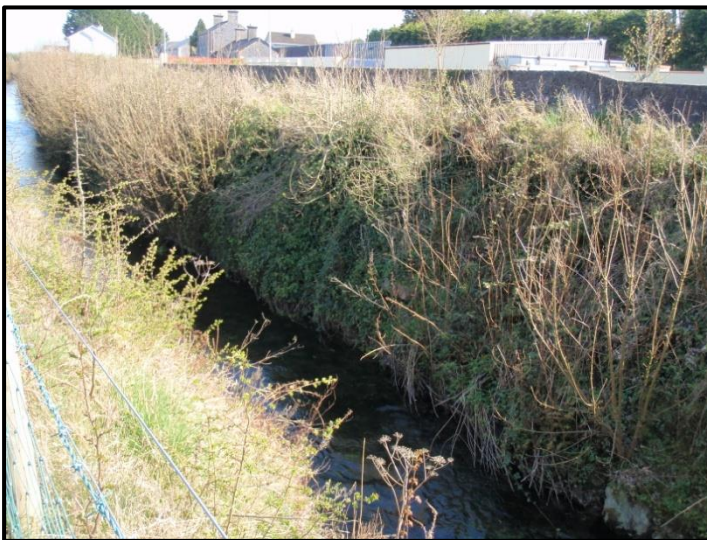
Plate No. 13 Looking SE along the Bulkan River.

The route of the track then turns ESE for a short length along a high mortared stone wall to the rear of a domestic dwelling, before resuming its SSW direction to meet the Bulkan river. The river channel measures *c.* 9m wide and *c.* 5m deep and appears to have been artificially deepened in modern times (Plate No. 13).
