Archaeological Report for Licence No. 18E0509 Cross West, Co. Mayo

Architects Section, Mayo County Council Áras
an Chontae, Castlebar

Sue Zajac, Archaeologist,
Mayo County Council
18-12-2018

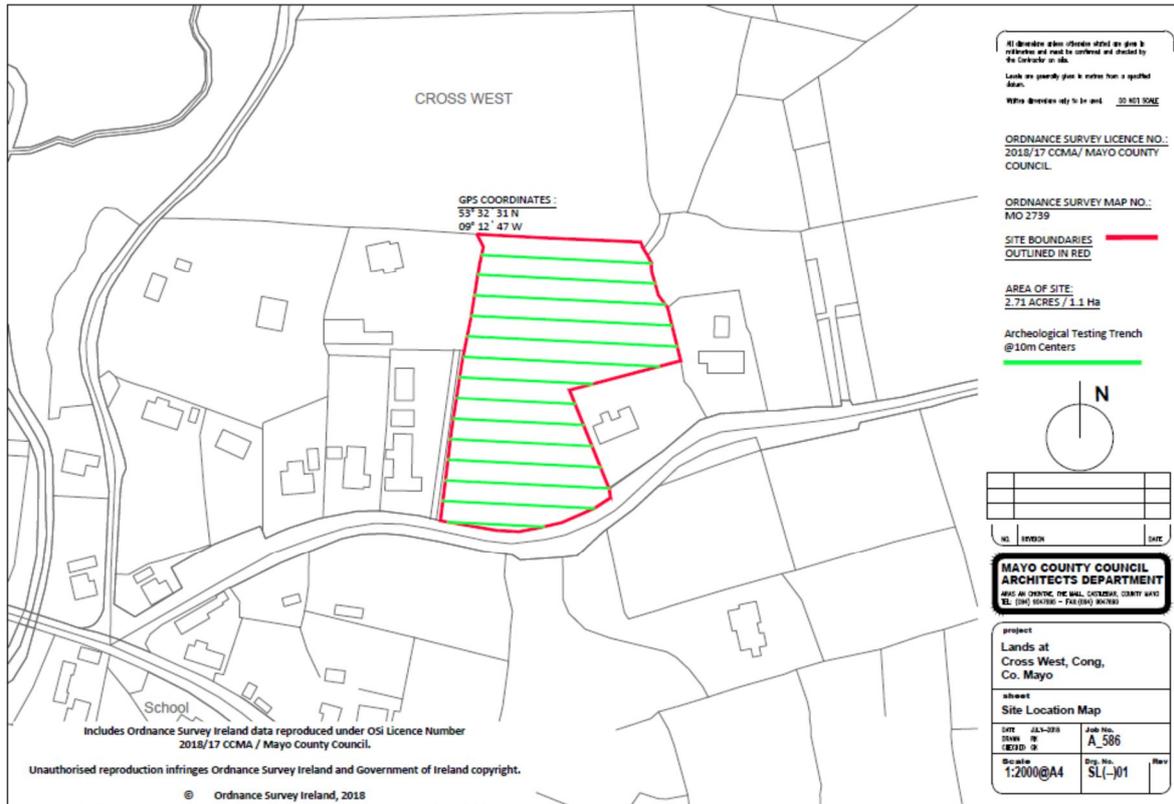
Fig 3 Location of Test Trenches 1-14 within Development Site

Test Trench 1 is located at the northern end of the site with remaining trenches running numerically in a southerly direction

The test trenches were numbered 1-14 and ran on an approximate east-west axis across the site (Fig 3). They ranged from a maximum of 97m long (Trenches 1-6) to 75m long (Trenches 7-14). All the test trenches were 2m wide and were spaced 10m apart (Fig 3). They were mechanically excavated using a toothless grading bucket. The testing was carried out over two days starting on the 27th September 2018.

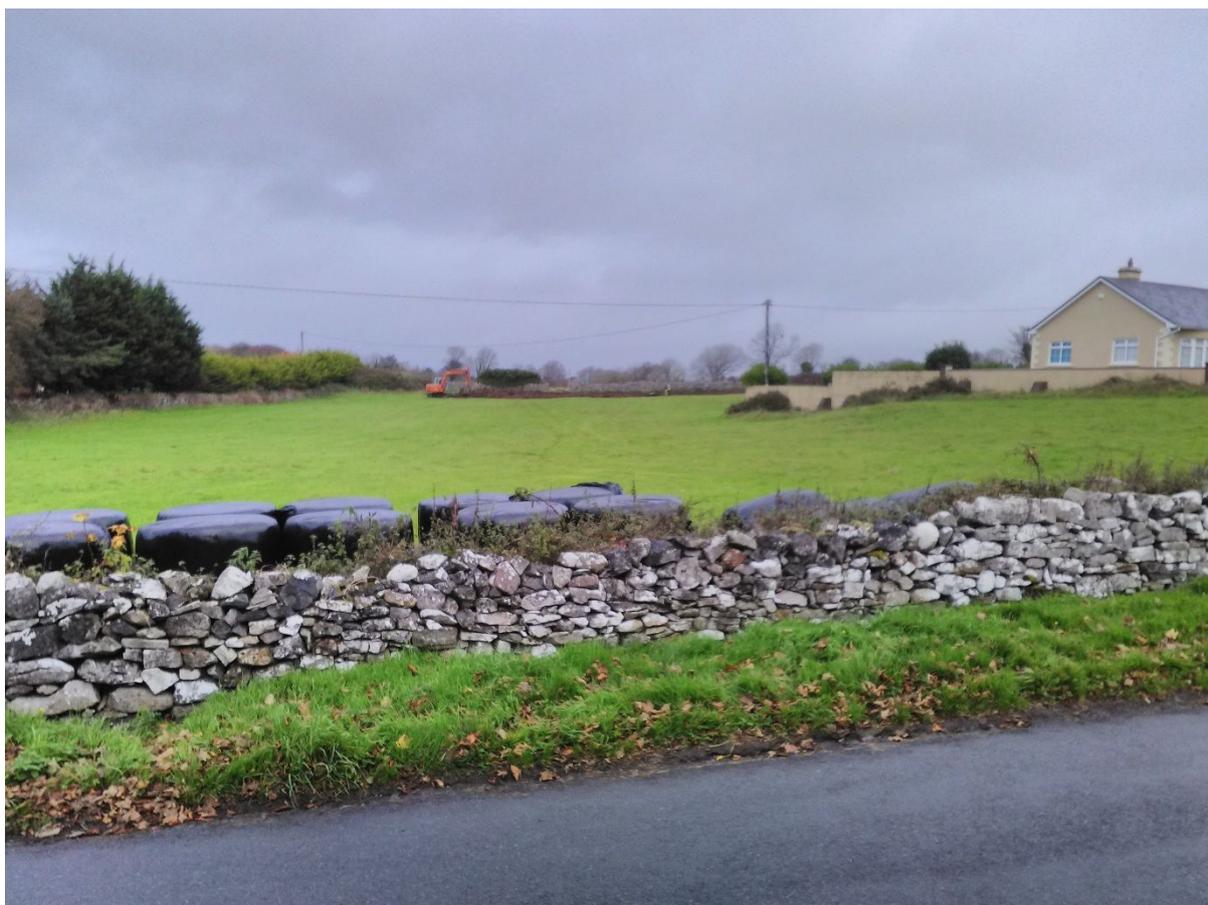
Plate 1 General view of Development Site and excavation of Test Trench Two

Nothing of archaeological significance is designated or could be seen at surface level within the proposed development area. The ground was characterised by good quality grass land which had been used to cut silage. A very large pile of grassed over, land clearance stones, was seen in the north-west corner of the site and had been fenced off from the remainder of the field. From this and the quality of the grassland, it suggested that land reclamation had already occurred within the development site. Silage bales were also seen within the field running in a line parallel to the regional road (Plate 1).

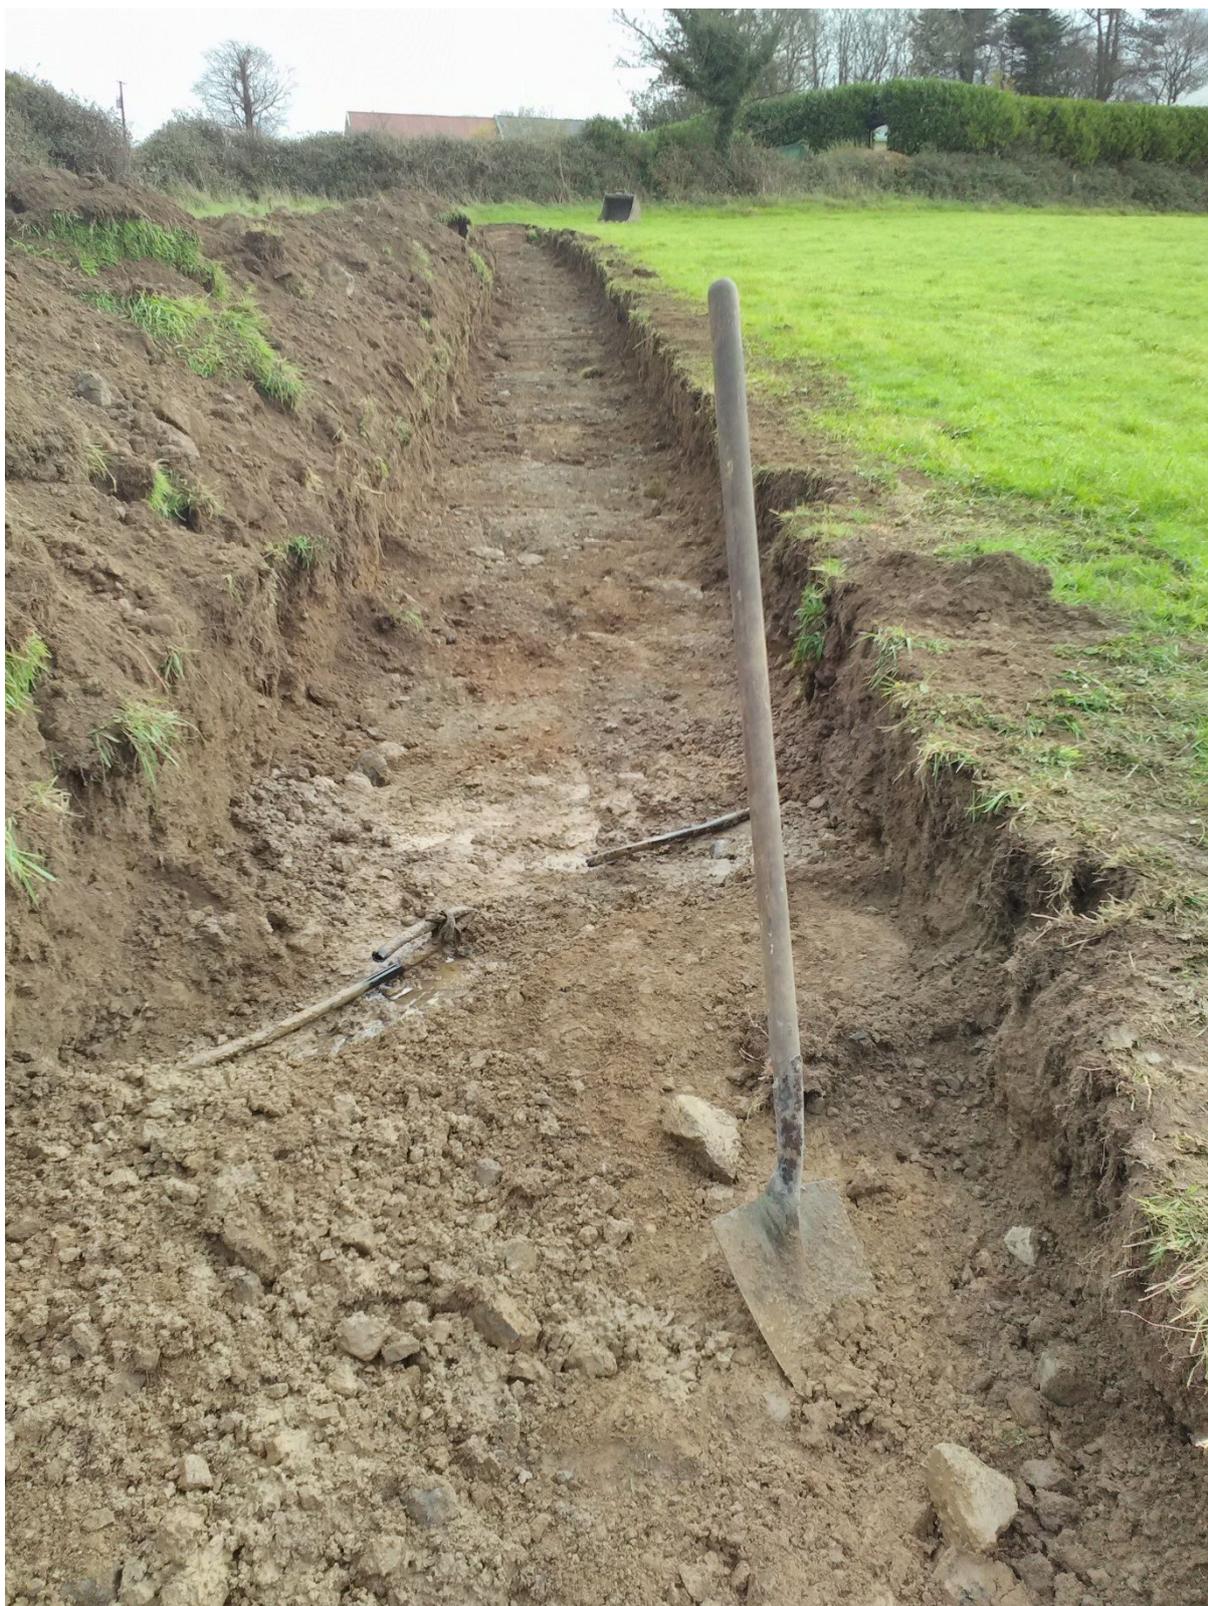
Plate 2 Excavation of Test Trench Two showing gravel (Context 3) and clay (Context 1) and marl (Context 2) above it

Three contexts were recorded during the archaeological testing and these are described in Appendix 1. In all trenches a reddish-brown clay (Context 1) overlay natural to a depth of between 0.1 and 0.3m. The clay had sparse inclusions of pebbles and roots, from the sod, going through it. It was archaeologically sterile and had almost no modern material, of any sort within it. Below the clay was a shallow layer of marl (Context 2), also reddish brown. It was difficult to distinguish between the two layers in terms of colour. The marl however was very smooth and composed of a very fine sand. The overlying clay was moderately loose. Below the marl was natural limestone gravel. On the higher ground this gravel was seen to contain sparse amounts of, large, limestone boulders or sheets of bedrock associated with the north-south

ridge. Generally, however the gravel was very coarse with frequent inclusions of pebbles and moderate inclusions of cobbles. The excavation did not go beyond this gravel layer. The testing showed that the ground had been thoroughly reclaimed prior to the archaeological testing. The ground was very sterile of any intrusive material and the soil stratigraphy was homogenous throughout all trenches. A narrow gage water pipe was seen crossing trench number eight and trench two. It seemed to be leading to the water trough and was deliberately avoided in all other trenches. Nothing of archaeological significance was uncovered.

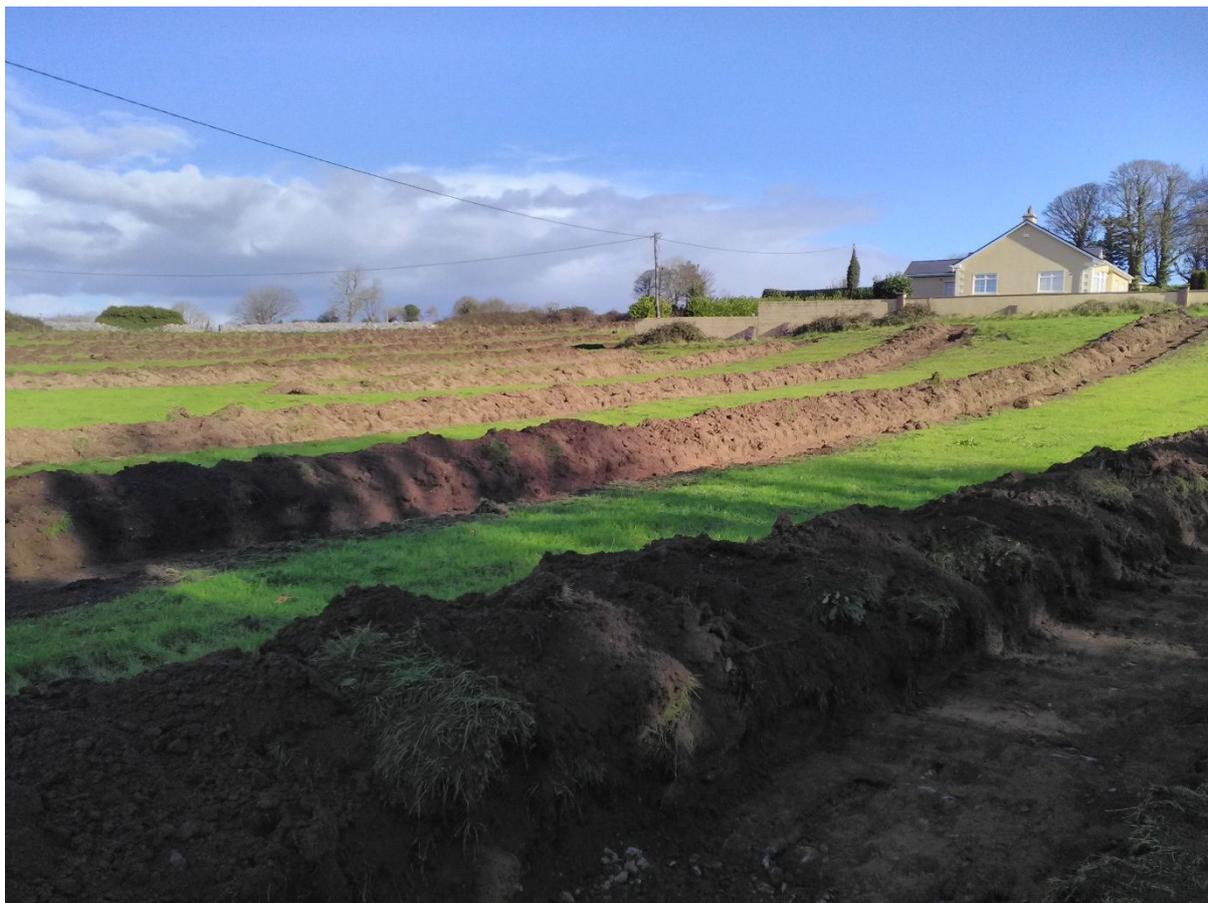
Plate 3 General view of Test trenches looking north-east.

Seven trenches were excavated in the smaller section of the field running on an east-west axis for 75m (Plate 3). The natural ridge already seen in trenches 1-6 was uncovered again for a short distance at the eastern end of trenches 7-14. In general, the clay topsoil (Context 1) became deeper in trenches 7-14 averaging 0.35m above the thin layer of natural marl (Context 2) and underlying gravel (Context 3). This was particularly apparent at the lower end of the

field in the south-west corner. Another water pipe was uncovered on top of the gravel in test trench 8.
