LICENCE NO. 19E0620

ARCHAEOLOGICAL REPORT ON  
PREDEVELOPMENT TESTING  
AT ROOGHAUN TOWNLAND,  
CARNACON, CO. MAYO

SUE ZAJAC ARCHITECTS  
SECTION ÁRAS AN CHONTAE  
CASTLEBAR

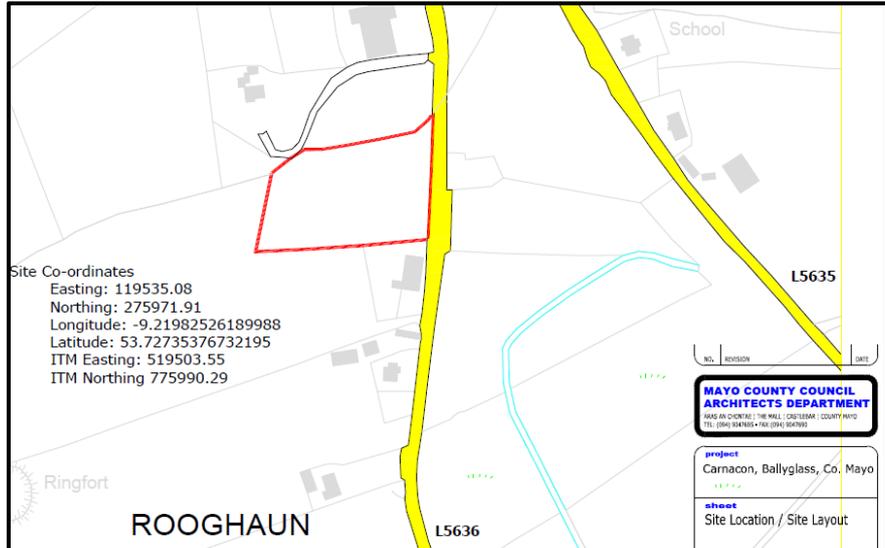
Fig. 2. Development site outlined in red.

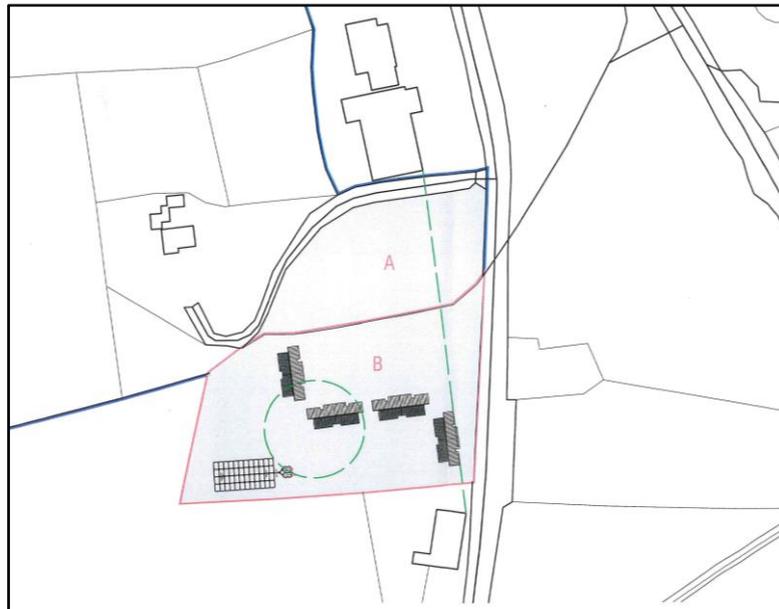
The proposed development is the construction, by Mayo County Council, of eight social and affordable housing units, as well as all auxiliary works. A second area marked 'A' below is also in Council ownership but is not being developed at this time (Fig 3).

Fig 3 Schematic drawing of housing units in the development site in Carrownacon, with Parish Church and Parochial House to north and north-west respectively.

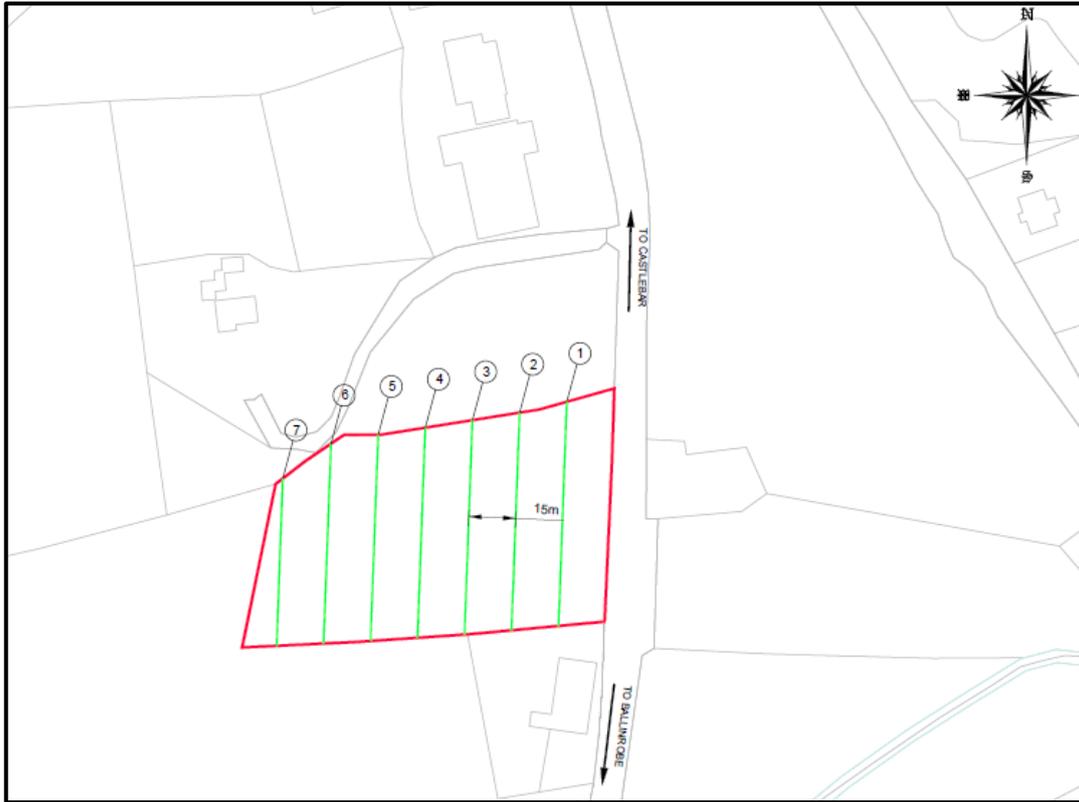
Seven test trenches were mechanically excavated using a toothless grading bucket. All trenches ran on a north x south axis for a maximum distance of 72m and a minimum distance of 54m and were spaced at a distance of 15m (Fig 4).

Fig 4 Location of Test Trenches 1-7 in Rooghaun Townland.

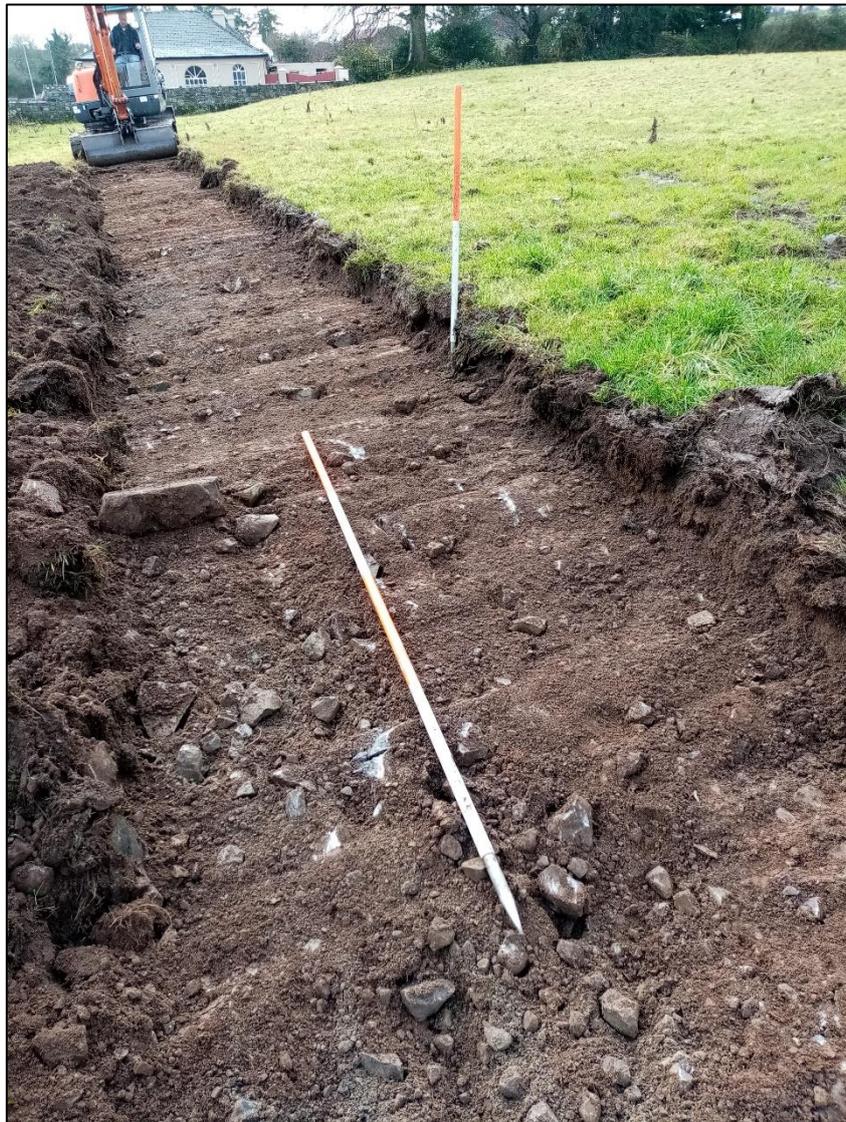
Test Trench One was 72m long. A shallow, clay topsoil (Context 1), overlay gravel for a depth of between 0.2m and 0.3m deep. A small piece of red brick was found on top of the gravel but nothing of archaeological significance was uncovered (Plate 1).

Plate 1 Looking south to limestone gravel (Context 2) below clay (Context 1) in Test Trench One.

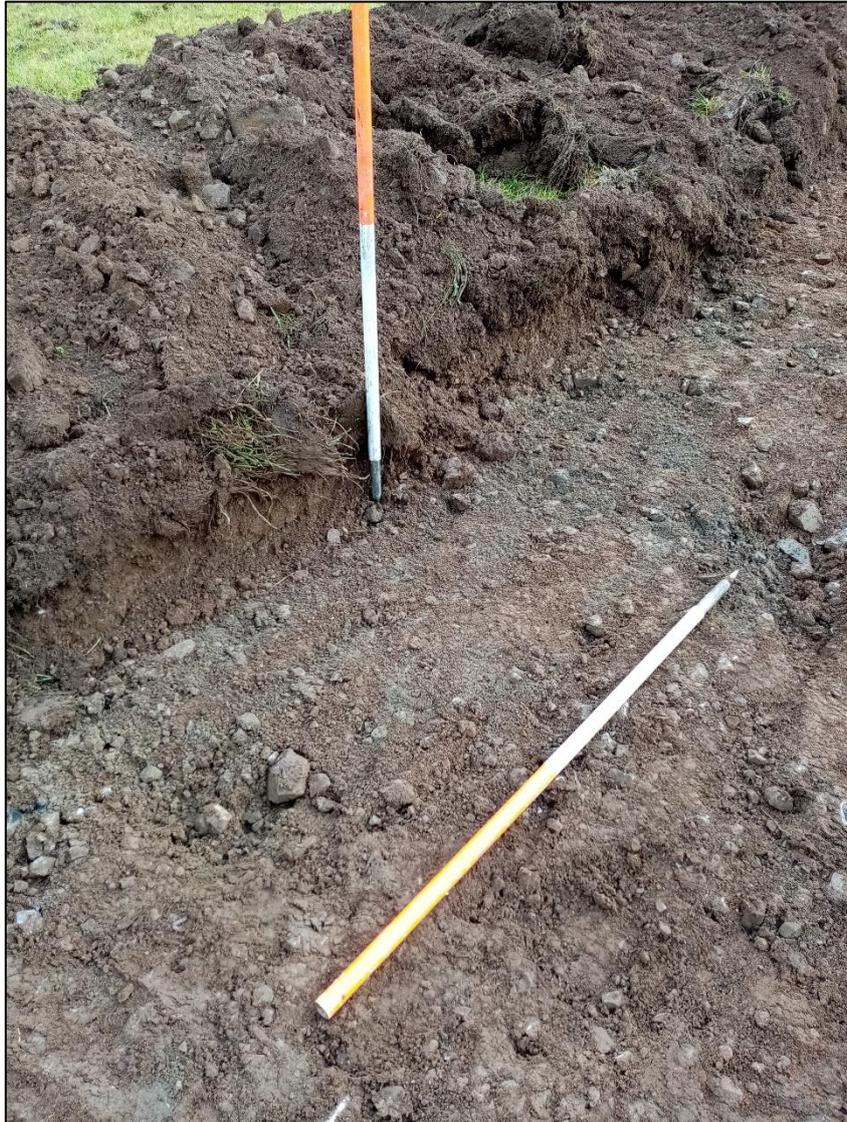
Located 15 m north-west of Test Trench One and parallel to it. Test Trench Two was 71m long. The stratigraphy was the same as in Test Trench One with a shallow layer of silty, clay (Context 1) overlying limestone gravel (Context 2). Nothing of archaeological significance was uncovered (Plate 2).

Plate 2 Gravel (Context 2) below clay (Context 2) in Test Trench Two.

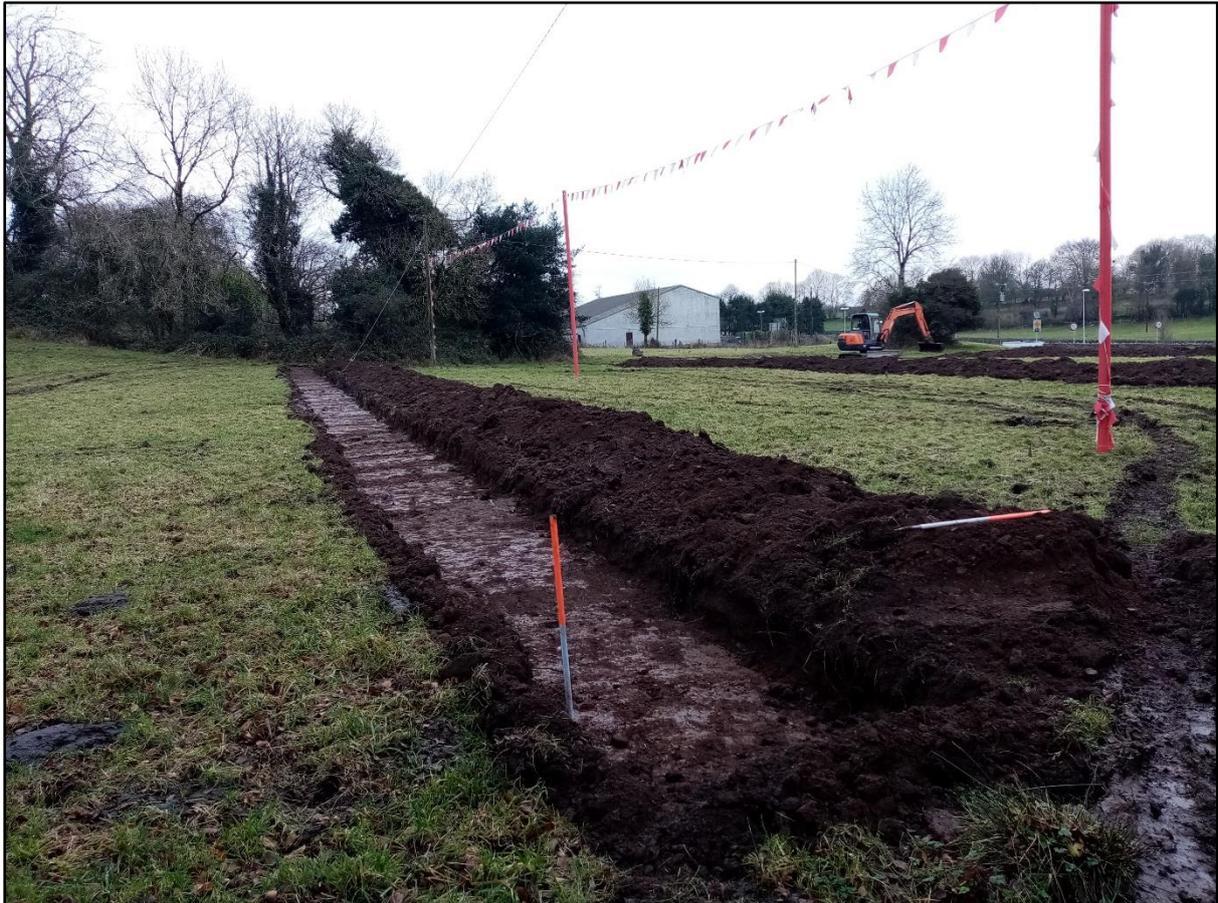
Located 15m north-west of Test Trench Two and parallel to it. Test Trench Three was 70m long. The stratigraphy was the same as in Test Trench One and Two, with a shallow layer of silty, clay (Context 1) overlying limestone gravel (Context 2). Nothing of archaeological significance was uncovered (Plate 3).

Plate 3 Looking north along Test Trench Three showing sterile clay (Context 1) with Test Trenches Two and Three in background.

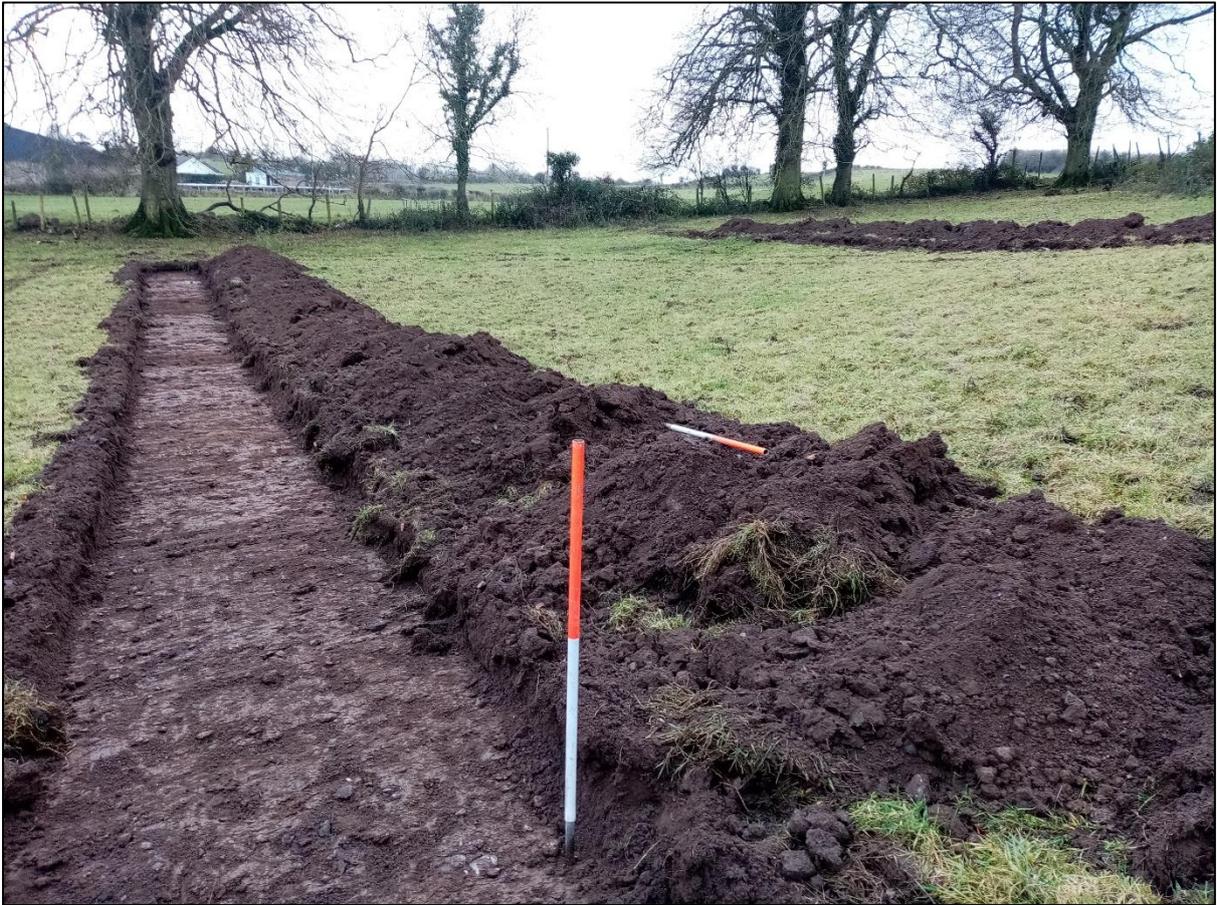
Located 15m north-west of Test Trench Three and parallel to it (Fig 3). Test Trench Four was 68m long. The stratigraphy was the same as in Test Trenches 1-3, with a shallow layer of silty, clay (Context 1) overlying limestone gravel (Context 2). Nothing of archaeological significance was uncovered in Test Trench Four (Plate 4).

Plate 4 Looking south to clay (Context 1)  
in Test Trench Four.

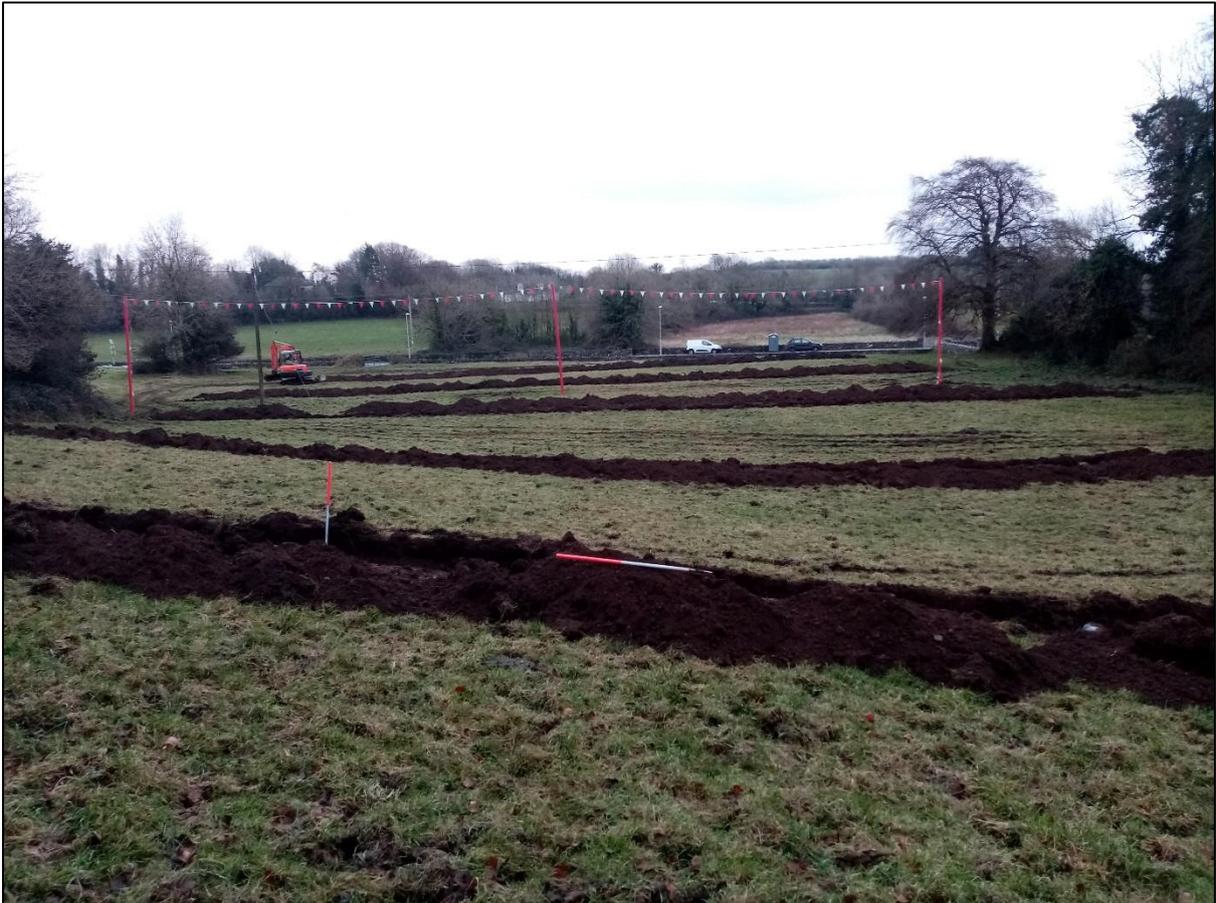
Located 15m west of Test Trench Four and parallel to it (Fig 3). Test Trench Five was 67m long. The stratigraphy was the same as in Test Trenches 1-4, with a shallow layer of silty, clay (Context 1) overlying limestone gravel (Context 2). Nothing of archaeological significance was uncovered in Test Trench Five (Plate 5).

Plate 5 Looking east from Test Trench 5 across development site to clay topsoil, in Test Trenches 1-5.
