Archaeological Report for Licence No. 18E0509 Cross West, Co. Mayo

Architects Section, Mayo County Council Áras
an Chontae, Castlebar

Sue Zajac, Archaeologist,
Mayo County Council
18-12-2018

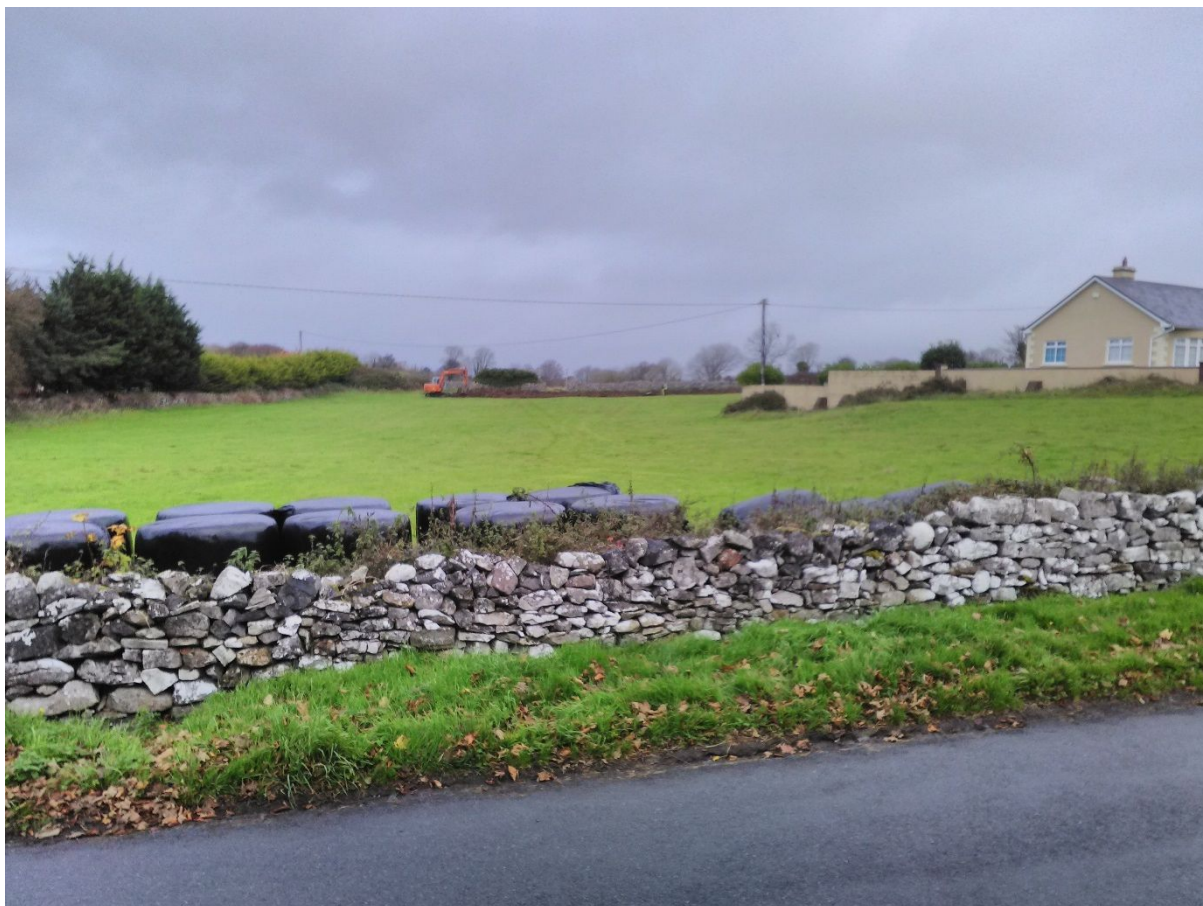
Plate 1 General view of Development Site and excavation of Test Trench Two

Nothing of archaeological significance is designated or could be seen at surface level within the proposed development area. The ground was characterised by good quality grass land which had been used to cut silage. A very large pile of grassed over, land clearance stones, was seen in the north-west corner of the site and had been fenced off from the remainder of the field. From this and the quality of the grassland, it suggested that land reclamation had already occurred within the development site. Silage bales were also seen within the field running in a line parallel to the regional road (Plate 1).

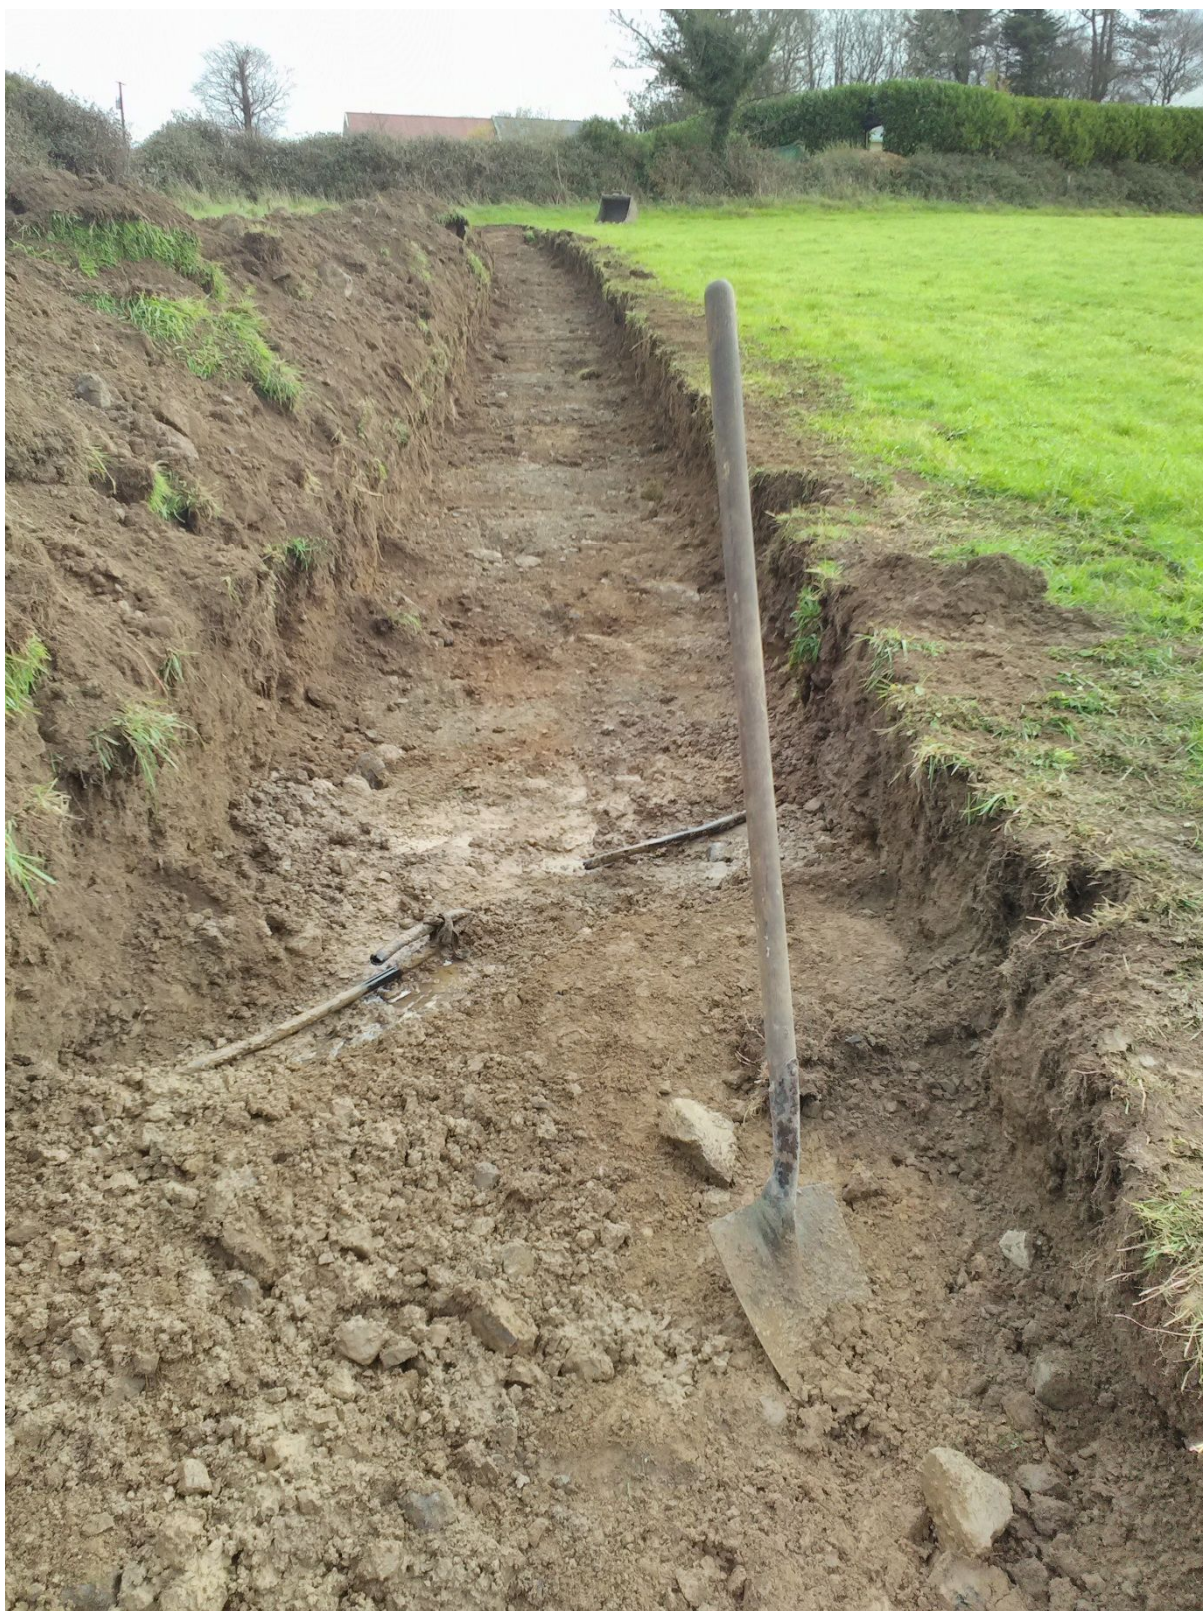
Plate 2 Excavation of Test Trench Two showing gravel (Context 3) and clay (Context 1) and marl (Context 2) above it

Three contexts were recorded during the archaeological testing and these are described in Appendix 1. In all trenches a reddish-brown clay (Context 1) overlay natural to a depth of between 0.1 and 0.3m. The clay had sparse inclusions of pebbles and roots, from the sod, going through it. It was archaeologically sterile and had almost no modern material, of any sort within it. Below the clay was a shallow layer of marl (Context 2), also reddish brown. It was difficult to distinguish between the two layers in terms of colour. The marl however was very smooth and composed of a very fine sand. The overlying clay was moderately loose. Below the marl was natural limestone gravel. On the higher ground this gravel was seen to contain sparse amounts of, large, limestone boulders or sheets of bedrock associated with the north-south

ridge. Generally, however the gravel was very coarse with frequent inclusions of pebbles and moderate inclusions of cobbles. The excavation did not go beyond this gravel layer. The testing showed that the ground had been thoroughly reclaimed prior to the archaeological testing. The ground was very sterile of any intrusive material and the soil stratigraphy was homogenous throughout all trenches. A narrow gage water pipe was seen crossing trench number eight and trench two. It seemed to be leading to the water trough and was deliberately avoided in all other trenches. Nothing of archaeological significance was uncovered.

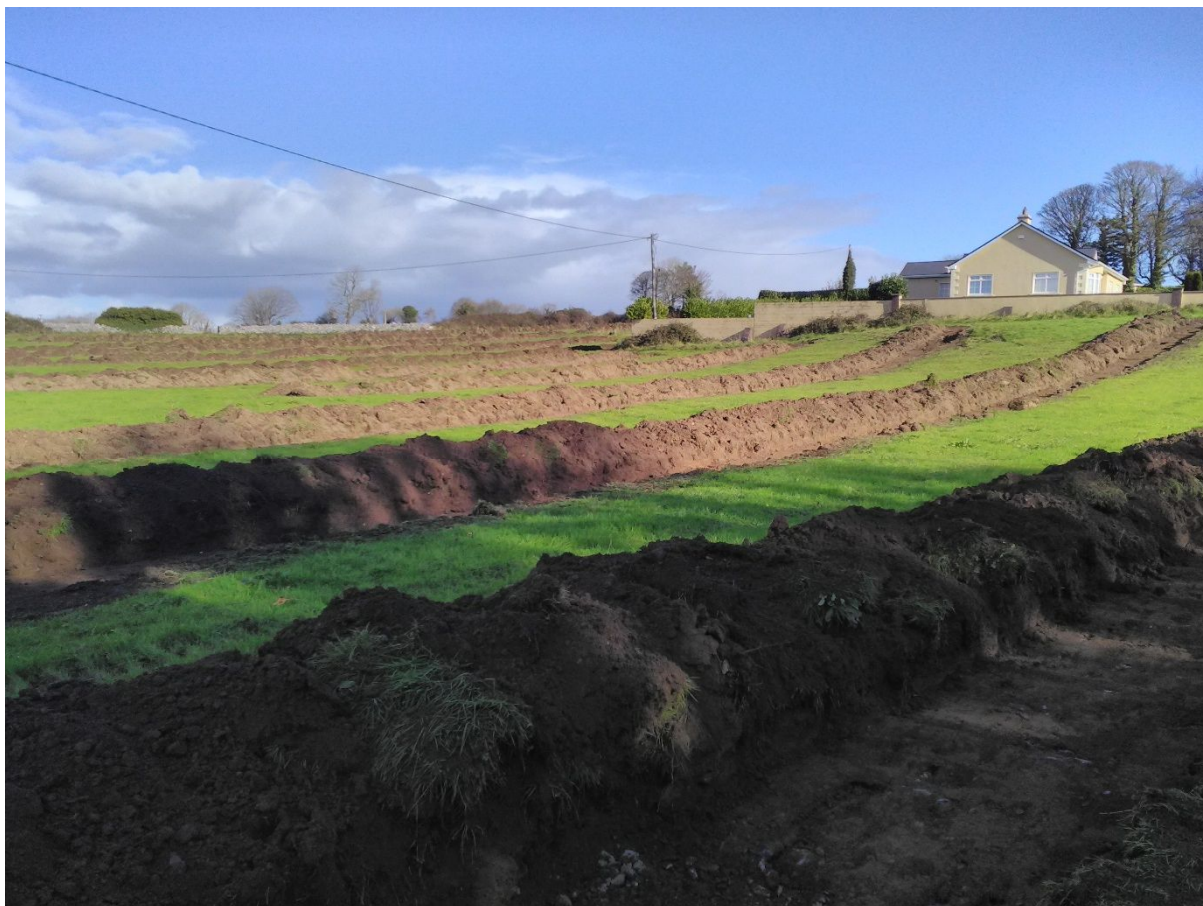
Plate 3 General view of Test trenches looking north-east.

Seven trenches were excavated in the smaller section of the field running on an east-west axis for 75m (Plate 3). The natural ridge already seen in trenches 1-6 was uncovered again for a short distance at the eastern end of trenches 7-14. In general, the clay topsoil (Context 1) became deeper in trenches 7-14 averaging 0.35m above the thin layer of natural marl (Context 2) and underlying gravel (Context 3). This was particularly apparent at the lower end of the
