Appropriate Assessment Screening Report & Natura Impact Statement to inform Appropriate Assessment

Proposed new open space development at
“Rising of the Water”, Cong, Co Mayo

For Mayo County Council

February 2021

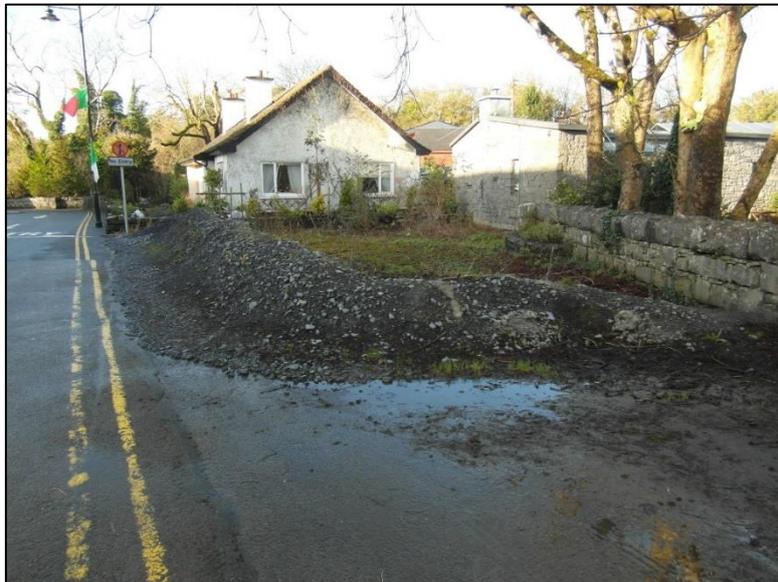
Photograph 1: Site at Cong, Co. Mayo showing location of proposed new open space

The client proposes to create a new public space area at the area known as “The Rising of the Waters” in the village of Cong, Clonbur, Co Mayo.

The proposed new open space will include new paved areas, stone benches and trees. The site is 0.033 ha in size. The ITM Coordinates are 514674E 755459N.

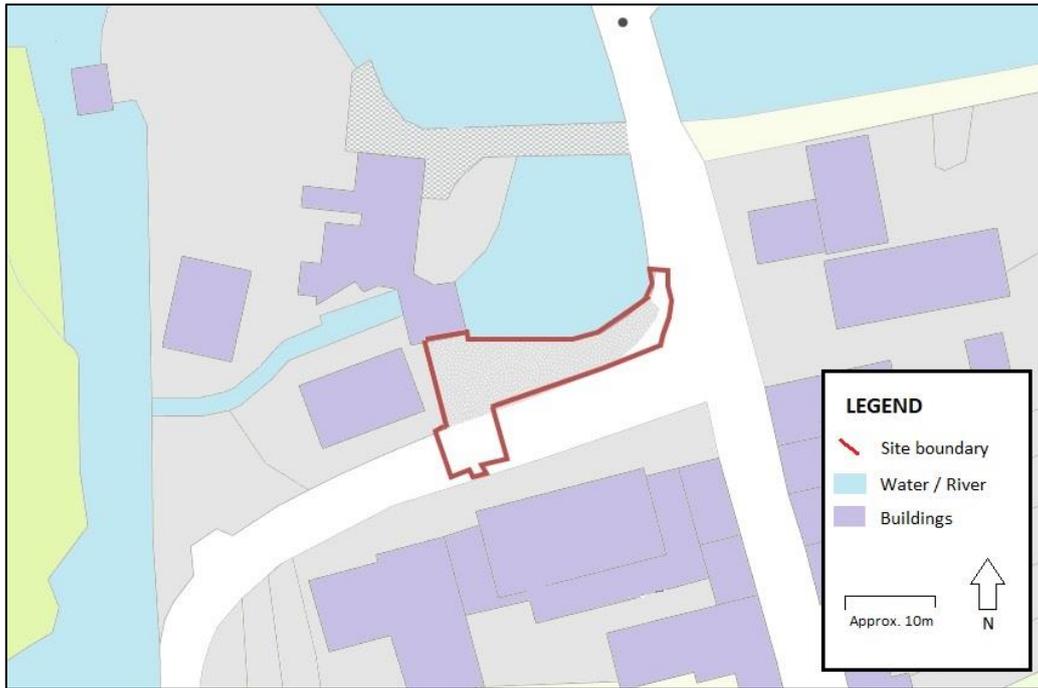
Diagram 1: Site layout at Cong, Co. Mayo showing location of proposed new open space

It is proposed to create a new open space in the village of Cong. It will include new paved areas, stone benches and trees. The site is 0.033 ha in size. The roughly triangular site is found at the junction of Circular Road (R345) and Main Street (R345). The roads form the east and southern boundaries of the site. To the west there is a neighbouring dwelling house and to the north there is a wall behind which is water, which is linked to the Cong Canal.

A pedestrian crossing area will be placed at the top south western corner of the site. This will cross the road to the shops on the other side. Additional vehicular parking (eight spaces, including one disabled parking space) is proposed for this location.

Site is flat, with no slope and is currently gravelled, hard standing or tarmac road surface..

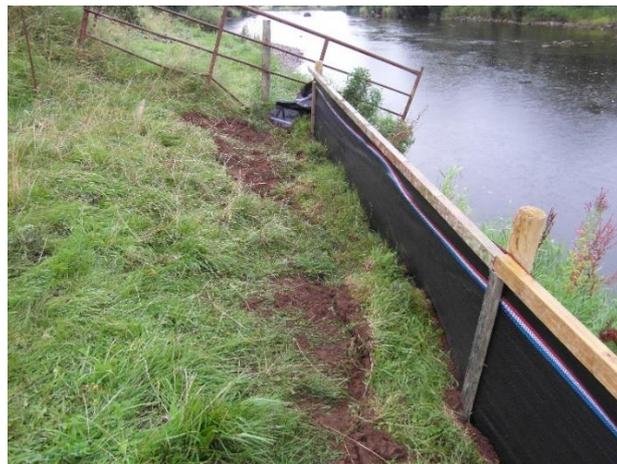
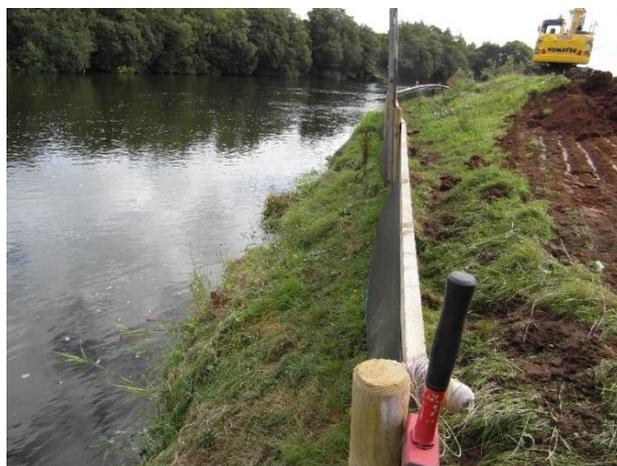
Photographs showing examples of silt fence along river bank

- Posts are placed every 3 to 5 m and a 1m high geotextile membrane is attached to this fence on the uphill side.
- Place about 600m of membrane on the post with the other 300mm loose at the bottom facing uphill.
- This membrane foot is then covered with soil / turf that is removed from the house plot area.
- The soil turfs should be bigger than the membrane foot, 400mm to 1000m wide. This is easily done with a digger bucket.
- The soil turfs hold the membrane down and any water/runoff has to go through the soil and membrane and is filtered as it goes.
- It is important not to leave any gaps in the membrane foot or to have any areas uncovered or lifted up as this will allow the runoff to go under the membrane foot and so it will not be filtered.
- When removing the fence, the turfs can be left in place the fence simply pulled out from under them.

SILT FENCING INSTALLATION GUIDELINES

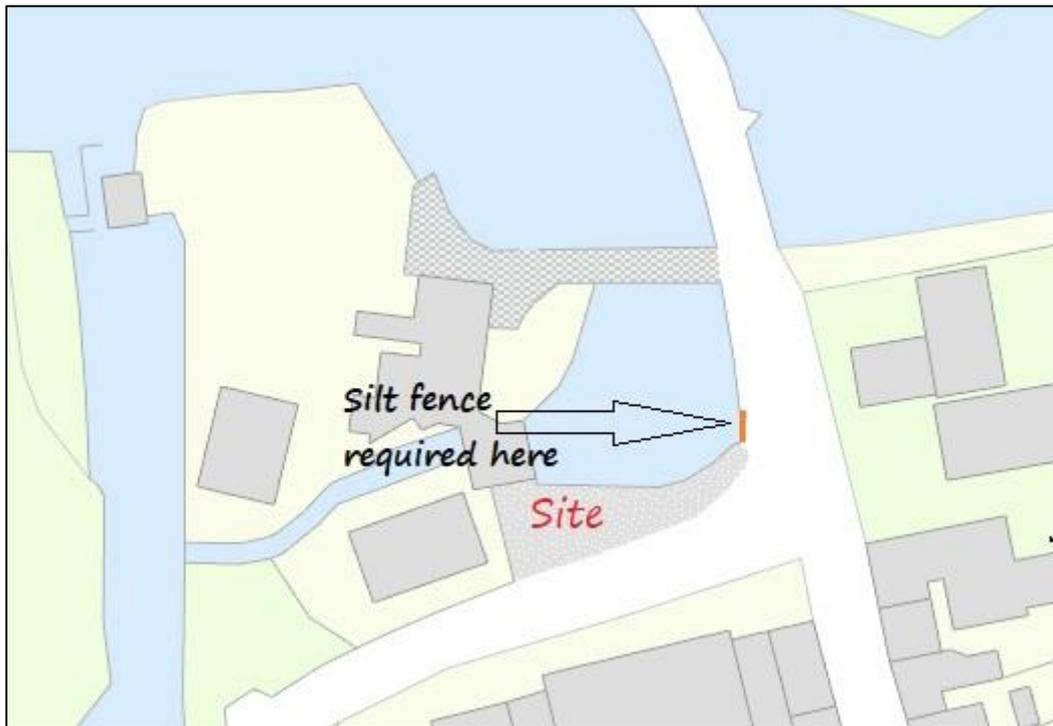
Map Showing recommended placement of silt fence

A silt fence using geotextile membrane and / or straw bales should be placed on slipway to prevent sediment running off into the water. See also photograph below.
