ARCHAEOLOGICAL
PREDEVELOPMENT TESTING
KEEL EAST ACHILL CO MAYO

MAYO COUNTY COUNCIL Áras an Chontae Castlebar

Archaeological Predevelopment Testing at Keel East, Achill, Co. Mayo.

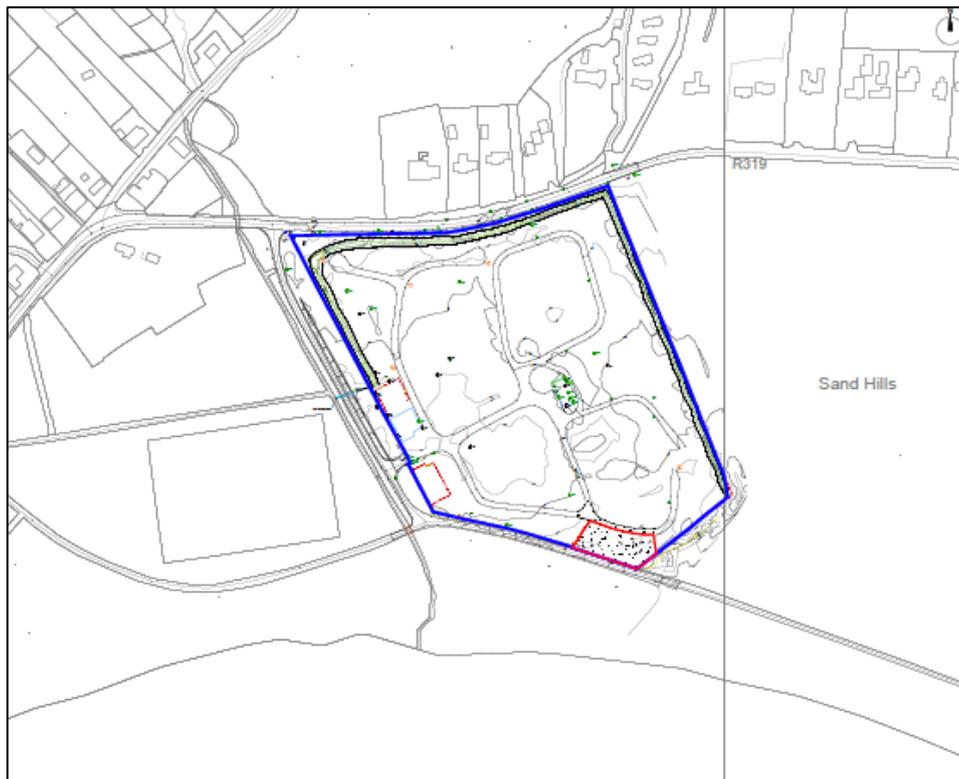
The development site is a roughly rectangular area measuring 75m east x west and 20m north x south tapering to 10m north x south at its eastern end. It is an undulating green field area used by sheep during the winter and consists of well grazed machair grassland. The proposed development comprises the refurbishment of existing buildings as well as the construction of a new a water sports facility at Keel Caravan Park (Fig 3). The development falls under the tourism investment scheme for Local Authorities only, known as *Platforms for Growth 2019-2025*, a national initiative funded by Fáilte Ireland (Fig 3).

Fig 3 Keel Caravan outlined in blue and area of new development outlined in red. Sandhills where archaeological site (MA054-14001) is designated to the right of the Caravan Park

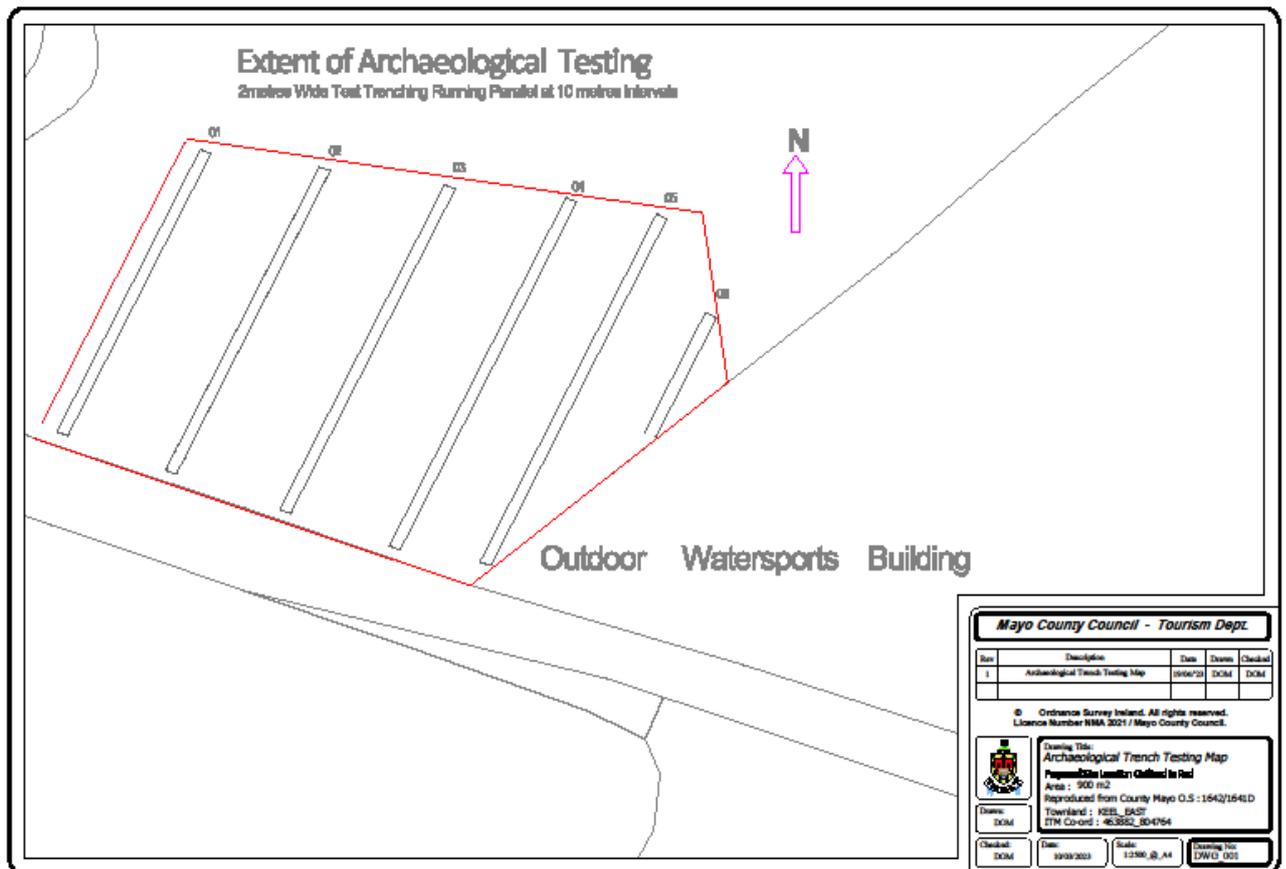
In order to ascertain the archaeological potential of the development site six Test Trenches were mechanically excavated across the area spaced at 10m intervals. The test trenches were all 18m long except for test trench 6 which was 9m long (Fig 4).

Fig 4 Location of Test Trenches in the proposed development site

All test trenches were 1.8m wide and aligned NNE-SSW. They all measured 18m long except for Trench 6 which was 9m long. Trenches were excavated within a roughly rectangular site measuring 75m x 20m. All trenches were de-sodded and then carefully backfilled once they had been recorded and prior to the excavation of the next trench. This was for safety reasons because of the site's proximity to Keel Caravan Park. (Plate 1). Trenches were generally excavated to a depth of 1.5m. In each case a pit was dug in the trench down to natural subsoil which varied in depth between 2.2m and 3m below the sod. It was not possible to dig all of the trench down to natural because of trench collapse and unstable sides from the weight of the excavated material sitting on top of the trenches. The trenches were all archaeologically sterile and there was no evidence to suggest that digging deeper in unstable ground conditions would yield archaeological material or deposits. No seashells were encountered in the sand, suggesting, the material may have accumulated as a result of being wind blown over time.

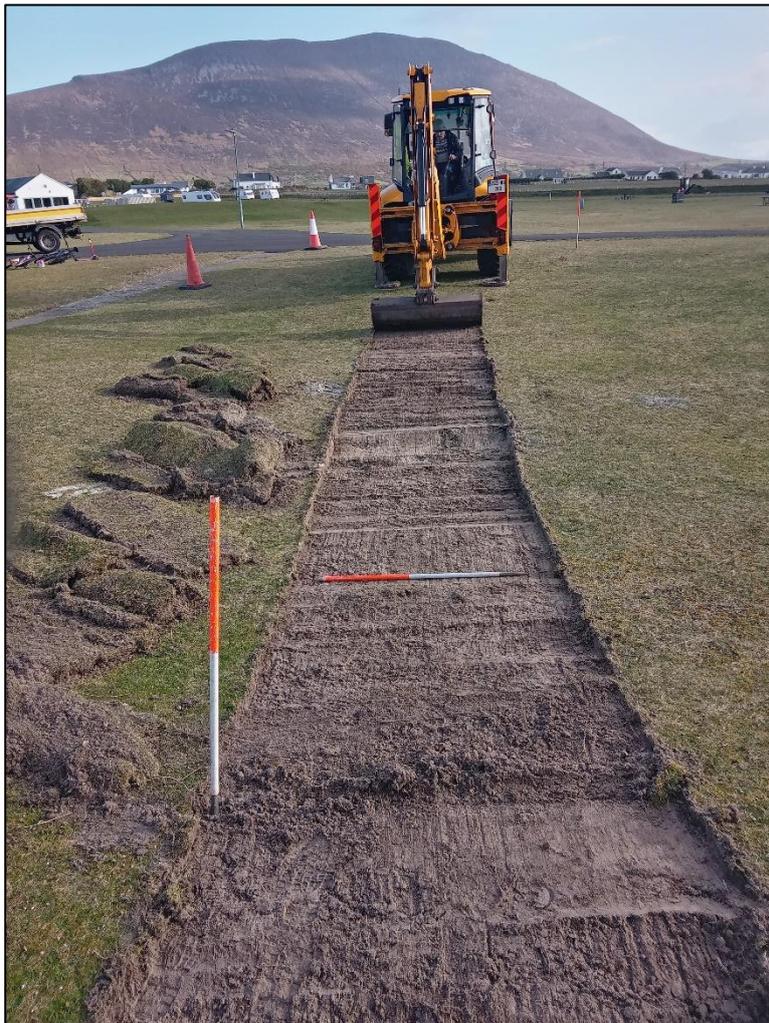
Plate 1 De-sodding Test Trench 1 looking North with Keel Caravan Park in the background

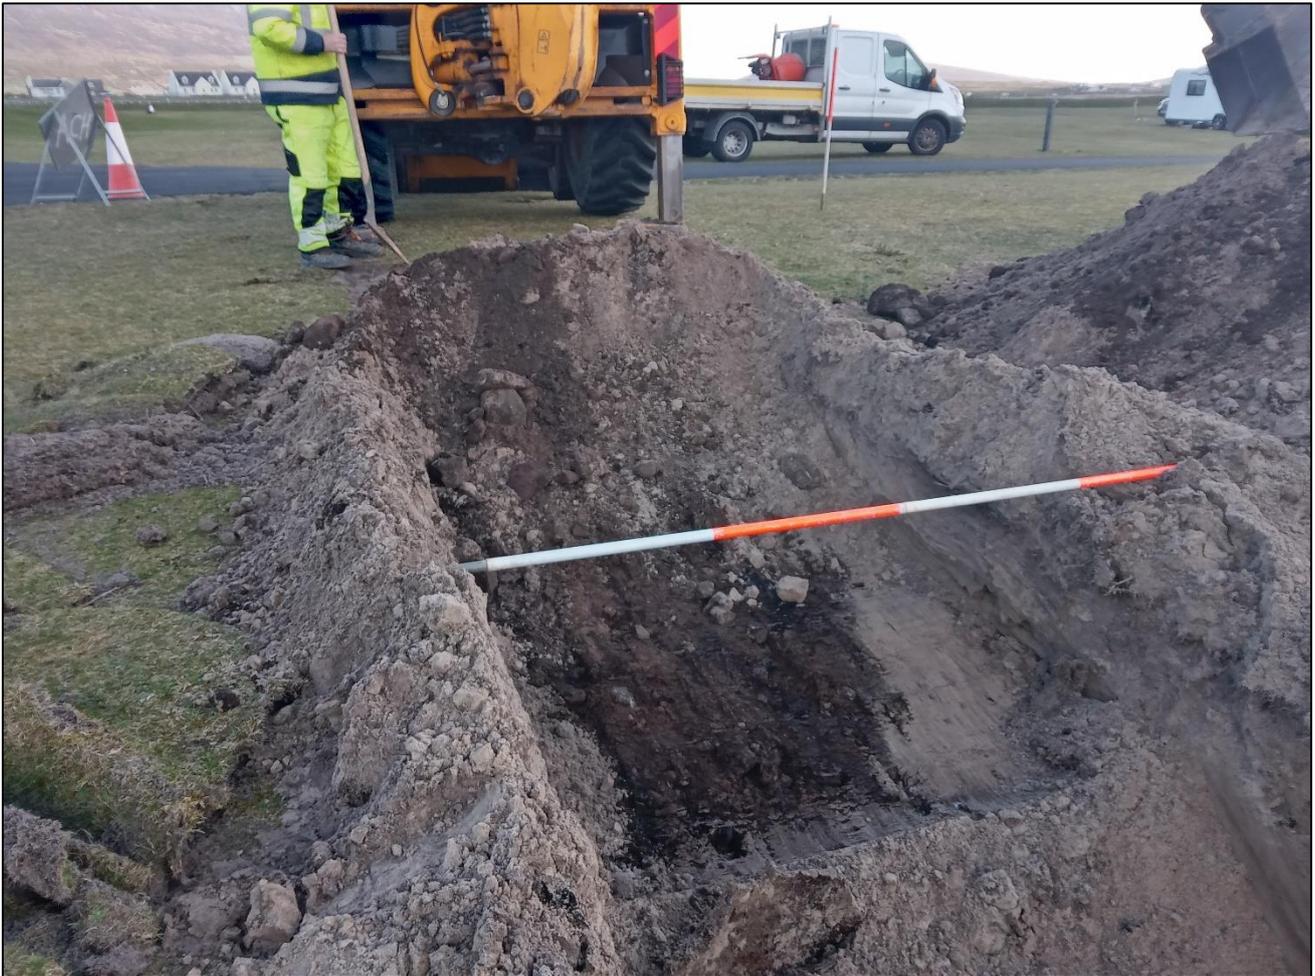
Natural subsoil (C1) comprising beach pebbles and angular rock was reached at 1.8m below sea sand (C2). Within the sea sand at the southern end of the trench and at a depth of 1m was a layer of clay 0.4m deep, with sparse inclusions of cobbles and boulders (C3). A small sherd of cream ware (Find No. 1) was found in the trench and seemed to be associated with this deposit which may be up cast from the construction of the adjacent road. At the northern end of the trench for the final 6m an undulation in the ground had been filled with modern debris, cobbles, and clay (C4). Nothing of archaeological significance was noted (Plate 2).

Plate 2 Fill turning up amongst the sand for the final 6m of Test Trench 1

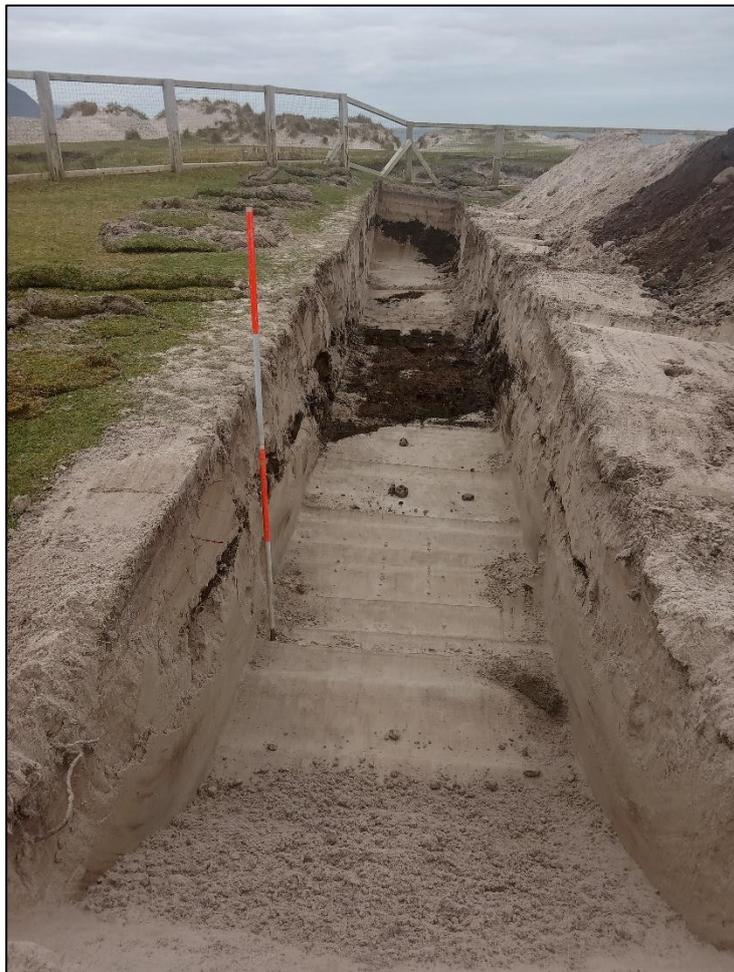
Plate 3 Looking south to peat (C3) coming up in Test Trench 4

Natural subsoil (C1) was reached at 2.4m, comprising angular stone or cobbles/beach pebble. A deposit of undulating peat was seen in each section face of Trench 4 between two layers of sand and found at varying depths within the Trench from 0.4m at the southern end of the trench to 1.1m near the centre of the trench. Nothing of archaeological significance was noted (Plate 3).

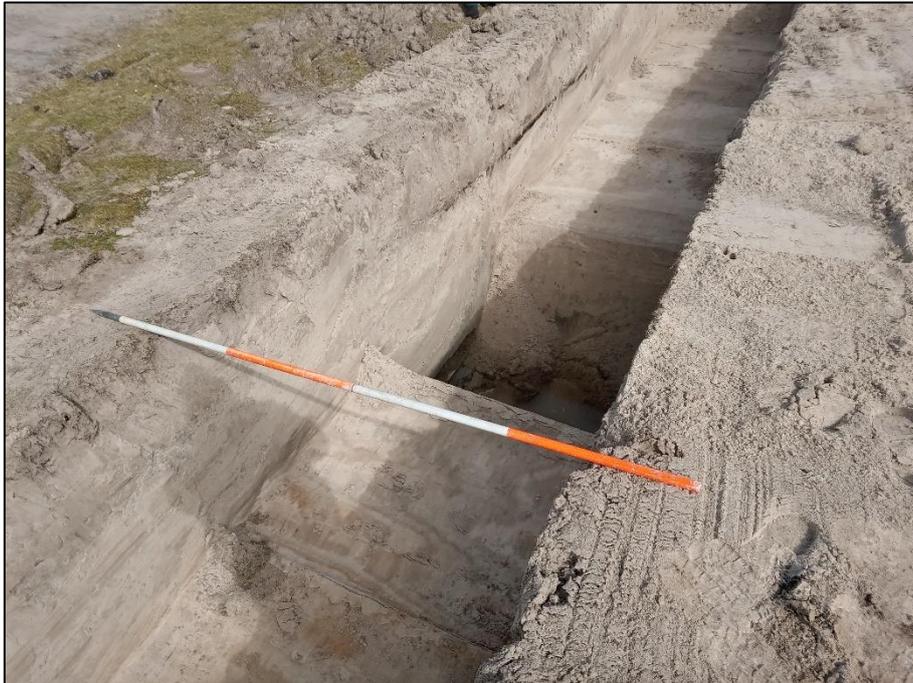
Natural subsoil (C1) was reached at 3m consisting of angular stone and the water table, a substantial deposit of sand was located above it overlain by a layer of fill (C4) consisting of peat, subsoil and cobbles that reached a maximum depth of 0.6m. A further deposit of sand was located above this. Both sand and the peaty fill were archaeologically sterile (Plate 4).

Plate 4 Water seeping into base of Test Trench 5 with water table reached at 3m
