Appendix
**10.1 Bat Surveys River Moy,
Ballina, Co. Mayo 2022**

Bat Surveys
River Moy
Ballina
Co. Mayo
2022

Mayo County Council are planning flood relief measures along the river Moy and tributaries in Ballina, Co. Mayo. This will involve strengthening of river embankments and new or altered defences where necessary. A selection of bat surveys were defined, to try to ascertain if there were any bat roosting points in any of the masonry or other built structures along the river within the town. Trees which would be affected by the flood relief works were surveyed for bat roost potential and those deemed to have potential were subject to a bat survey.

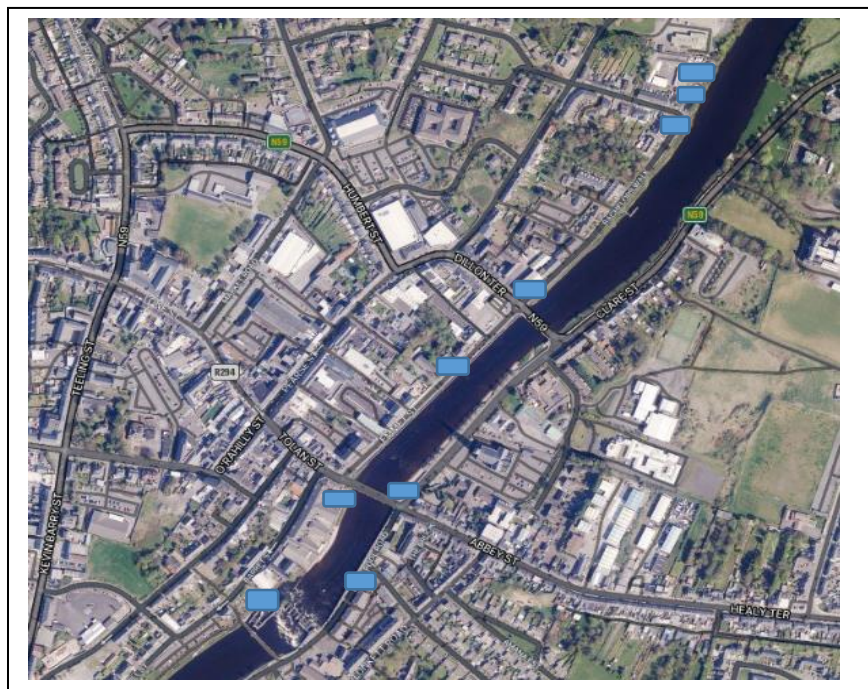
Fig 6: Song Meter 4 placements along the river Moy in Ballina town. ■

Song Meter 4 bat detectors were deployed at points in the survey areas and recorded for the duration of some of the surveys. Location of Song Meters 4 may be seen in Fig 6. Song Meter 4 data were then downloaded and analysed to identify bat species using the river area.

Song Meter 4 were deployed on 11 different occasions along the river Moy in Ballina Town during the bat surveys. See Fig 6: These recordings were downloaded and calls checked and verified to species level.

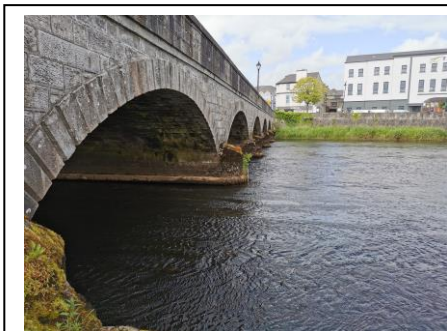
Soprano Pipistrelle first noted at 22.14, two feeding around the bridge. Leisler’s bat was foraging also. See Fig 7.

Fig 7: View from VP 9 beside the Upper Bridge just off Cathedral Road, Ballina.

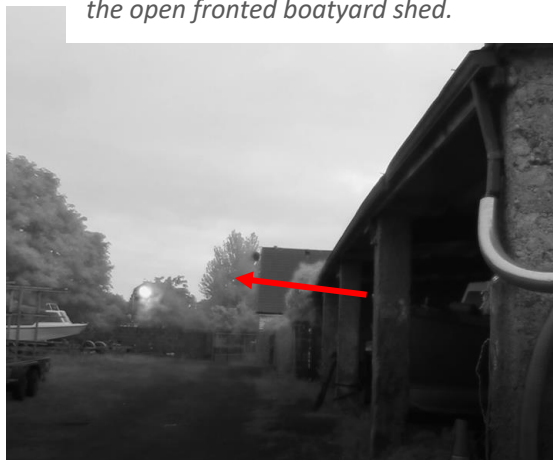
VP 17 Boatyard shed - dusk
A Soprano pipistrelle was observed emerging from within the boatyard shed (20.17pm), third bay from entrance gate. See Fig 8. It foraged consistently in the yard throughout the survey. Daubentons bat was also observed coming up the boat slip and returning to the river. Two Daubentons bats foraged along this stretch of river during the survey. Leisler's bat was also recorded foraging in the area.

Fig 8: Location of emerging Soprano Pipistrelle from the open fronted boatyard shed.

The results of all the bat surveys along the river Moy in Ballina, Co. Mayo would indicate that there are no bat roost points along the surveyed infrastructure of the river within the town. Only one bat roost was found in the boatyard shed – a structure that is not likely to be affected by any flood relief works.

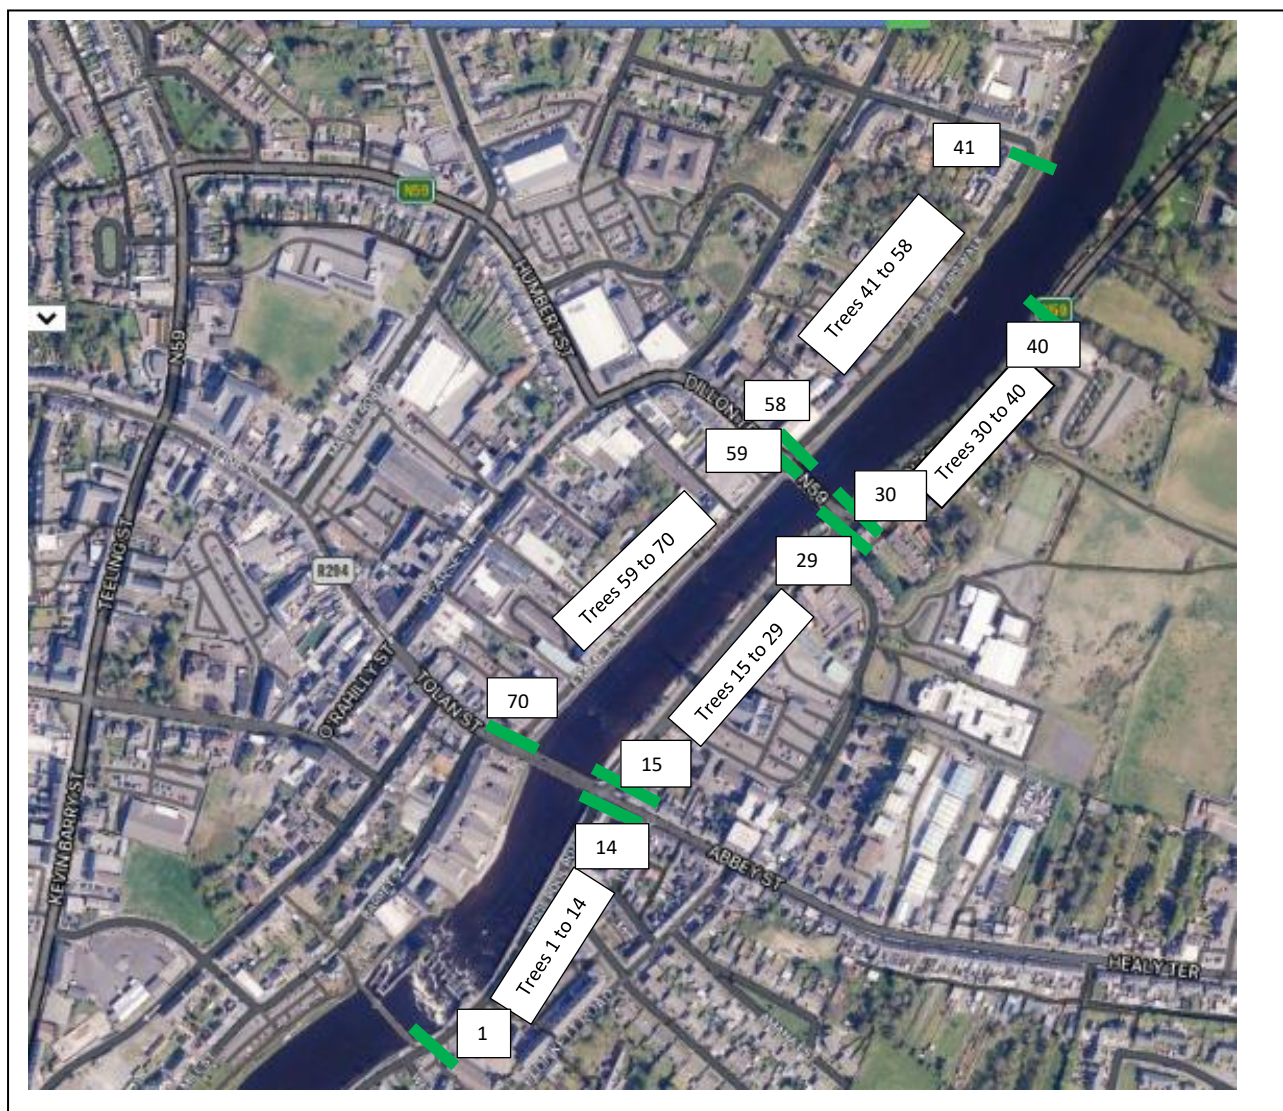
Trees along the section of river as shown in Fig 9 were surveyed for potential bat roost features (PFR). Each tree was assessed from ground level – the majority being young isolated trees along the foot paths. Each tree species was documented along with its level of potential as a bat roost. Trees that had a moderate or higher level of potential were later surveyed. A summary of trees inspected can be seen in Table 2.

Fig 9: Trees surveyed for potential roost spots along the banks of the River Moy in Ballina. See also table 2

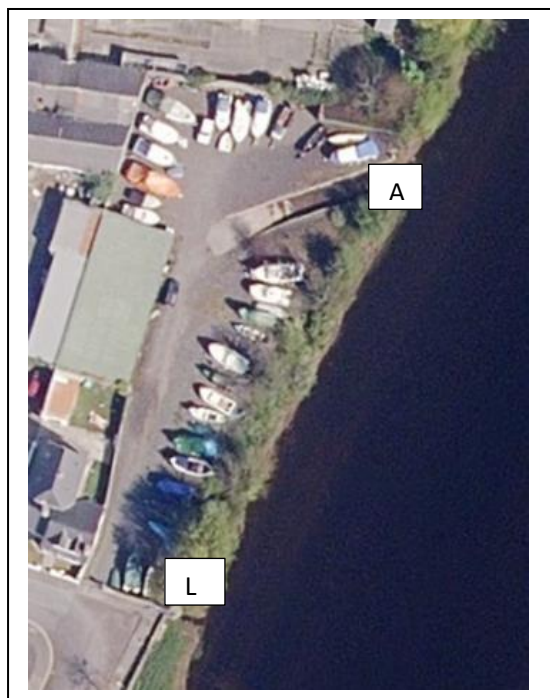
There is a tree/shrub line along the private boatyard at the end of Bachelors walk in Ballina town. Fig 10. Each of these trees were assessed for PFR's and their species and bat roost potential is listed in Table 3. Note: only one area in this tree line was deemed to have bat roost potential. There is a cluster of multi stem sycamore which had ivy growing on them. This was surveyed on the 13/09/2022 at dusk, but did not have any bat activity particularly associated with it. No bat emerged from these trees.

Fig 10: Boatyard, Bachelors walk, Ballina town

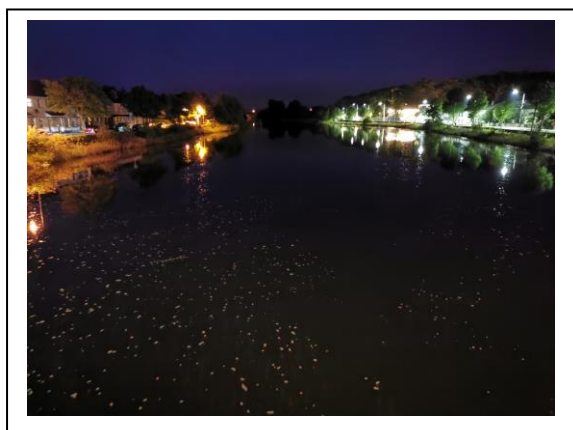
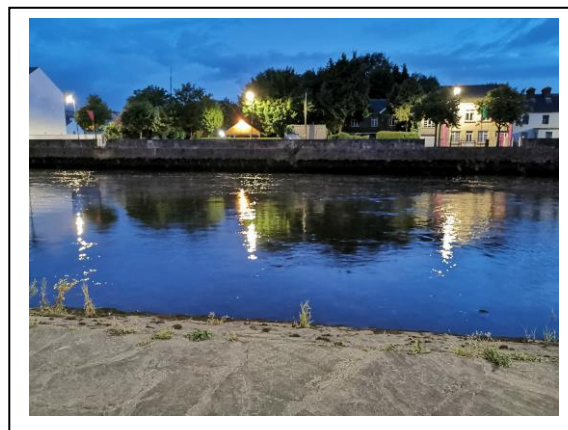
No bats were observed entering the bridge to roost. Only Soprano Pipistrelles were foraging on the northwest side of this bridge at dawn. Note: the reflections of street lights on the water – a constraint in terms of visibility during surveys. See Fig 11.

The street lighting along the river were a constraint at times with light reflecting on the river. This impeded the vision of the surveyor of commuting and foraging bats and is likely to cause reduction in foraging potential of some bat species See Fig 11. Future lighting schemes should reduce this light spill.

Fig 11: Street lighting impacting the darkness of the river Moy. These lit up areas reduced the foraging potential of the Daubenton's bats and made their movements hard to follow during the surveys. Future lighting schemes should endeavour to eliminate the light spill onto the river.
