9.6 Ridge Pool Survey

Ballina Flood Relief Scheme

Appendix 9.6: Ridgepool Instream Survey

Construction Phase Temporary Works Areas

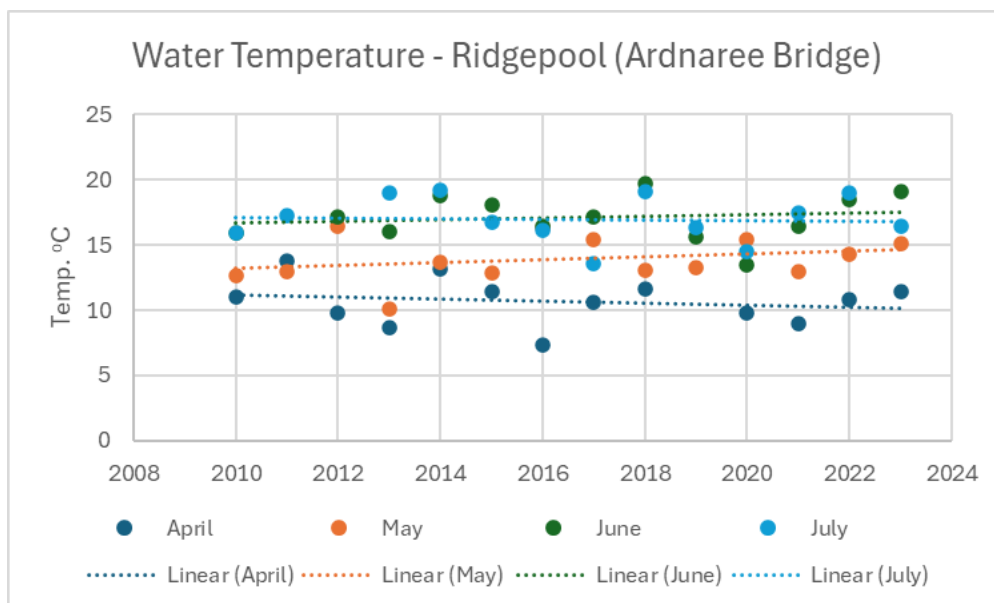
Figure 1-1 Water Temperature by month (spring/summer) – Ridgepool, River Moy (EPA data)

Sea lamprey eggs have very exacting temperature requirements for successful hatching, being 15–25°C (Maitland, 2003). In this regard, EPA monitoring data shows that water temperature in the Ridgepool does not exceed 15°C in April, and very occasionally reaches this threshold in May (**Figure 1-1**). This means sea lamprey spawning would typically not commence before early-May.

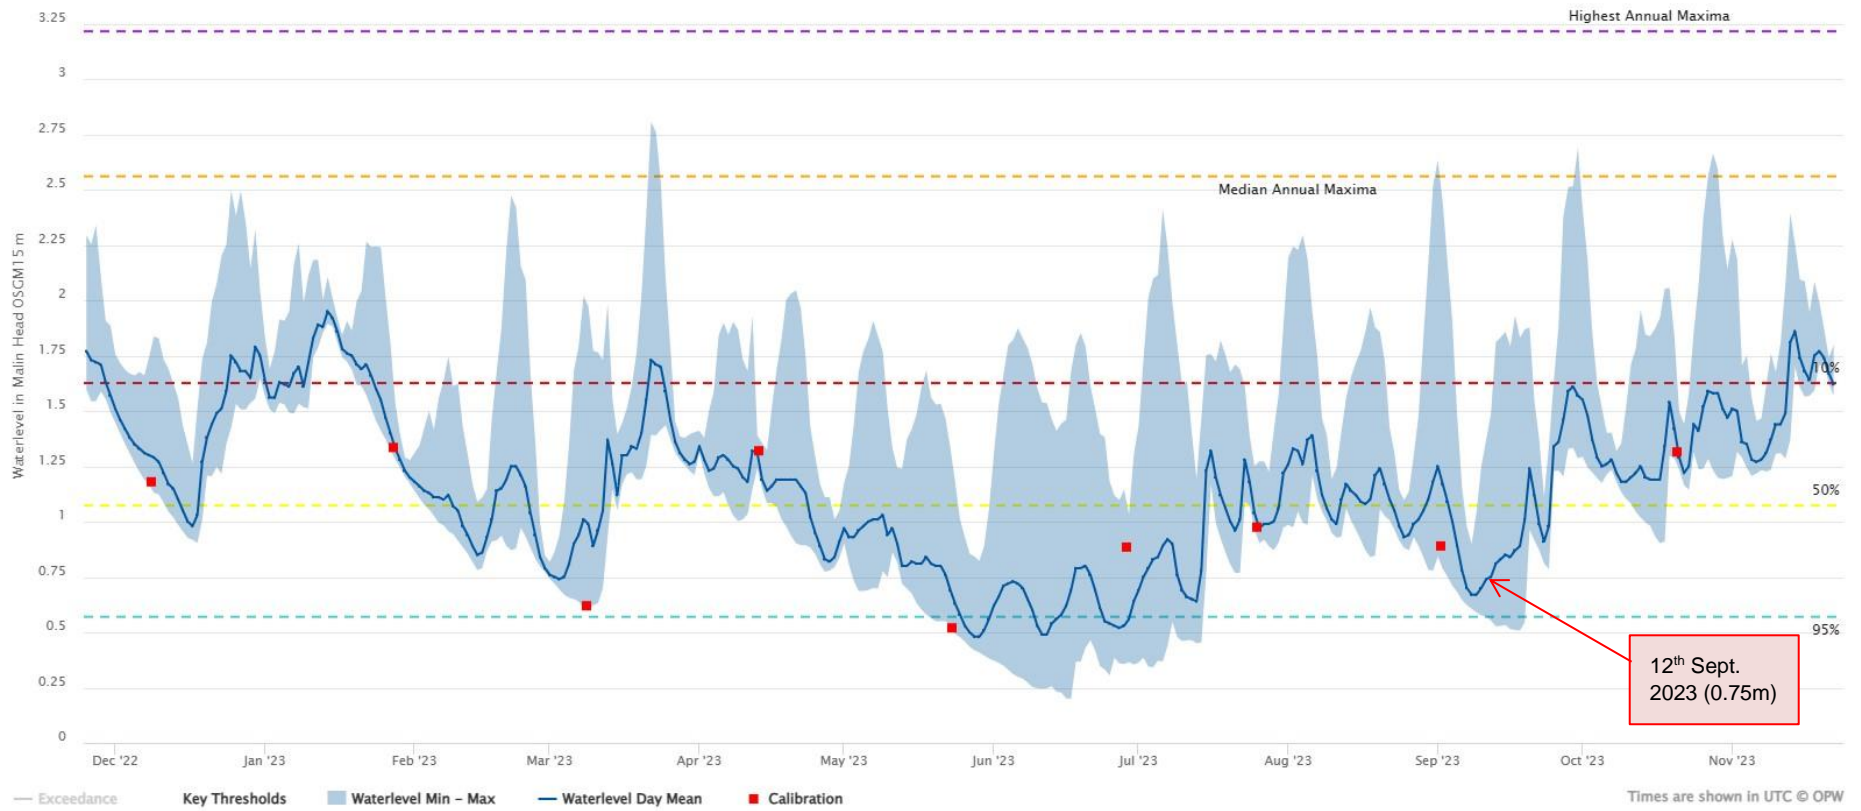
Figure 3-2 Water Level OPW Station: Ballina (34061) (Dec 2022 – Nov 2023)

Figure 3-1 and **Figure 3-1** show water levels at OPW Hydrometric Station 34061: Ballina, located opposite Arbuckle Row on the tidal River Moy (downstream N59 Lower Bridge). Daily mean water level during field survey on 12th September 2023 was 0.75m (**Figure 3-2**), which equates to approximately 82 percentile daily mean water level for the tidal Moy, with low tide level of 0.552 representing 95 percentile (OPW data derived for the period 2007 to 2023). Field survey of 22nd July 2021 occurred during a daily mean water level of 0.65m equating to 95 percentile (**Figure 3-3**), with low tide level of 0.304 which was below 99 percentile of water levels on the tidal Moy.

Lower water levels tend to occur from May to July, coinciding with sea lamprey spawning season, the relevance being that sea lamprey require water of sufficient depth and velocity in which to spawn and marginal habitats need to remain submerged for juvenile survival. Areas of the Ridgepool that are prone to dewatering during low flow and low tide are entirely unsuitable for Sea lamprey recruitment.

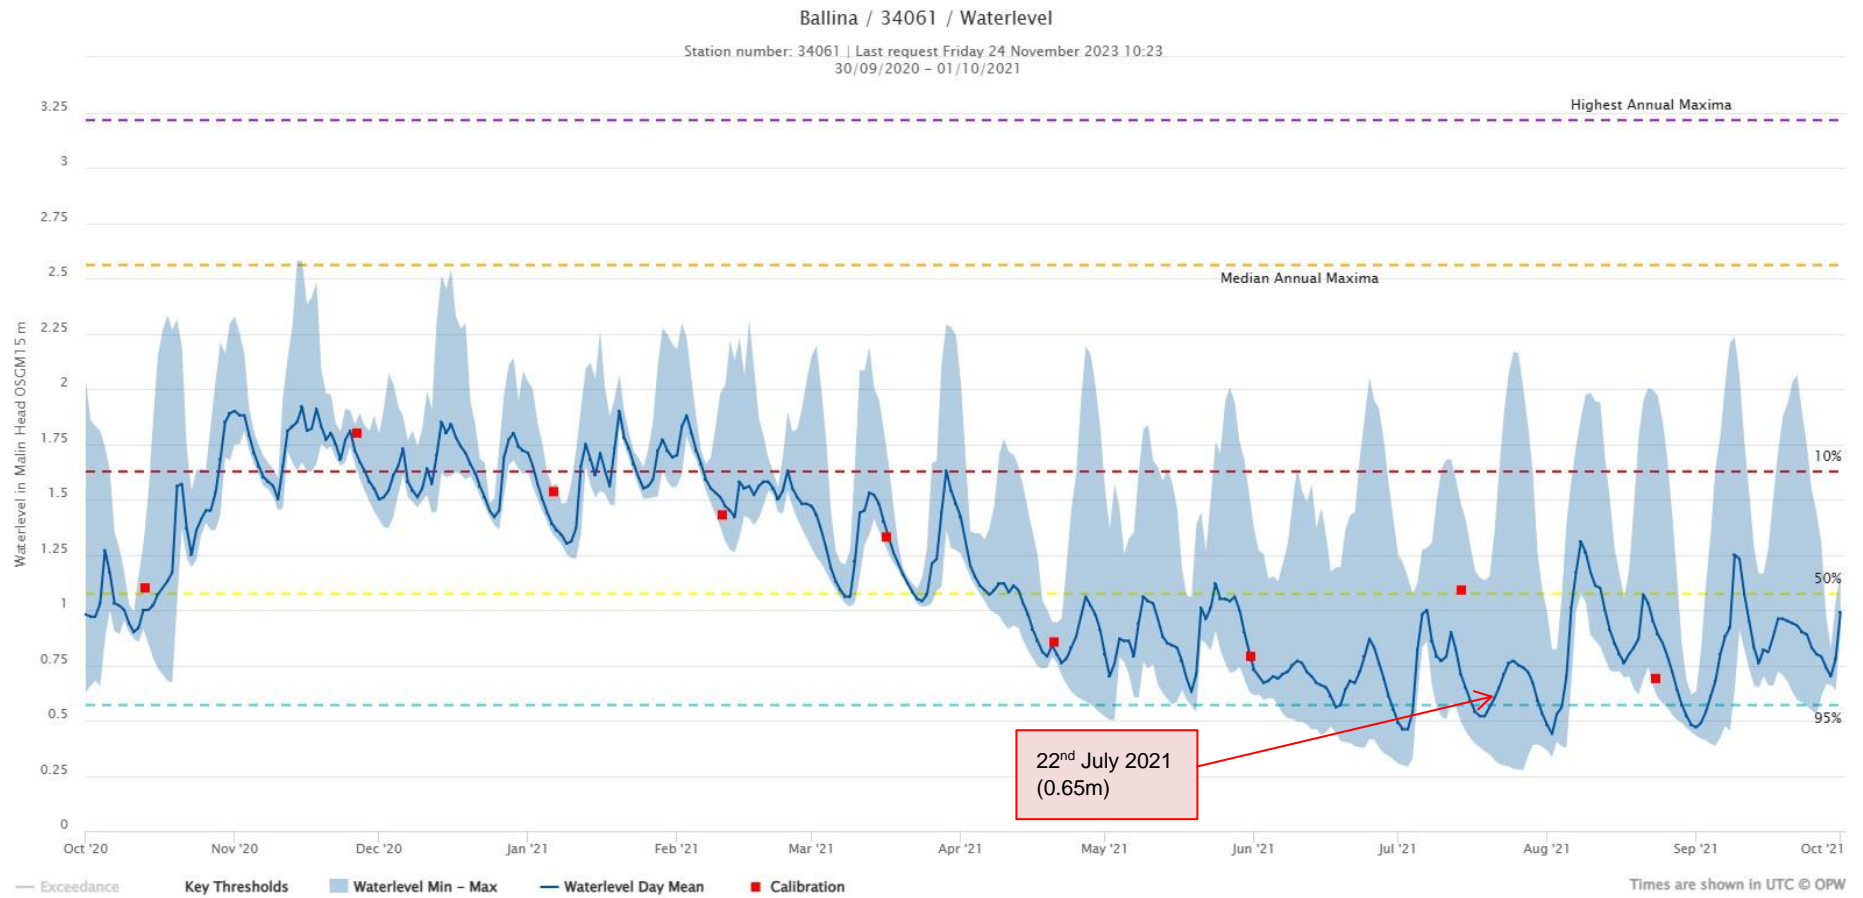
Figure 3-3 Water Level OPW Station: Ballina (34061) (Oct 2020 – Oct 2021)

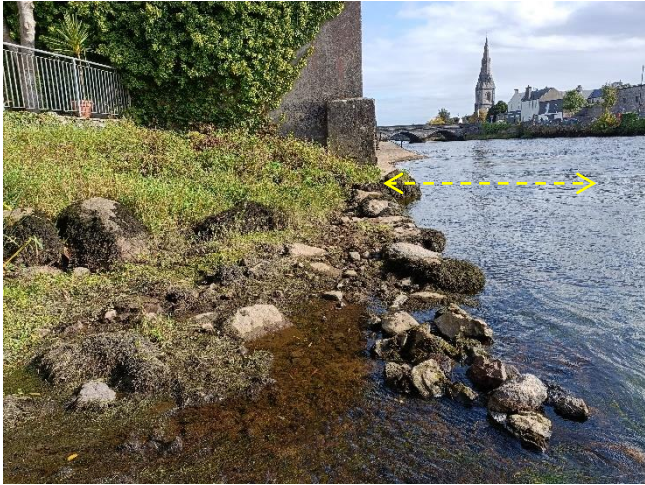
<p data-bbox="304 1581 860 1610">Image 3.3.2 View downstream from RP1 at low tide</p>	<p data-bbox="979 1088 1415 1778">Rock ‘groyne’ (historical modification) extends directly upstream from corner of old warehouse (next to IFI Building). The temporary access route would extend at most 7.5m into the channel at the corner of the warehouse then curve inwards towards the shallow, raised ‘groyne’ area (see Image 3.3.1 above). The bank margin below the proposed new flood wall (steel fence in Image 3.3.2) is ‘dry’ at this point dominated by <i>Phalaris arundinacea</i> and <i>Mentha aquatica</i> with small amounts of <i>Sparganium erectum</i> in more submerged bankside patches. No existing or potential lamprey nursery or spawning habitat in this reach either bankside of the groyne nor instream adjacent to the groyne owing to embedded cobble substrate (90%) (see RP2 instream habitat detail). The shallow groyne area is dewatered during low flow / low tide.</p>

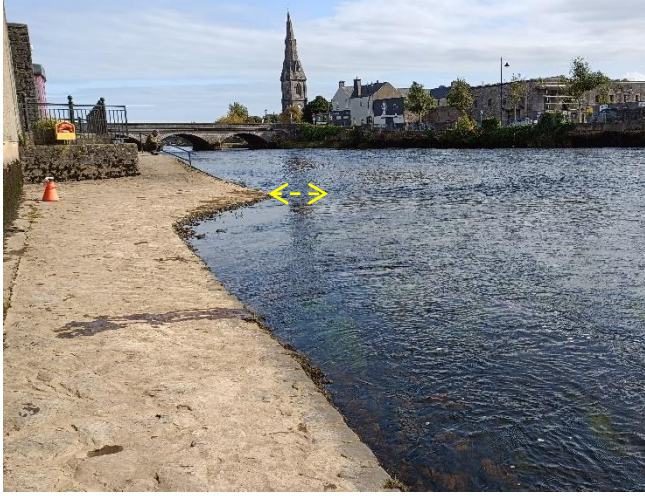
Site	Image	Habitat Description
RP2

<p data-bbox="304 748 858 779">Image 3.3.3 View downstream from RP2 at low tide</p>	<p data-bbox="979 241 1414 904">Concrete / stone apron at the channel margin extends 2-3m out into the channel from base of the warehouse, increasing to 6m downstream (at orange cone in image). Proposed access ramp utilises this apron, extending c.1.5m into the channel (yellow arrow). Instream habitat along the apron at RP2 was 30-50cm glide (low tide) but gradually shallows with downstream distance, largely dewatering under low flow / low tide. Embedded cobble dominates at RP2 with common bryophytes (as for RP1), <i>Cladophora</i> common, plus occasional <i>Ranunculus</i> and <i>Potamogeton</i> spp. and interstitial fine silt. No lamprey spawning or nursery habitat within 6m out into the channel from the edge of the apron at RP2. Salmon holding habitat in the deeper glide out from the u/s corner of the warehouse.</p>

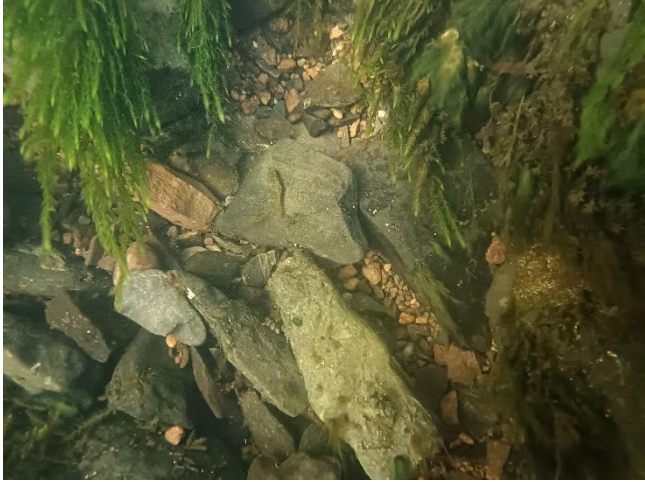
RP2A

<p data-bbox="304 1415 874 1447">Image 3.3.4 Underwater detail of substrates at RP2A</p>	<p data-bbox="979 922 1414 1460">At a location 9-10m out into the channel perpendicularly in line with the upstream corner of the warehouse, substrates of pebble and gravel with some coarse interstitial sand are present, which, in the low flow wetted channel may be suitable for sea lamprey spawning, although gravels were scarce. This area was also not ideal because water backs up during high tide, increasing depth and reducing velocity. It was not an area that sea lamprey nest building has been observed by IFI staff. The area is being highlighted as a precaution owing to potential substrate suitability. The instream access ramp does not extend this far out into the channel.</p>
RP3	  <p data-bbox="304 1953 730 1984">Image 3.3.5 Detail of substrates at RP3</p>	<p data-bbox="979 1478 1414 1908">Very shallow at low tide in margin bordering existing concrete apron from the downstream corner of the warehouse extending all the way along in front of the IFI Building. Substrates comprise gravel and pebble with >50% <i>Cladophora</i> cover and interstitial fine silt. The area forms a trickling riffle/run then largely dewateres at low tide / low flow. It forms a slack backwater at high tide. There is absolutely no sea lamprey spawning or nursery habitat within the footprint of the proposed access ramp along this reach.</p>

It is recommended that works in the vicinity of these sensitive areas should be managed to avoid any possibility of *indirect* effects. The **EIAR Chapter 9, Aquatic Ecology - Mitigation: Section 9.5.1.3** details the precautions that shall be taken in relation to Sites **RP2A** and **RP8-RP8A**.

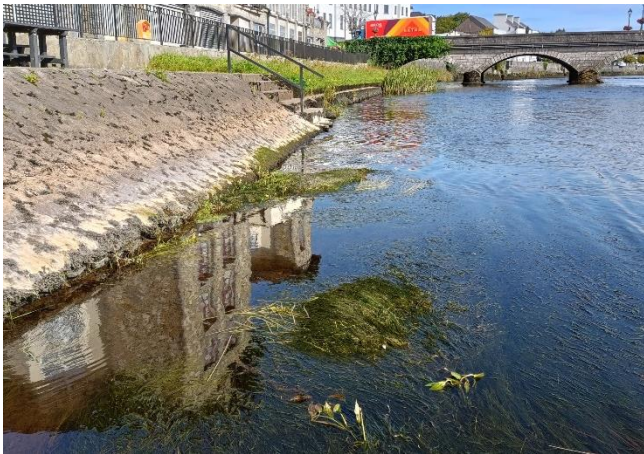
Site	Image	Habitat Description
RP4

<p data-bbox="304 701 699 730">Image 3.3.6 Marginal habitat at RP4</p>	<p data-bbox="979 241 1414 779">Very shallow river margin in front of and downstream of IFI Building (just upstream from angling access steps which will be left in-situ with no instream footprint further downstream of that point). This marginal area is comprised of silty gravel and pebble with silt covered <i>Ranunculus</i> spp., <i>Myriophyllum spicatum</i>, <i>Sparganium emersum</i> and <i>Alisma plantago-aquatica</i> and a high degree of wispy <i>Cladophora</i>. The margin almost fully dewater at low flow / low tide, then forms slack backwaters under high tide where rooted macrophytes dominate. There is absolutely no sea lamprey spawning or nursery habitat within the proposed temporary works footprint at this point.</p>
RP5

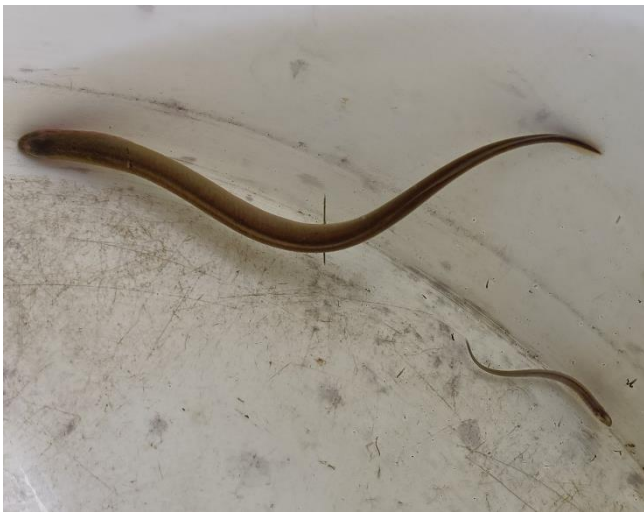
<p data-bbox="304 1895 879 1924">Image 3.3.7 Lamprey ammocoetes at RP5 (12/09/23)</p>	<p data-bbox="979 1373 1414 1921">Two lamprey ammocoetes of different age classes (15cm, 4cm) were captured within 5min in pond sweeps of marginal silt accumulating around the above stand of <i>S. erectum</i>, 40m upstream from the Upper Bridge. Size class included young of the year, indicating spawning success in 2023. This was a very discrete area of nursery habitat. Manual searches for 30min outside of this stand of marginal vegetation revealed no juvenile lamprey. Species was not differentiated – but likely to be sea lamprey based on past juvenile lamprey surveys (O'Connor, 2004). The temporary instream works footprint does not directly affect this lamprey nursery area.</p>

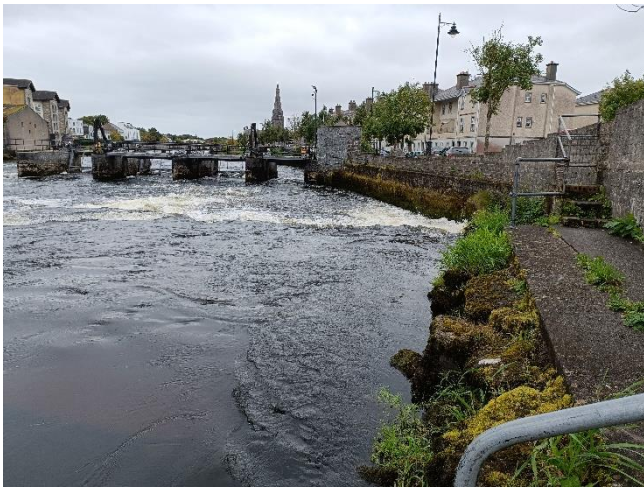
<p>Image 3.3.8 View downstream from RP6 (12/09/23)</p>	<p>Between the footbridge upstream of Salmon Weir (RP6) and the head of the Ridgepool the river is highly modified and constrained by existing walls. Fast rapids over bedrock and large boulder form the habitat type with very little instream vegetation owing to high water velocity. Pockets of coarse sand accumulate behind larger boulders, but with no clast sizes between boulder and sand. Habitat is completely unsuitable for lamprey spawning and nursery along this reach between RP6 and RP7. This margin of the river is also far less likely to be used by migrating lampreys as water velocity is concentrated and high. Salmon may be attracted to the strong flow but would pass the obstacle in lower velocity areas than the rapids at the river wall.</p>
<p>RP7</p>

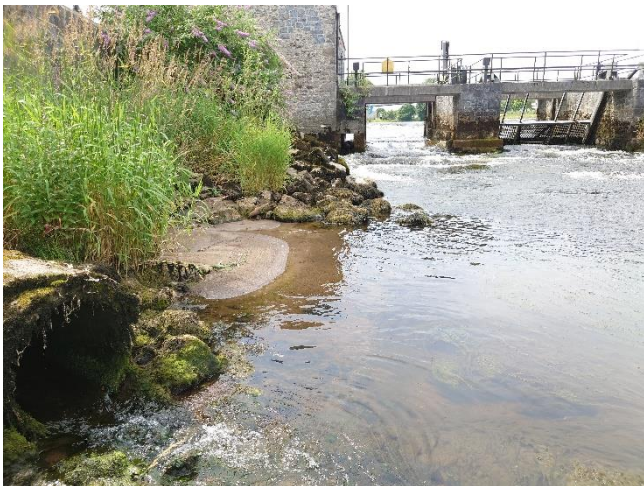
<p>Image 3.3.9 View upstream at RP7 (22/07/21)</p>	<p>At the head of Ridgepool (RP7) on the RHS, strong flows over bedrock and boulder merge to a bouldery marginal reach with coarse sandy deposits. Boulders are covered in <i>Cinclidotis</i> mosses. A relatively 'dry' marginal berm has formed downstream of the weir control building, supporting a stand of relatively species poor fringing reeds, mainly <i>P. arundinacea</i> and tall herb (including Meadowsweet, Loosestrife). There is a stormwater pipe discharge at this point. No lamprey spawning or nursery habitat or potential at all within 5m (and more) of the Quay wall along this reach.</p>

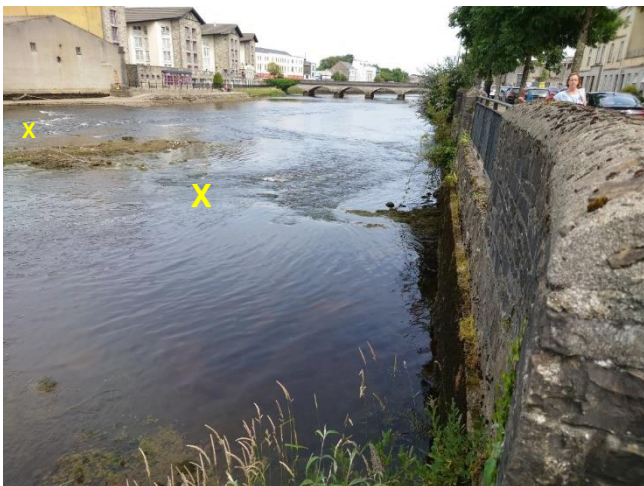
<p>Image 3.3.10 Overview of RHS margin from RP7 (22/07/21)</p>	<p>This image taken at 99 percentile low tide / low flow shows the Ridgepool Road side of the river, highlighting the areas of the channel that IFI staff report observations of potential sea lamprey nest building (yellow 'X'). These are the only areas that retain even remotely suitable flow and depth (at the top of riffles which is common for sea lamprey redd sites) that could potentially support sea lamprey spawning during the generally low flow months of May-July when sea lamprey spawning occurs. The marginal areas are generally unsuitable as they largely dewater or have slack flow of embedded cobble and or bedrock with silt and filamentous green algae.</p>

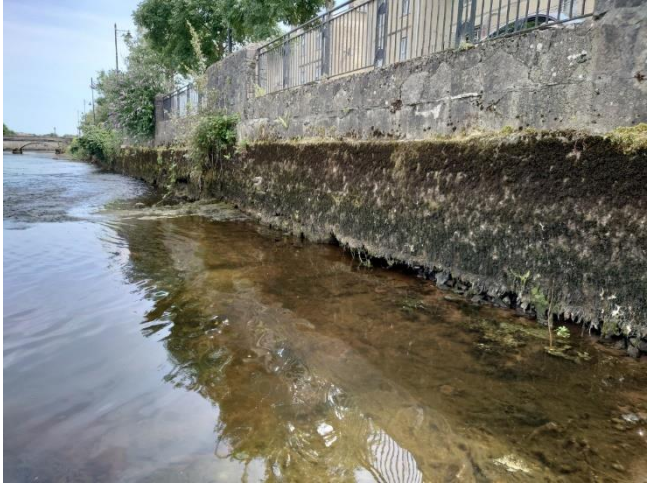
<p data-bbox="304 741 874 775">Image 3.3.11 View downstream from RP8 (22/07/21)</p>	<p data-bbox="978 248 1417 674">Slack and very shallow flow along the marginal reach upstream of the first riffle area (i.e., RHS riffle marked 'X' in Image 3.3.10 above). Substrates were angular cobble, either embedded with interstitial fine silt and silt trapped on mats of Cladophora covered moss. Large areas of underlying bedrock also occur. The foot of the Quay wall is undermined in sections along this reach, becoming more eroded and collapsing further downstream towards RP8A and RP9 (see Image 3.3.13 below).</p>
RP8

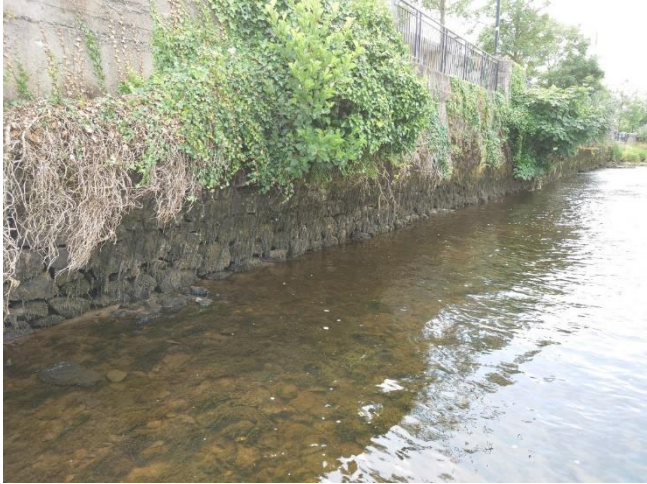
<p data-bbox="304 1294 898 1328">Image 3.3.12 View upstream at RP8 / RP8A (22/07/21)</p>	<p data-bbox="978 801 1417 1227">This image shows the base of the Quay walls along the RP8 reach viewed back upstream in the direction of RP7. Ivy and bramble coat the upper walls in places with occasional Buddleia, Alder and Sycamore bushes. The lower blocks of the Quay wall are eroded and slumping in places. Instream habitat in the 5m from the wall is as described above for RP8 (Image 3.3.11). No sea lamprey spawning or nursery habitat occurs within 5m from Quay wall at this point owing to dewatering and/or shallow slack flows at low tide.</p>

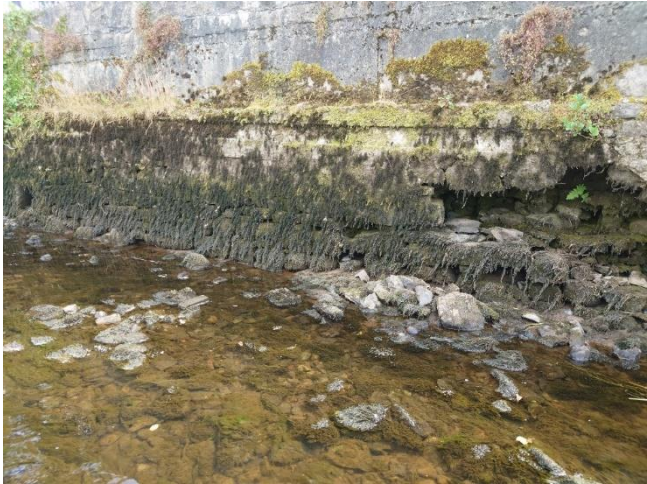
RP8A to RP9

<p data-bbox="304 1848 951 1881">Image 3.3.13 Quay wall between RP8A and RP9 (22/07/21)</p>	<p data-bbox="978 1355 1417 1534">Marginal instream habitat alongside eroded and collapsing section of the Quay wall at RP8A. Partially dewatered at low flow and low tide. See detailed description of instream habitat accompanying Image 3.3.14, below.</p> <p data-bbox="978 1545 1417 1939">This area is subject to erosive forces arising from rapid flows in high water where the riffle marked in Image 3.3.10 hits the Quay wall. No sea lamprey spawning or nursery habitat occurs within 5m from Quay wall, but because of the riffle habitat, the channel beyond 5m from the Quay wall is considered to have some potential sensitivity for sea lamprey spawning from May to mid-August of any year. The works footprint shall be narrowed as close as possible to the Quay wall at this point.</p>

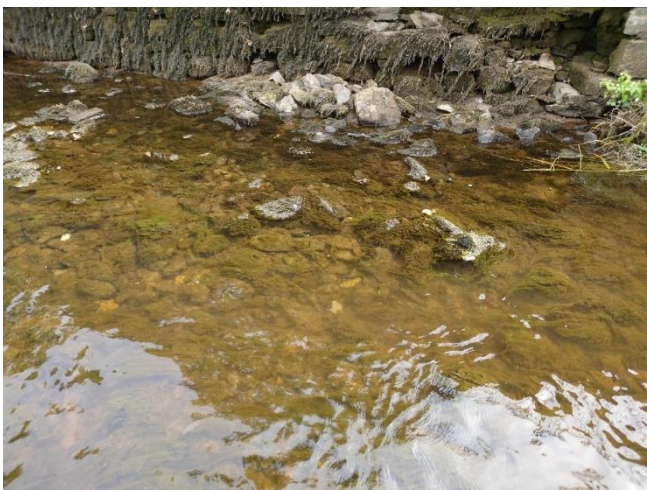
<p data-bbox="304 741 954 786">Image 3.3.14 Instream habitat detail RP8A / RP9 (22/07/21)</p>	<p data-bbox="983 241 1426 786">Marginal instream habitat detail between RP8A and RP9. Partially dewatered at low flow and low tide. Very slack, virtually stagnant water over heavy FGA (>50% cover) and moss-covered angular cobble, embedded in places and in other locations loose over bedrock. Cobbles covered in FGA and brown diatom encrusted mosses (<i>C. fontanaloides</i> with <i>S. rivulare</i> and <i>F. antipyretica</i> further out from walls). No sea lamprey spawning or nursery habitat occurs within 5m from Quay wall.</p>
RP9 to RP10

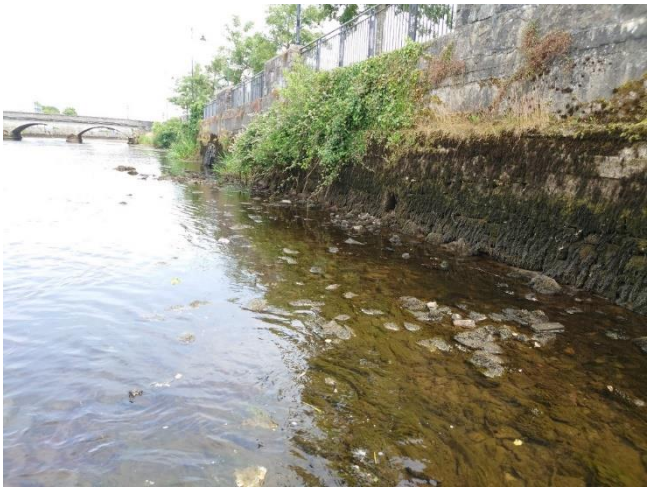
<p data-bbox="304 1296 954 1341">Image 3.3.15 View downstream from RP9 (22/07/21)</p>	<p data-bbox="983 797 1426 1341">The entire margin from RP9 downstream, for 5m (and more) out from the Quay wall, forms a shallow, slack glide at low flow/ low tide, with details of habitat as for Image 3.3.14 (above). Heavy steel flap of stormwater culvert in distance at RP10. Lower walls are dominated by <i>Cinclidotus</i> moss. Ivy and bramble coat the upper walls in places with occasional alder and sycamore bushes). No sea lamprey spawning or nursery habitat occurs within 5m from Quay wall.</p>

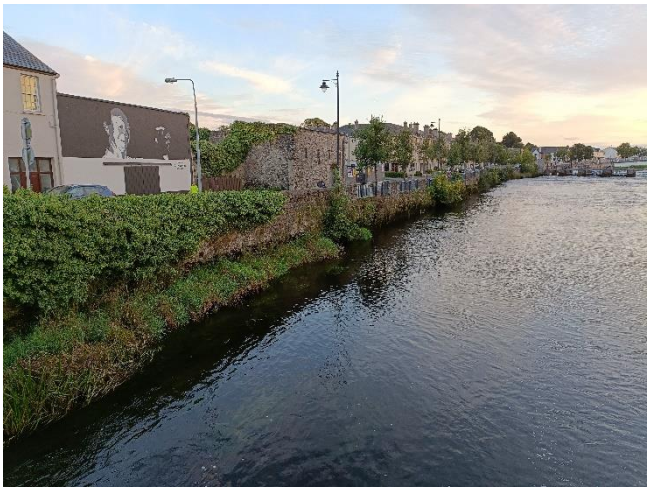
<p data-bbox="304 1852 954 1897">Image 3.3.16 Marginal berm at RP11 (12 /09/23)</p>	<p data-bbox="983 1352 1426 1897">RP11 is located just upstream of the Upper Bridge where a relatively 'dry' berm has formed on the inside edge upstream of the bridge. The berm occupies up to 2.5m of the river margin. Instream habitat within the band 5m from the Quay wall is dominated by glide flow over mainly pebble and gravel with coarse sandy deposits and occasional cobbles. Patches of <i>Ranunculus</i> spp., <i>Myriophyllum spicatum</i> and <i>Potamogeton</i> spp. (incl. <i>P. perfoliatus</i> and <i>P. x nitens</i>). A narrow marginal band of <i>S. erectum</i> occurs closer to the Upper Bridge. It is inaccessible for manual sampling but has potential to support larval lamprey.</p>

There is potential for direct impact on juvenile lamprey habitat at one point (Site RP11) on the RHS (Ridgepool Road) just upstream of the Upper Bridge. Larval lampreys were not confirmed in this location, but the area must be treated as potential juvenile habitat as there is a reach of sluggish depositing backwater with silty substrate and patches of emergent *Sparganium erectum*.

The patch of *potential* larval lamprey on the RHS on Ridgepool Road upstream of the Upper Bridge (**Site RP11**) is directly affected by the proposed 5m instream works area. If possible, it is recommended that works on Quay walls at this point are conducted from the road above, without an instream footprint. In the event this is not possible, mitigation will be required to remove lamprey ammocoetes prior to dewatering of the margins. It may be possible to achieve this using electrofishing techniques at low flow / low tide. Alternatively, marginal silt/mud can be excavated from the river margin within cofferdams at low flow / low tide and spread out at the bank to allow for removal of juvenile lamprey. Ammocoetes can be kept in a bucket of clean water and relocated to suitable habitat at the floating pontoon adjacent to Bachelors Walk, downstream of the N59 Lower Bridge. Juvenile lamprey will re-burrow very quickly following disturbance once they encounter suitable marginal habitat (Maitland 2003).
