Clifton Scannell Emerson & Associates

Castlebar Town, Co. Mayo

Non-Motorised Road User Accessibility
Assessment

Document Ref:	P22-018-UQA-GEN-RP-001
----------------------	-------------------------------

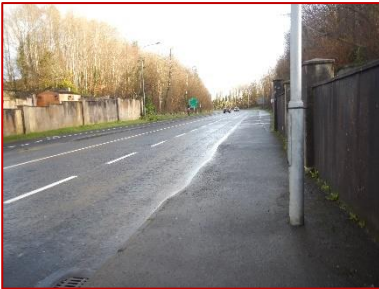
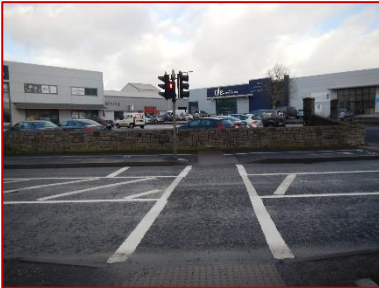
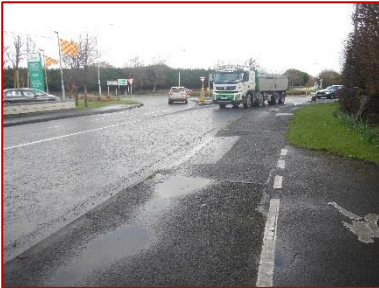
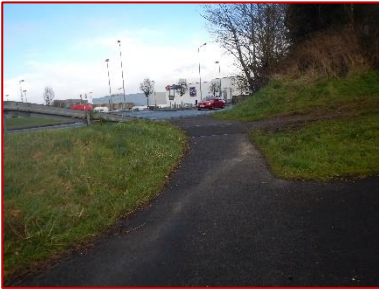
4.1.10 Ladder and Tramline Tactile Paving

At the start & end of shared pedestrian and cycle facilities the roadmarkings provided (e.g. pedestrian and cyclist symbols and straight-ahead arrows) are faded and there is no 'Ladder & Tramline' tactile paving to advise visually-impaired pedestrians that they are entering/leaving an area shared with cyclists.

Adequate warning signage, markings and 'Ladder & Tramline' tactile paving should be provided at the start and end of shared pedestrian/cycle facilities.

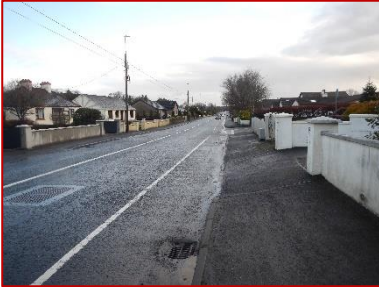
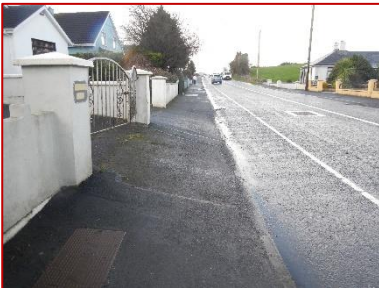
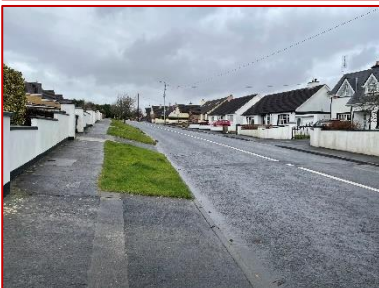
4.1.16 Step Transverse Gradient (crossfall) on Footpaths

At number of locations along the existing footpaths have relatively steep crossfalls. Steep crossfalls make it difficult for elderly or encumbered pedestrians to walk on the footway. Crossfalls steeper than 3% are uncomfortable to walk on and if the slope runs towards a road it can be dangerous, as wheeled users will tend to edge down the crossfall.

Crossfalls at these locations should be revised to more suitable gradients.

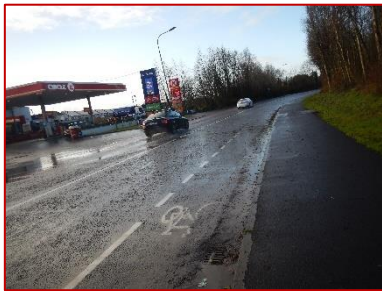
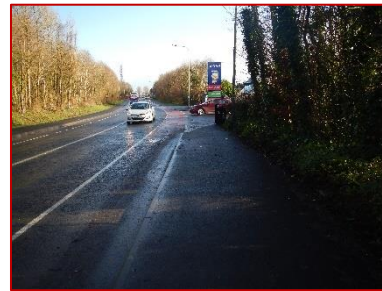
4.2.2 N5 Humbert Way Service Station

An existing service station is located at Humbert Way (N5) which has two wide vehicle access/egress points. At the entrance and exit to the service station the existing footpath terminates and there are no crossing facilities to the opposite footpath.

The layout of the entrance and exit to the service station should be revised & if possible the width reduced, and continuous footpaths provided across the access/egress.

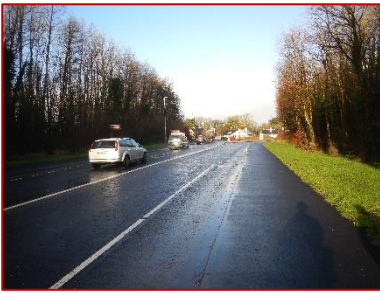
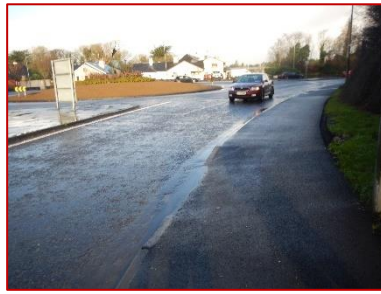
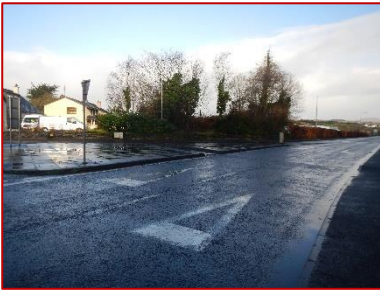
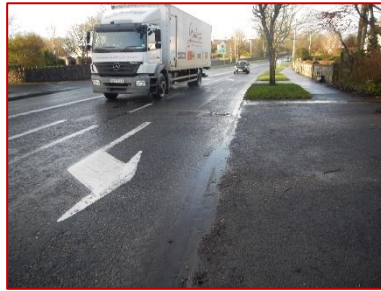
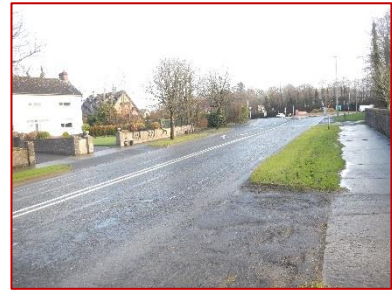
The absence of pedestrian crossing facilities presents an obstacle for the mobility impaired proceeding past the roundabout.

No cyclist provisions are provided on the approaches to, or at the roundabout which would present challenges to less-confident cyclists in navigating the roundabout.

The junction should be amended/ upgraded to incorporate pedestrian crossings and cyclist facilities.

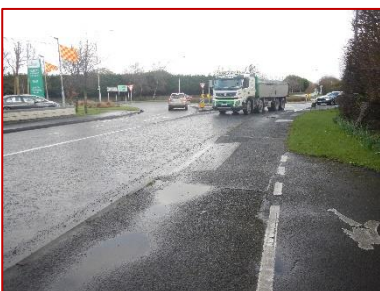
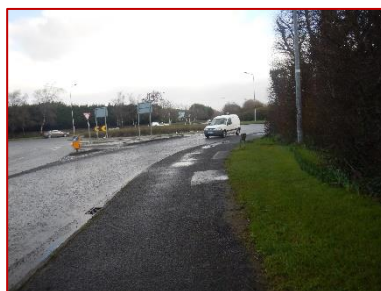
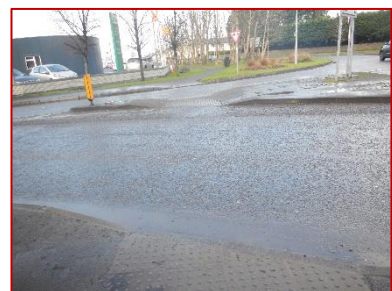
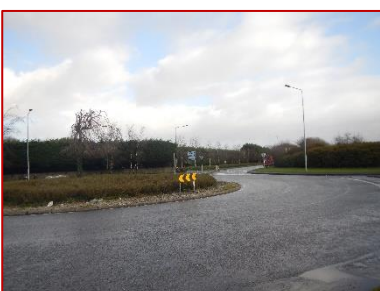
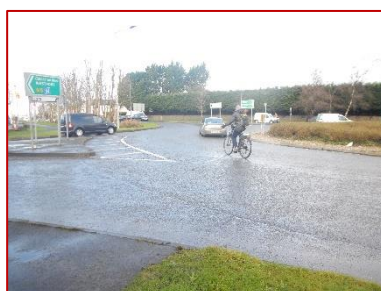
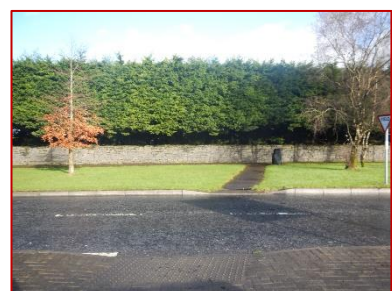
Uncontrolled pedestrian crossings are provided on the roundabout arms, however these crossing facilities do not cater for visually-impaired pedestrians resulting in them being unable to cross at the roundabout safely & independently.

No cyclist provisions are provided on the approaches to, or at the roundabout which would present challenges to less-confident cyclists in navigating the roundabout.

The junction should be amended/upgraded to incorporate pedestrian crossings and cyclist facilities.

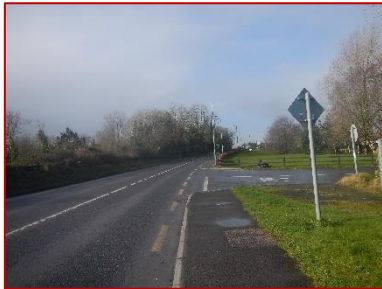
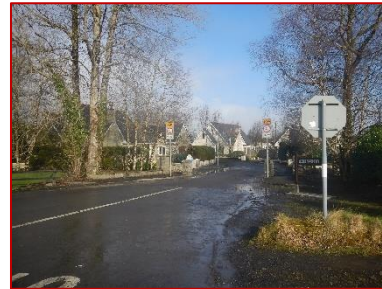
4.2.5 Ashwood/ N60 junction

The existing footpaths within Ashwood and along the N60 are not linked, with pedestrians having to walk on the verge or in the carriageway to access to the footpath on the N60, with a consequent increased risk of slips, trips and falls or of being struck by a vehicle.

The footpaths within Ashwood and along the N60 should be linked and an appropriate crossing provided at this residential estate access junction.

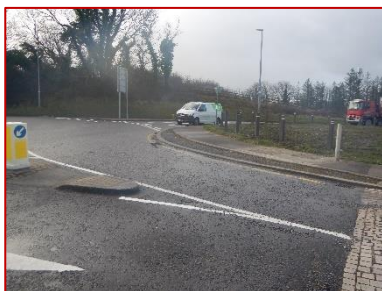
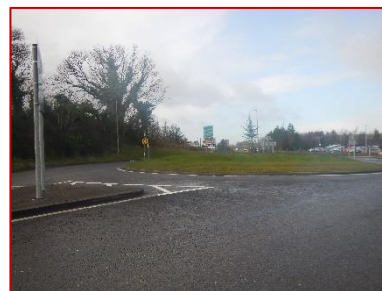
The existing N60/IDA roundabout has three wide approach arms, but lacks suitable pedestrian crossing facilities and cyclists facilities. The absence of pedestrian crossing facilities prevents visually impaired pedestrians from being able to cross the roundabout independently.

No cyclist provisions are provided on the approaches to, or at the roundabout which would present challenges to less-confident cyclists in navigating the roundabout.

The junction should be amended/upgraded to incorporate pedestrian crossings and cyclist facilities.

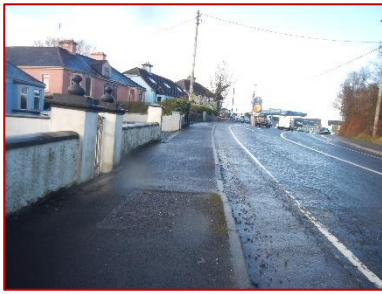
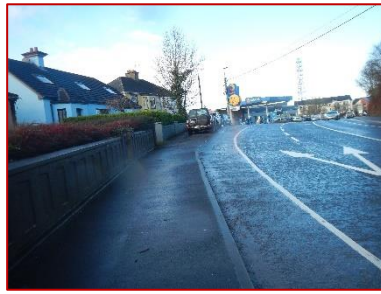
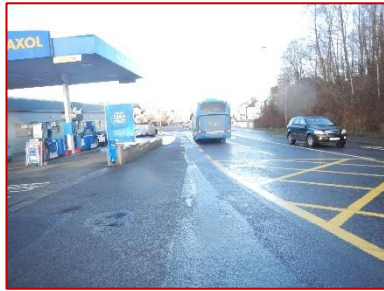
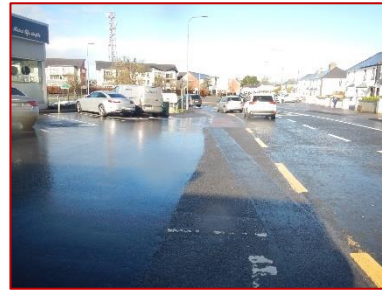
An existing service station is located at Station Road (N60), which has wide accesses/egresses. The footpath along Station Road terminates at these entrances and no crossing facilities are provided. In addition, the service station includes a number of echelon (angled) parking spaces. Entry to these parking spaces would require reversing manoeuvres across the pedestrian route.

The footpath layout at this location would present difficulties for visually impaired in safely and independently travelling along Station Road.

A continuous footpath should be provided across the entry and exit of the service station. In addition, the parking arrangements should be revised such that no reversing manoeuvres would take place across the footpath or within the N60 carriageway.

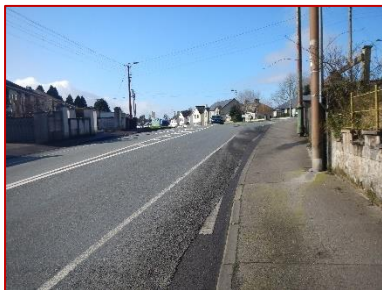
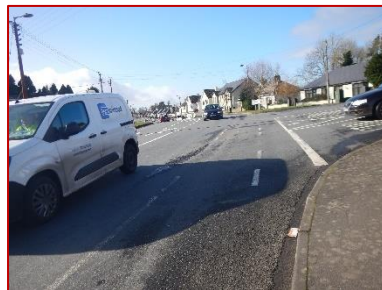
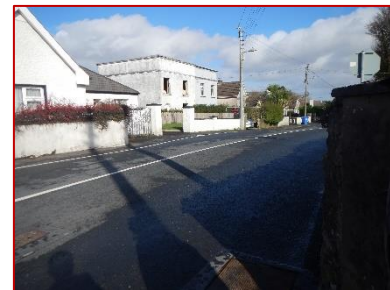
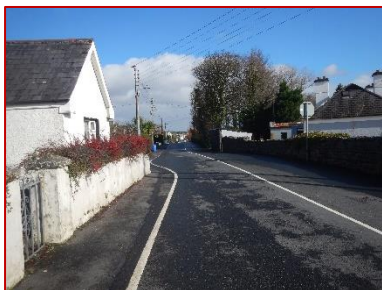
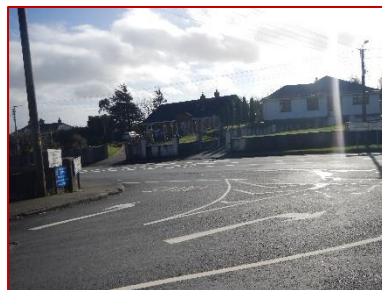
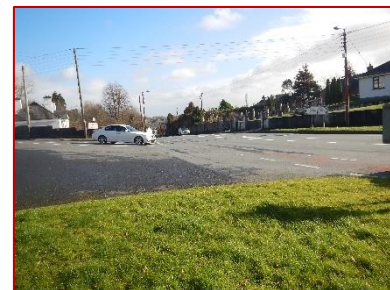
4.2.11 Newport Road (R311)/Pound Road junction

At the Newport Road (R311)/Pound Road junction a number of issues were identified as follows: -

- Wide junction mouth resulting in lengthy crossing for the mobility-impaired and/or elderly pedestrians;
- Faded red surfacing within the cycle lane which could reduce the awareness of drivers of the likely presence of cyclists;
- A lack of pedestrian crossings which would prevent visually impaired pedestrians from crossing at the junction safely and independently; and
- A lack of footpaths linking Newport Road and Pound Road.

The absence of crossing facilities at the Newport Road could result in pedestrians crossing the road at unsafe location increasing the likelihood of conflicts with vehicles. In addition, the lack of crossing facilities would also prevent the mobility impaired from crossing to the opposite side of Newport Road resulting in them having to undertake a longer route to access the footpath on the other side.

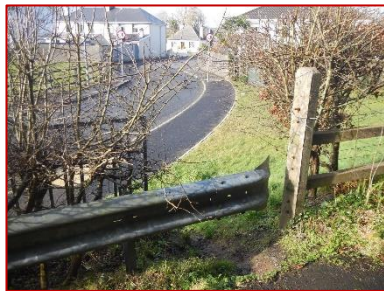
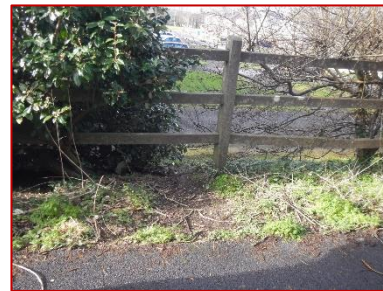
4.2.13 Lough Lannagh Amenity Park link via Newport Road

Along the link between Lough Lannagh Amenity Park and Newport Road a number of pedestrian desire lines along informal routes to and from Blackfort Manor were identified that are not catered for by formal pedestrian facilities. Pedestrian and/or cyclists traversing unpaved routes increases the risk of slips, trips or falls particularly during wet or icy weather.

Pedestrian/cyclist facilities for access to Blackfort Manor should be provided along the link between the Lough Lannagh Amenity Park and the Newport Road.

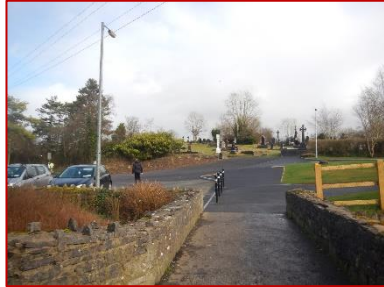
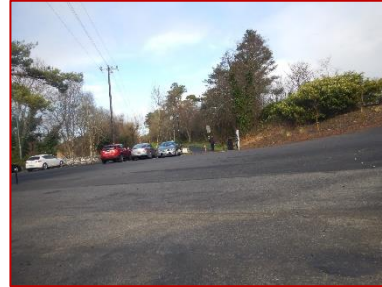
4.2.16 Greenway Interface with Car Parks

The Greenway travels through car parks at number of locations within the Lough Lannagh Amenity Park. The arrangement at these locations is that the Greenway's shared surface terminates at the car park, and there are no routes provided to enable the visually impaired to continue safely and independently to cross the car park and rejoin the Greenway.

A continuous footpath/shared surface should be provided along the Greenway route through the car park areas. Appropriate crossing facilities should be provided where the Greenway crosses a carriageway.

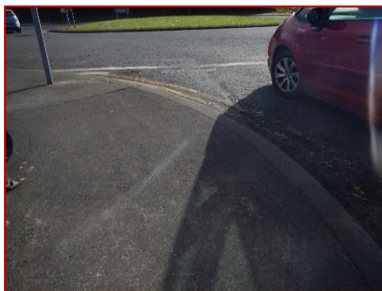
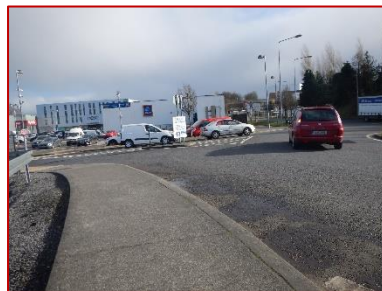
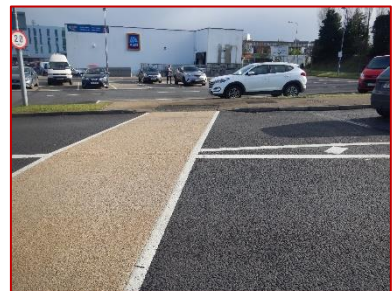
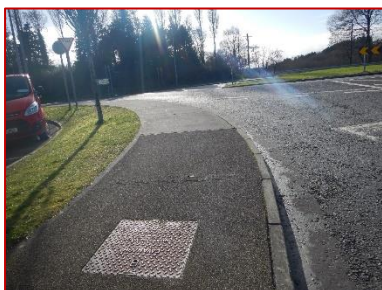
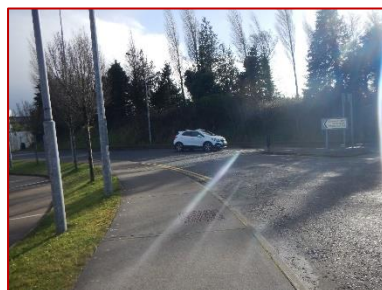
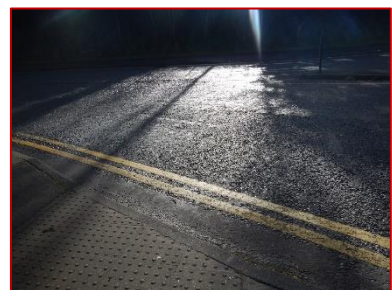
The roundabout to the southwest of the car park serving TK Maxx, Next & Aldi has three wide approach arms. Uncontrolled pedestrian crossings are provided on the roundabout arms, however these crossing facilities do not cater for visually-impaired pedestrians resulting in them being unable to cross at the roundabout safely & independently.

No cyclist provisions are provided on the approaches to, or at the roundabout which would present challenges to less-confident cyclists in navigating the roundabout.

Measures should be provided to cater for all non-motorised road users at this junction.

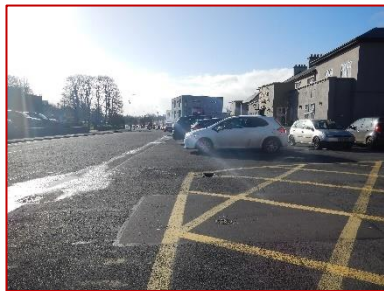
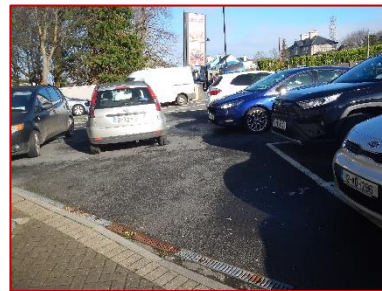
The footpath along Westport Road in the vicinity of The Royal Theatre and Event Centre terminates abruptly at a location where perpendicular parking spaces are provided in front of The Royal Theatre and Event Centre.

This arrangement results in pedestrians having to enter the carriageway to continue their journey resulting in increased risk of being struck by a vehicle. In addition, this arrangement would prevent visually impaired pedestrians from traversing this location safely and independently.

A continuous footpath should be provided at this location linking the existing footpath along Westport Road.

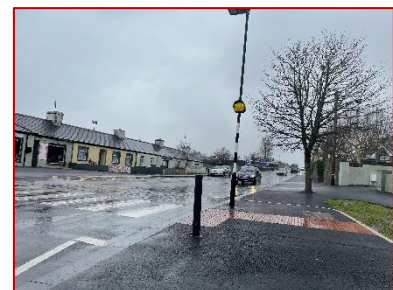
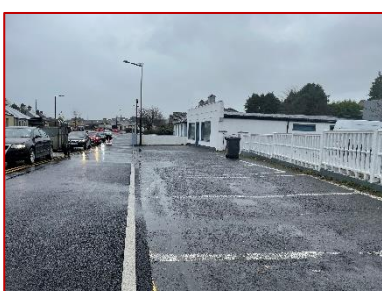
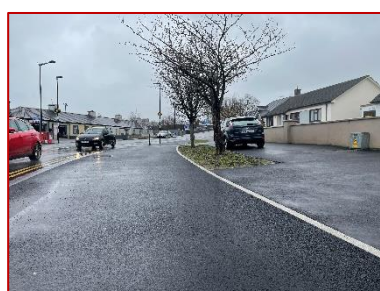
There is an existing shared surface along Springfield Road, located in front of a wide parking area. There is no vertical separation between the carriageway and the shared surface, and the position of the parking spaces to the rear of the shared surface increases the risk of conflicts between drivers and pedestrian/cyclists.

The lack of vertical separation between the carriageway and the shared surface could result in visually-impaired pedestrians inadvertently entering the carriageway.

The position of the shared path and the parking arrangements at this location should be reconfigured such that the path runs to the rear of parallel parking along the roadside.

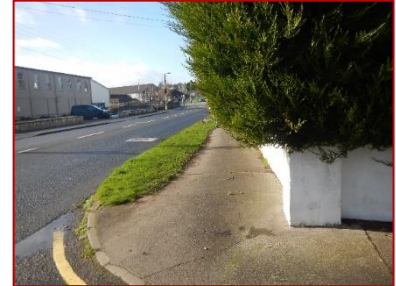
Vegetation resulting in reduced footpath width and presenting an obstacle for the mobility-impaired and a hazard for visually-impaired pedestrians.

Vegetation should be cut back and regular maintenance undertaken.

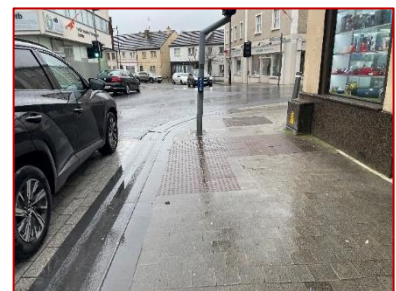
4.3.9 Linenhall Street/ Rush Street/ Lucan Street/ Main Street Junction

There is no vertical separation between the carriageway and the footpaths at the Linenhall Street/ Rush Street/ Lucan Street/ Main Street signalised junction.

Full-height kerbs should be provided between footpaths and the adjacent carriageway, other than at crossing locations. Where this is not feasible/possible then footpaths shall have minimum of 60mm vertical separation to the carriageway, 25mm at vehicular accesses and a maximum of 6mm at pedestrian crossings.
